# Mitigation best practices

## Building codes helped Bolivar Peninsula homes survive

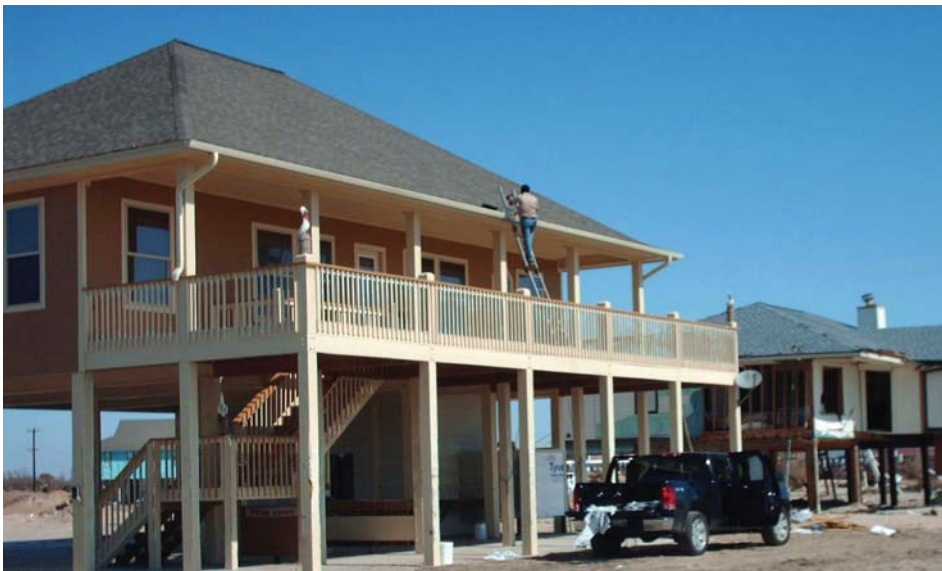
Jimmy and Debbie Bishop's house survived Hurricane Ike nearly unscathed. Their neighbor's older home, pictured on right, was built 4 to 5 feet lower and was significantly damaged.

When they reached their house, they found the bottom-level breakaway walls gone, as the design had called for. Their stairs were a little askew but still sturdy enough to climb to the second-level living area.

The building elevation may have been the most important safety factor. The required elevation was 16 feet, but the house was

raised an additional seven feet, as a margin of safety. The additional amount of height above the required elevation is called “freeboard.” It provides added protection and results in lower flood insurance premiums.

Jimmy empathizes with his neighbors. “Next door, our neighbor’s house is older and probably 4 to 5 feet lower than ours. It took the surge and the waves, and the beach

side of it is totally gone. It may have to come down,” he said. “We feel for these people.”

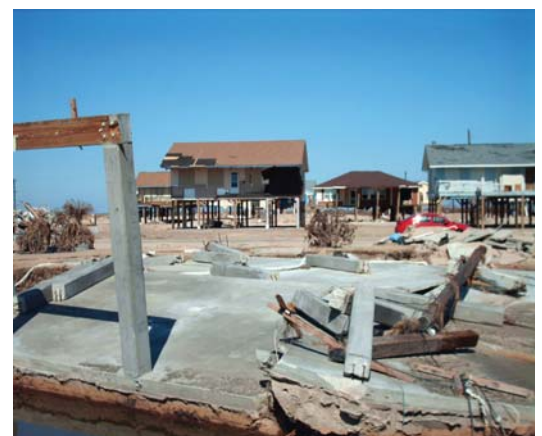
Bolivar destruction.

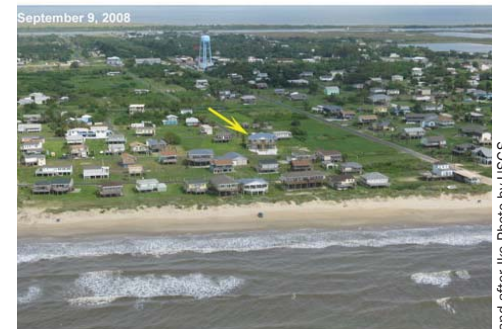
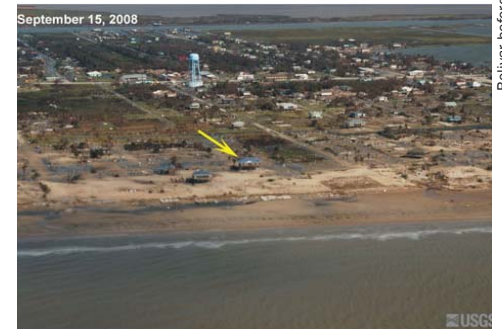
Bolivar before and after Ike Photo by USGS
