Mitigation Assessment Team Report

Hurricane Harvey in Texas

Building Performance Observations,
Recommendations, and Technical Guidance

FEMA P-2022 / February 2019

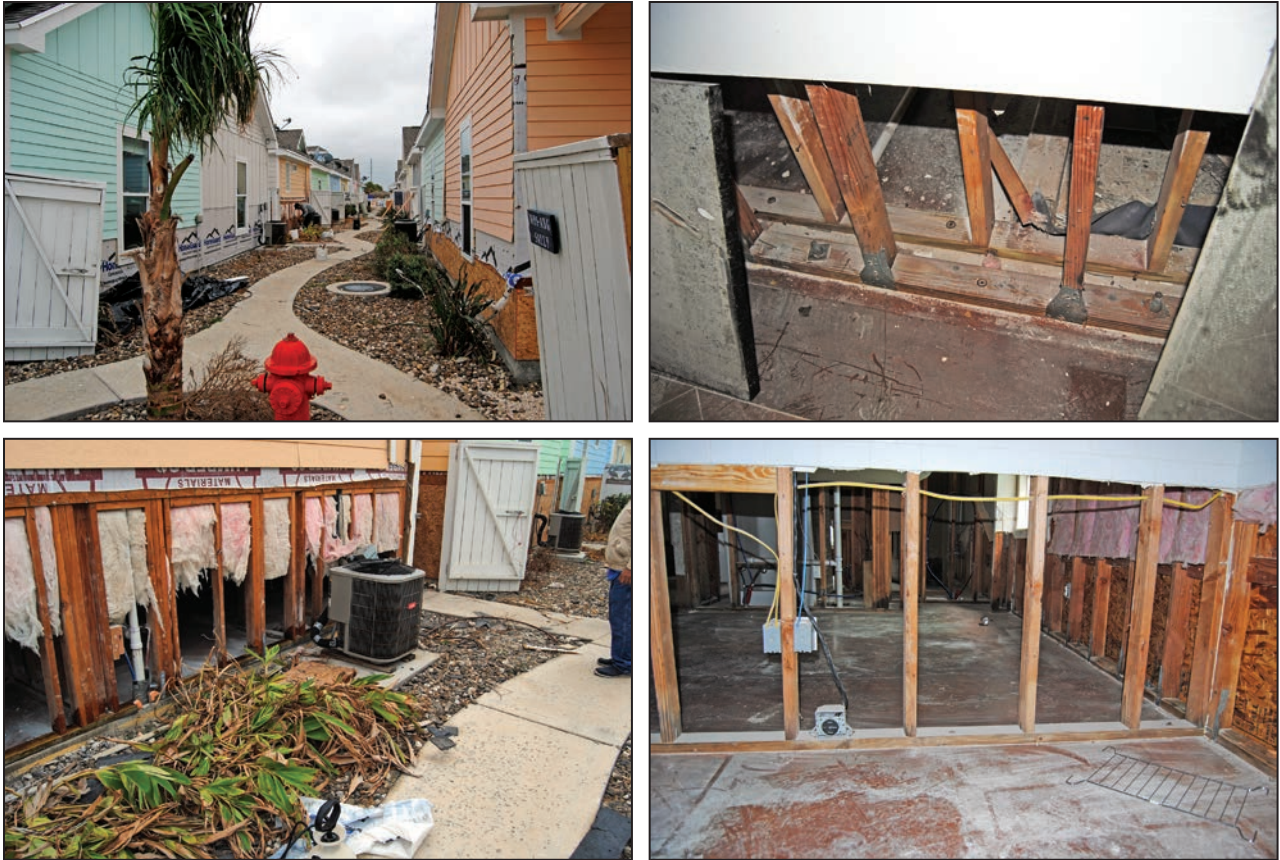
These one-story apartments in Nueces County were inundated by approximately 6 inches of floodwater. The flood damage resulted in extensive repairs to walls and flooring, including the party walls (top right) and to some condenser units (bottom left).

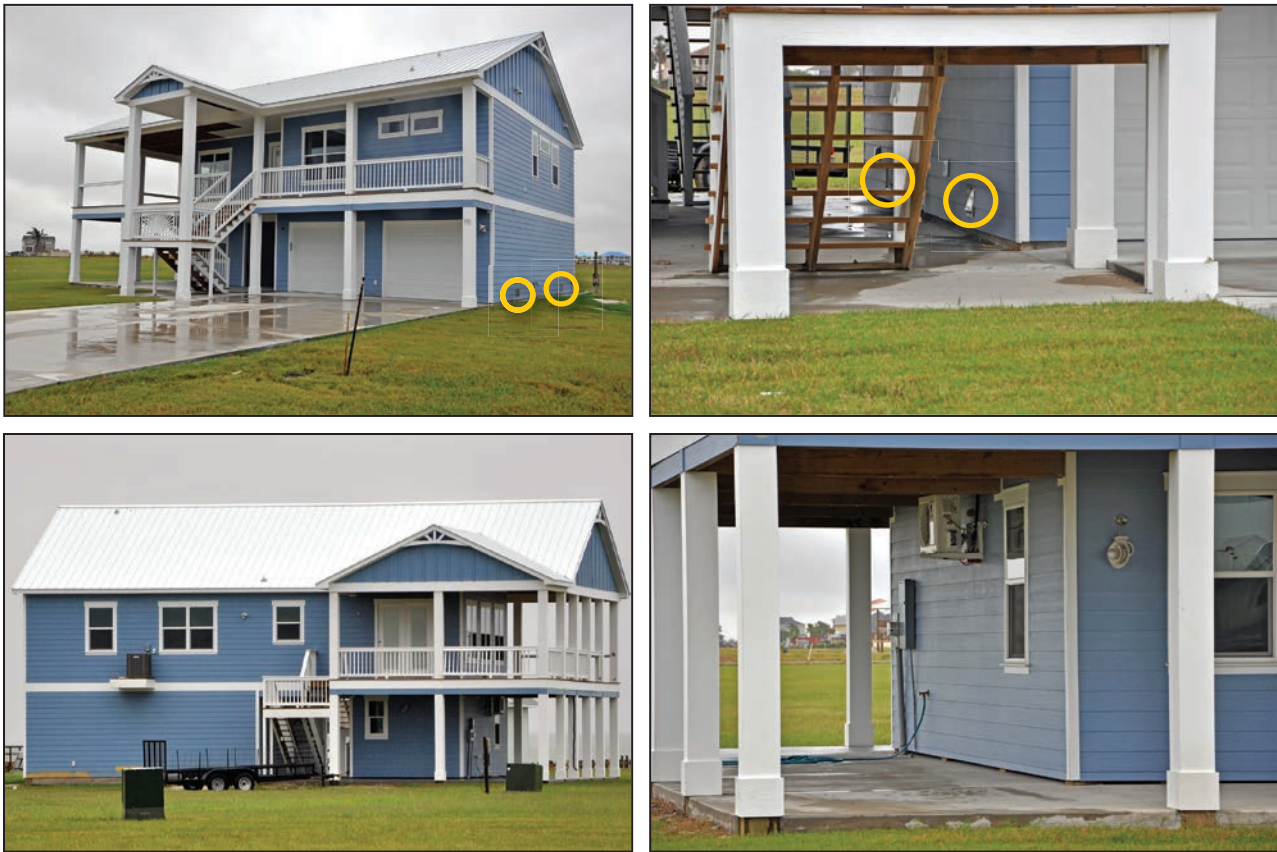
Residential building constructed with proper openings for the garage enclosure (top row, indicated by yellow circles), but no opening in the enclosure for access to the house (bottom row).

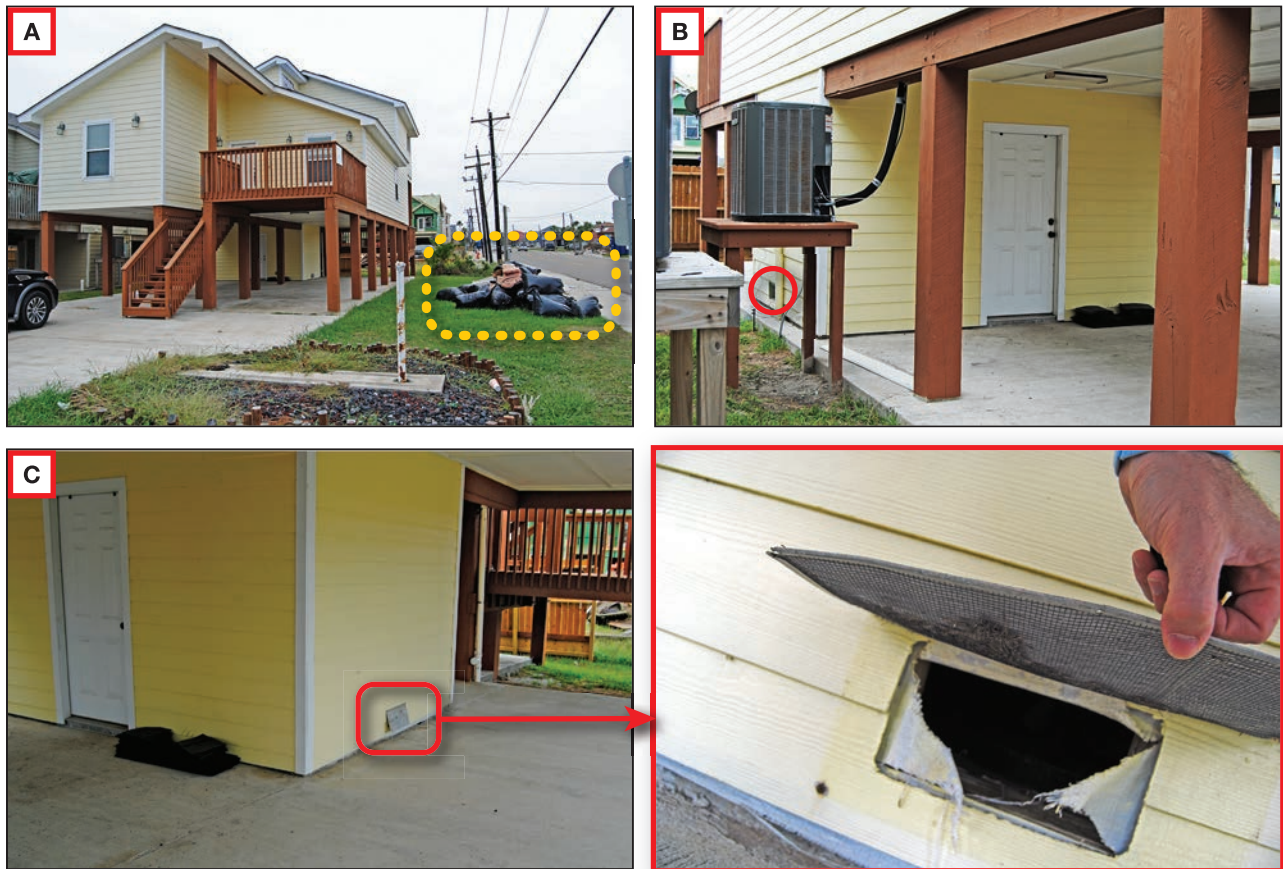
- [A] Elevated house in Nueces County with evidence of non-flood damage-resistant materials in the enclosure (yellow dotted circle identifying debris piles).
- [B] An engineered opening (red circle).
- [C] A non-compliant flood opening (red circle).

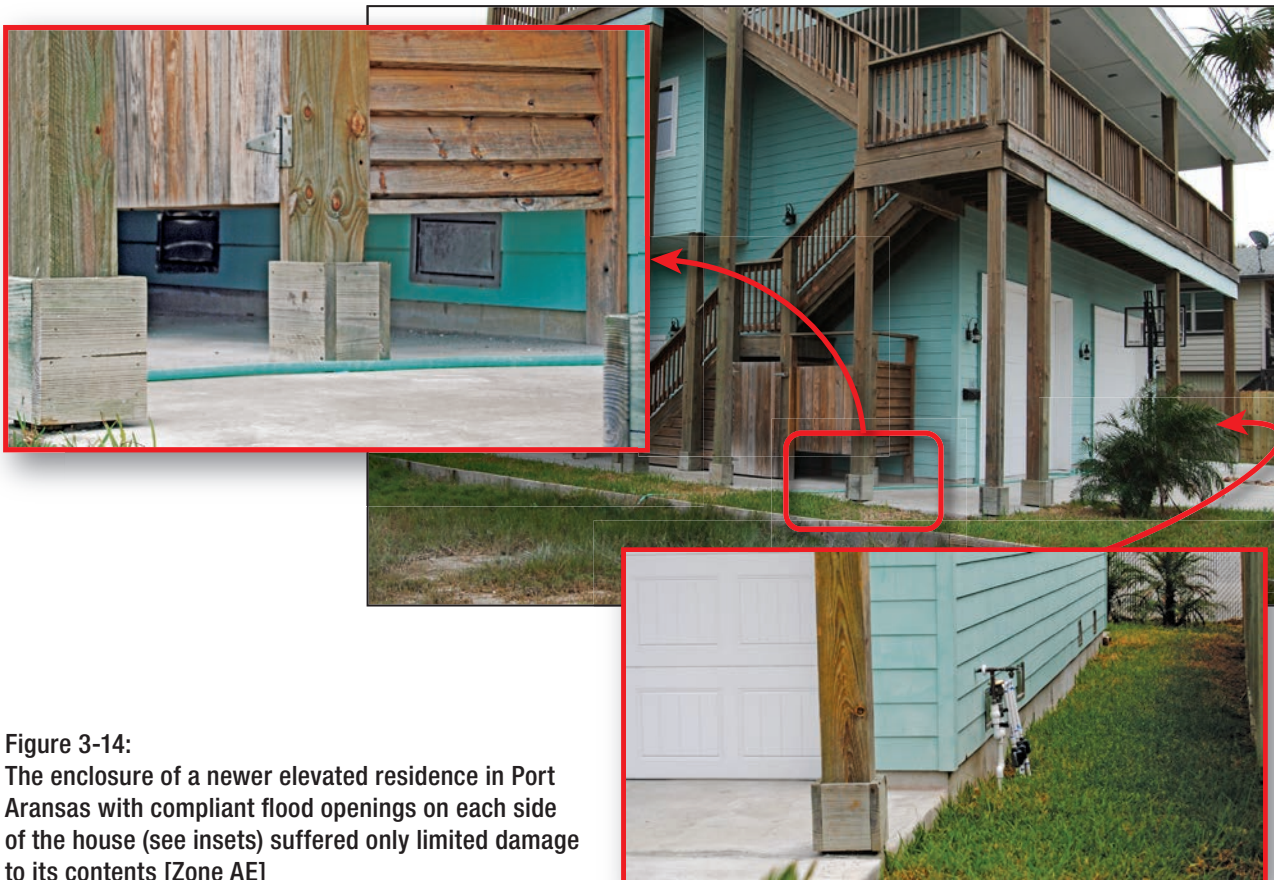
Figure 3-14: The enclosure of a newer elevated residence in Port Aransas with compliant flood openings on each side of the house (see insets) suffered only limited damage to its contents [Zone AE]

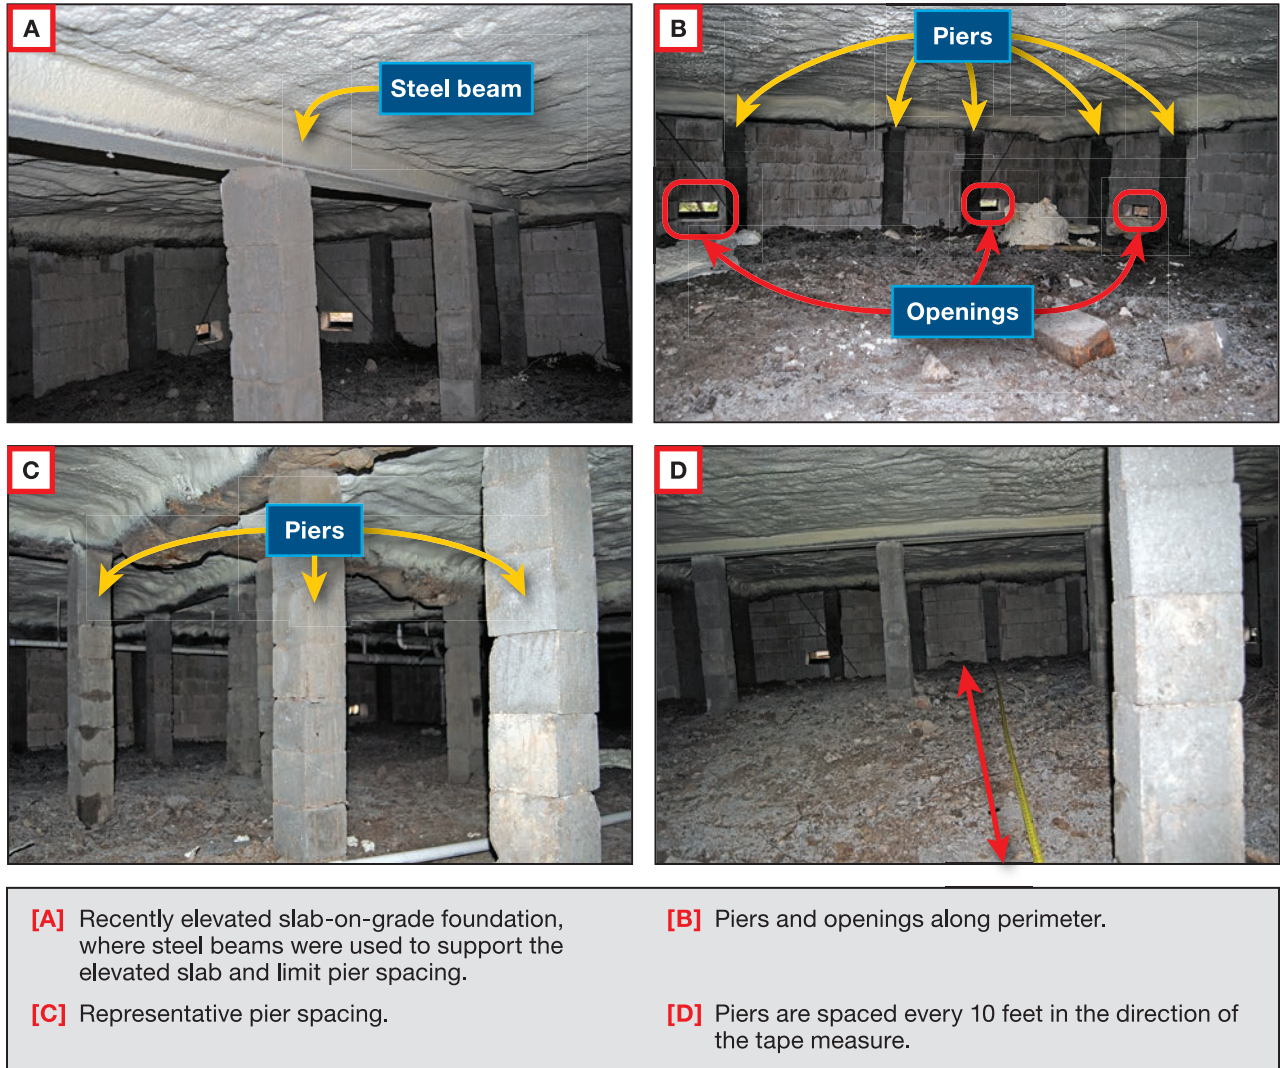
Figure 3-18: Recently elevated slab-on-grade foundation where steel beams were used to support the elevated slab and limit pier spacing [Zone AE]

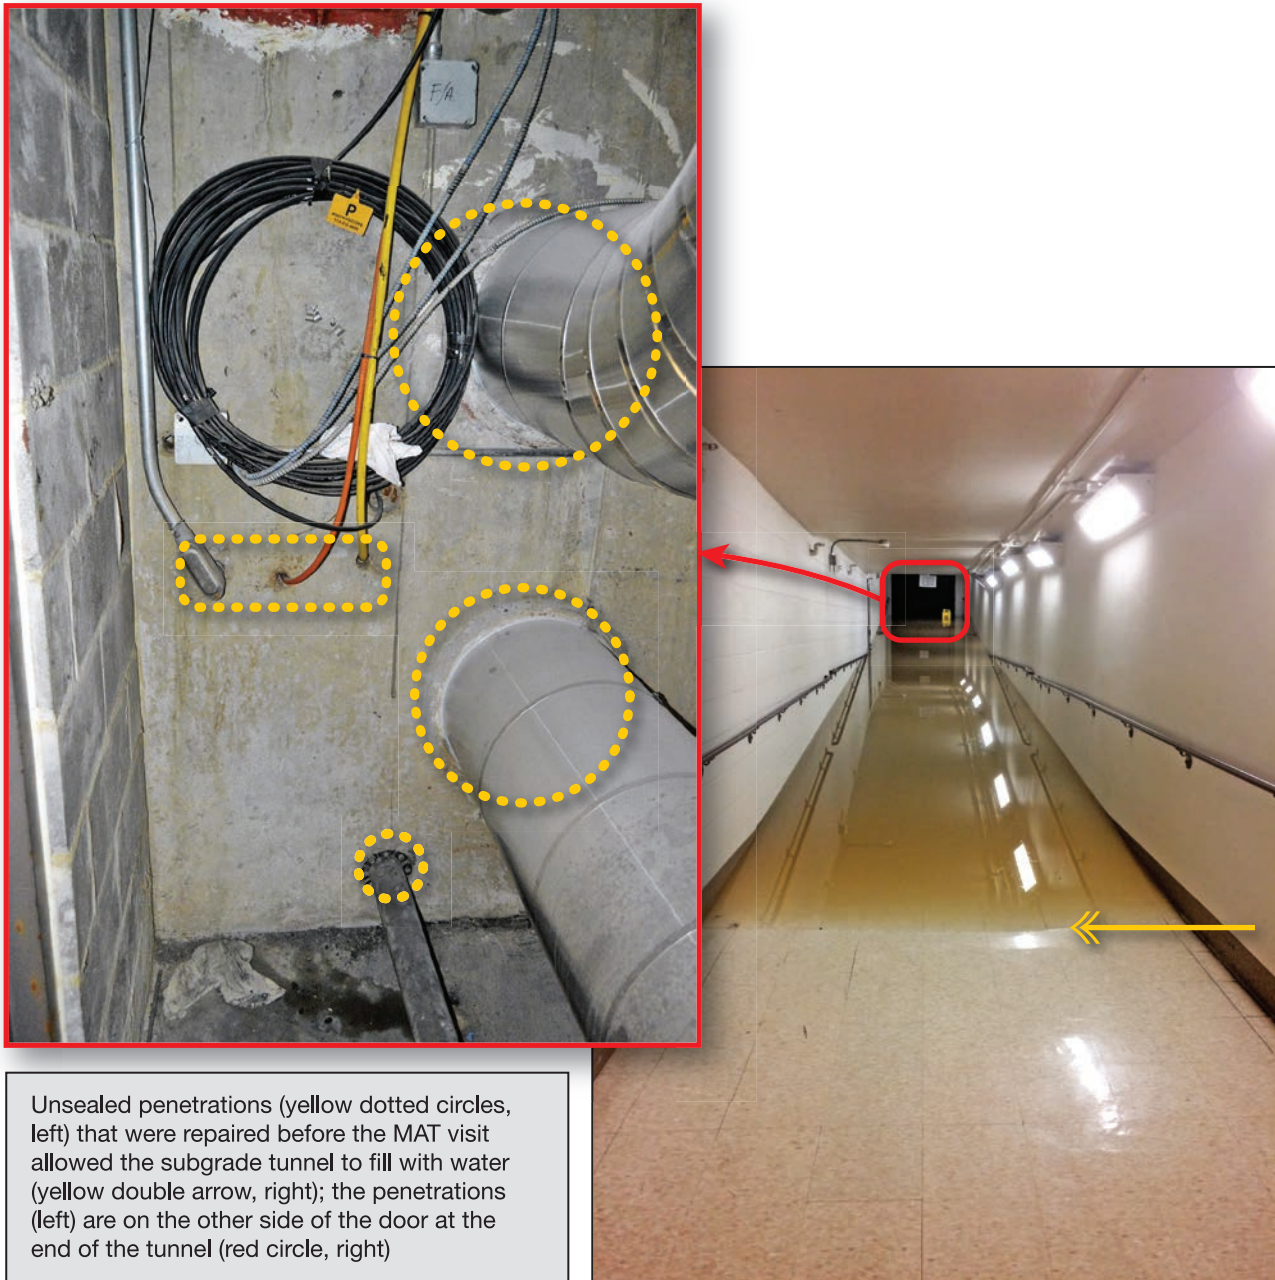
Unsealed penetrations (yellow dotted circles, left) that were repaired before the MAT visit allowed the subgrade tunnel to fill with water (yellow double arrow, right); the penetrations (left) are on the other side of the door at the end of the tunnel (red circle, right)

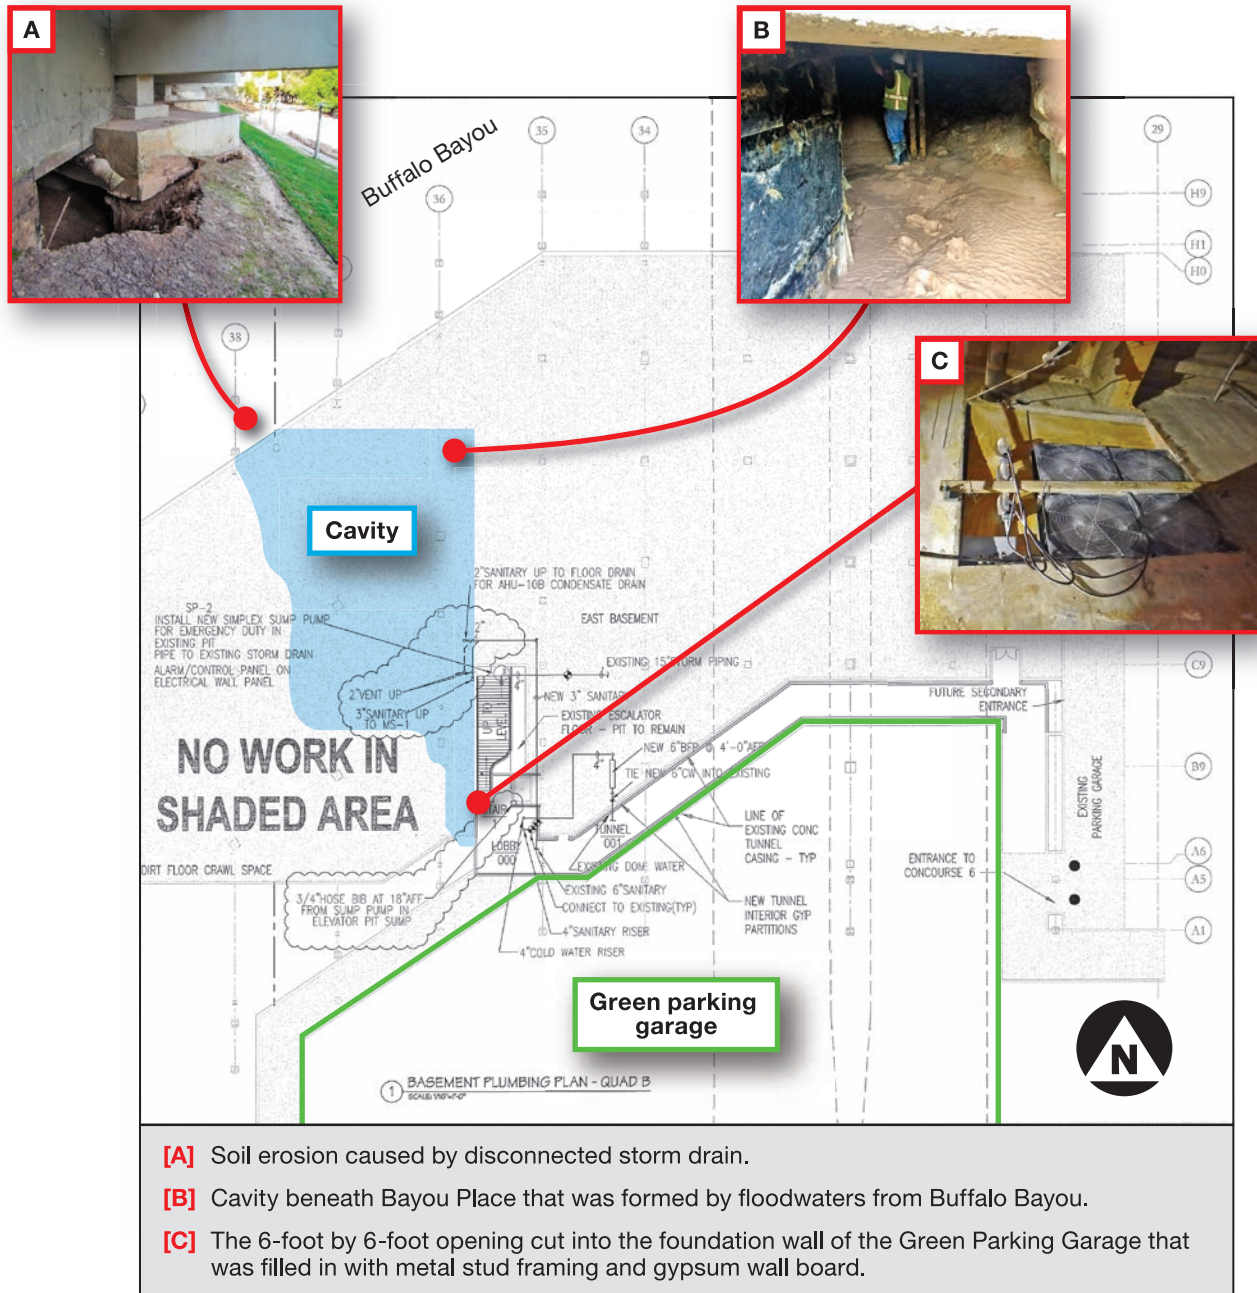
Figure 3-57: A disconnected pipe allowed stormwater to enter the cavity under the Green Parking Garage floor slab, resulting in the complete inundation of the garage

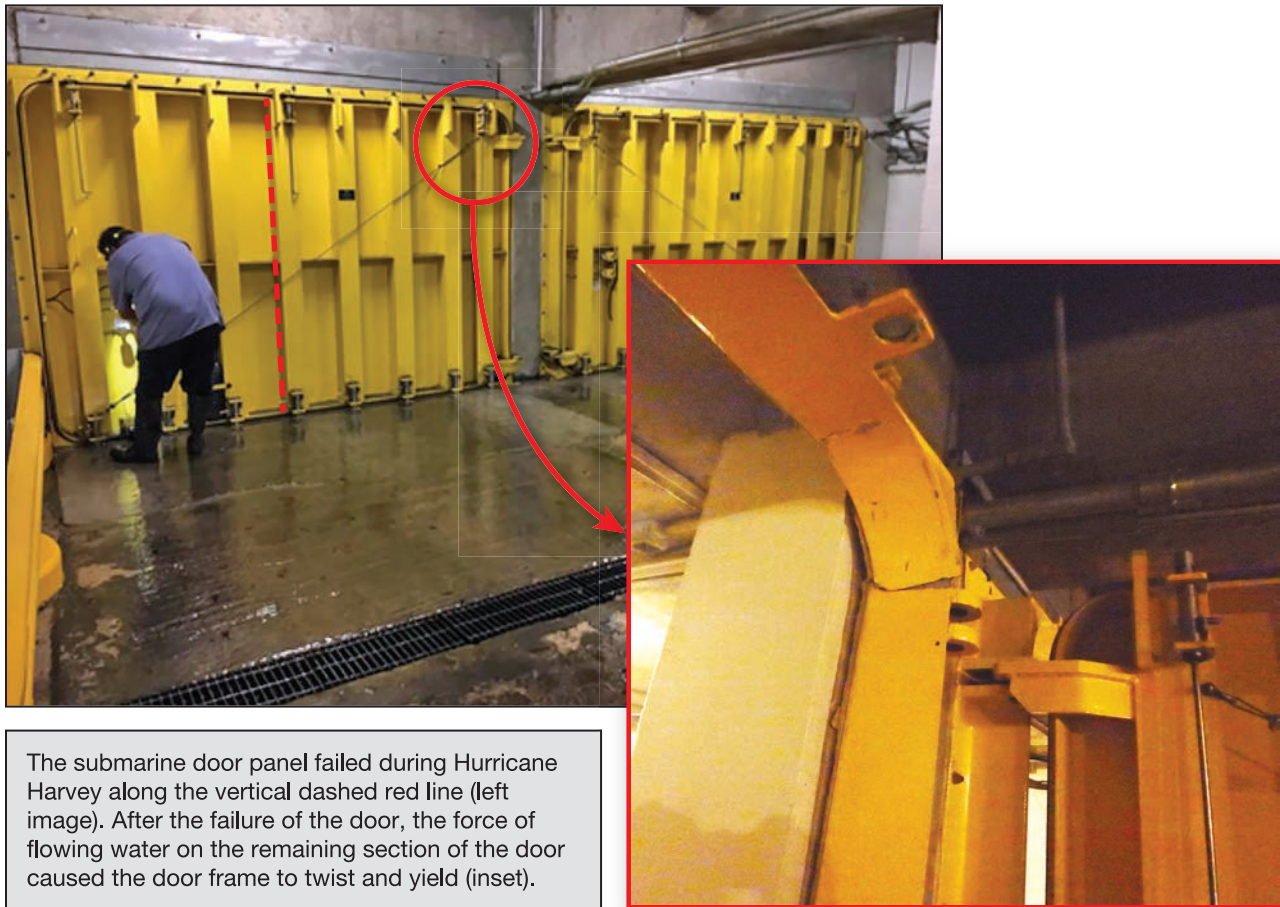
The submarine door panel failed during Hurricane Harvey along the vertical dashed red line (left image). After the failure of the door, the force of flowing water on the remaining section of the door caused the door frame to twist and yield (inset).

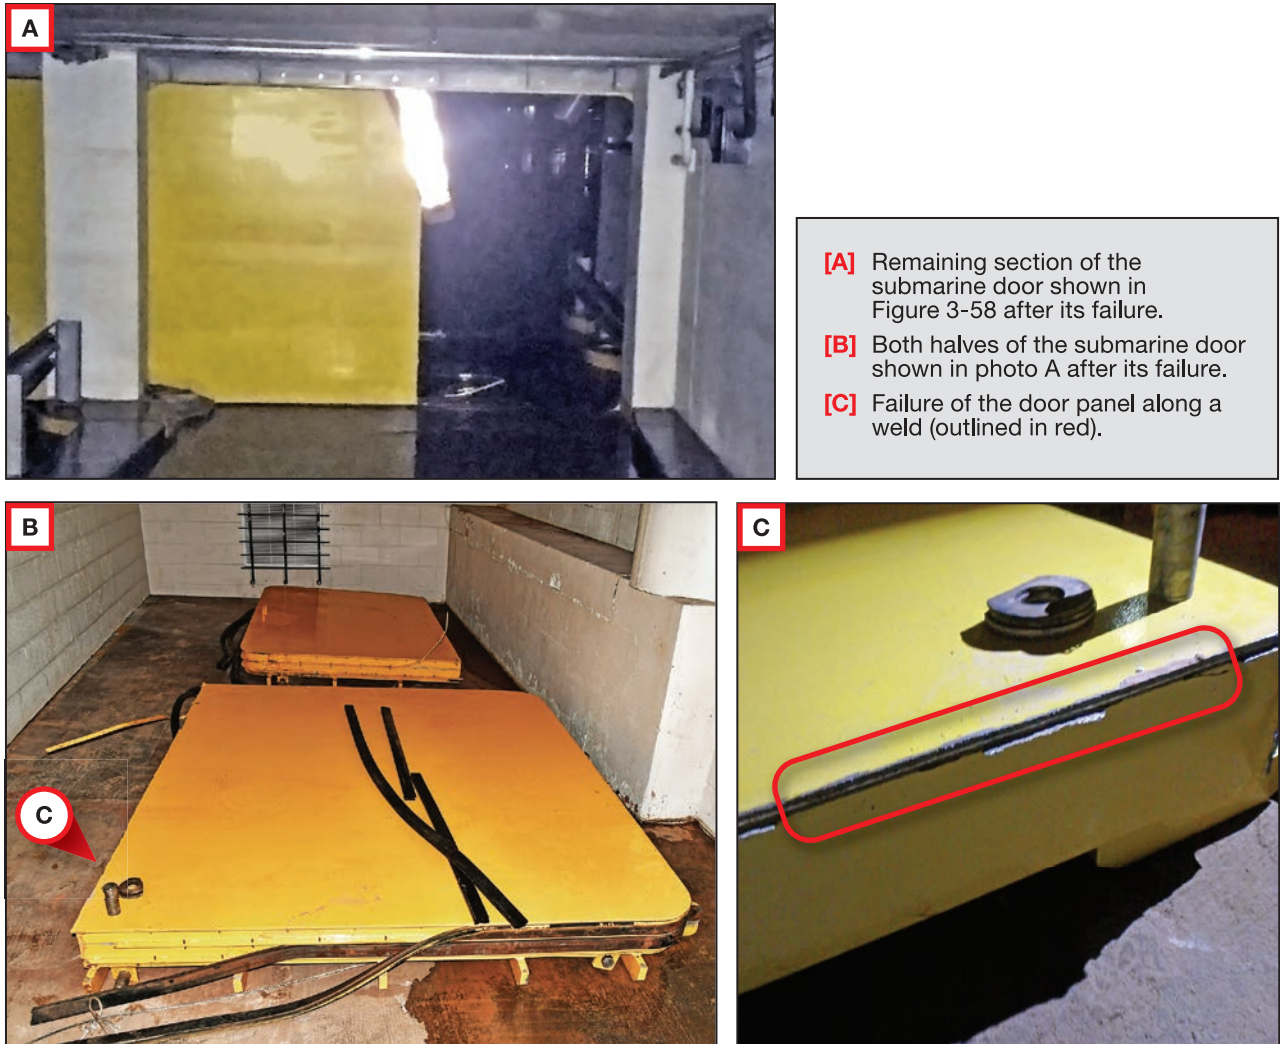
Figure 3-59: Submarine door shown in Figure 3-58 after its failure
 PHOTOGRAPHS COURTESY OF CARLOS GUTIERREZ, CSF CONSULTING

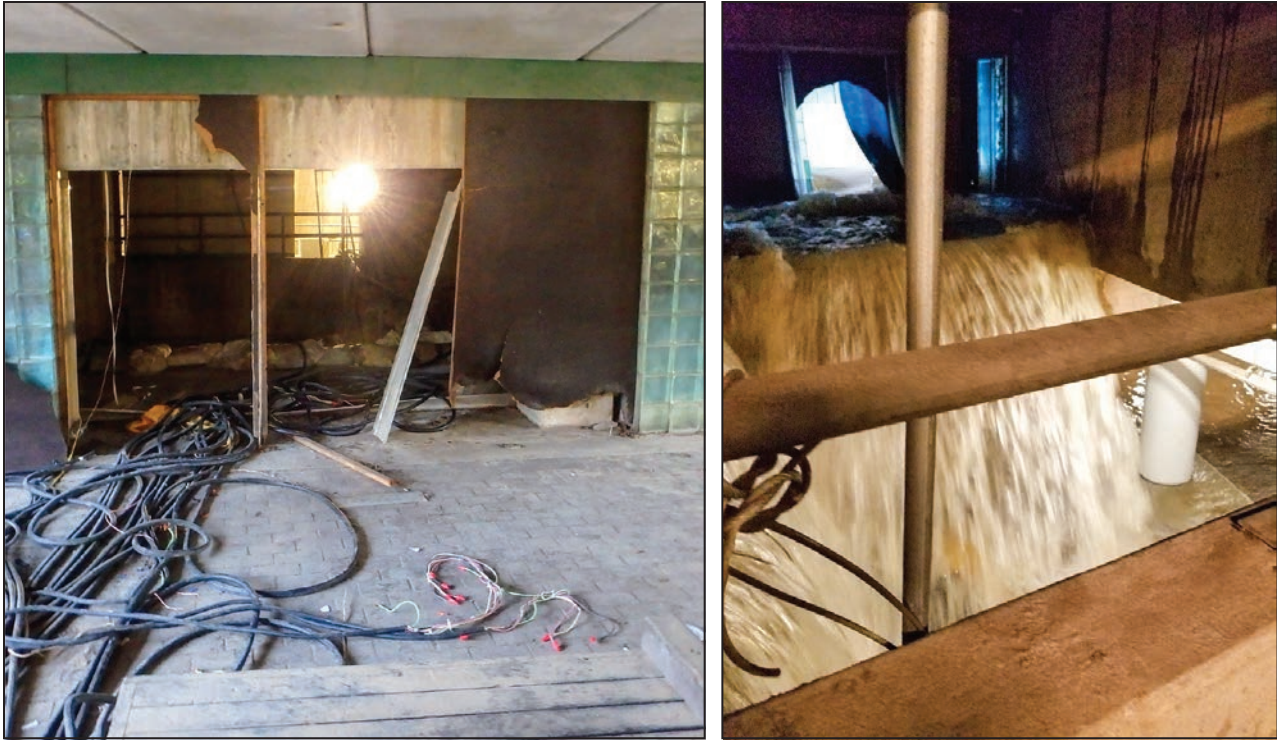
Figure 3-60: Glass block wall that failed when exposed to floodwater pressures (left); floodwater entering through Breach No. 3 (right)

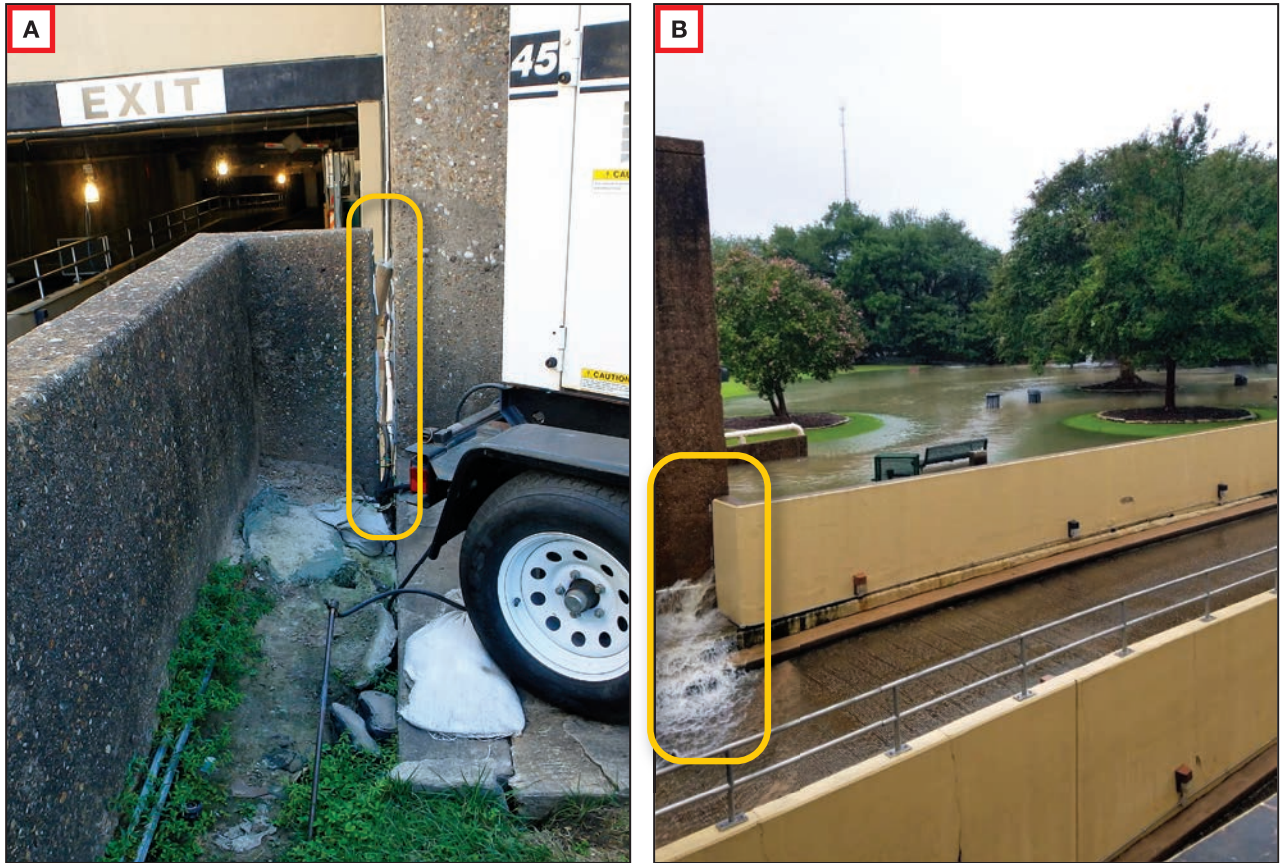
[A] Gap between a retaining wall and foundation wall of the Little Tranquility Park Parking Garage (yellow outline); the cables running through the gap were placed there after Hurricane Harvey.

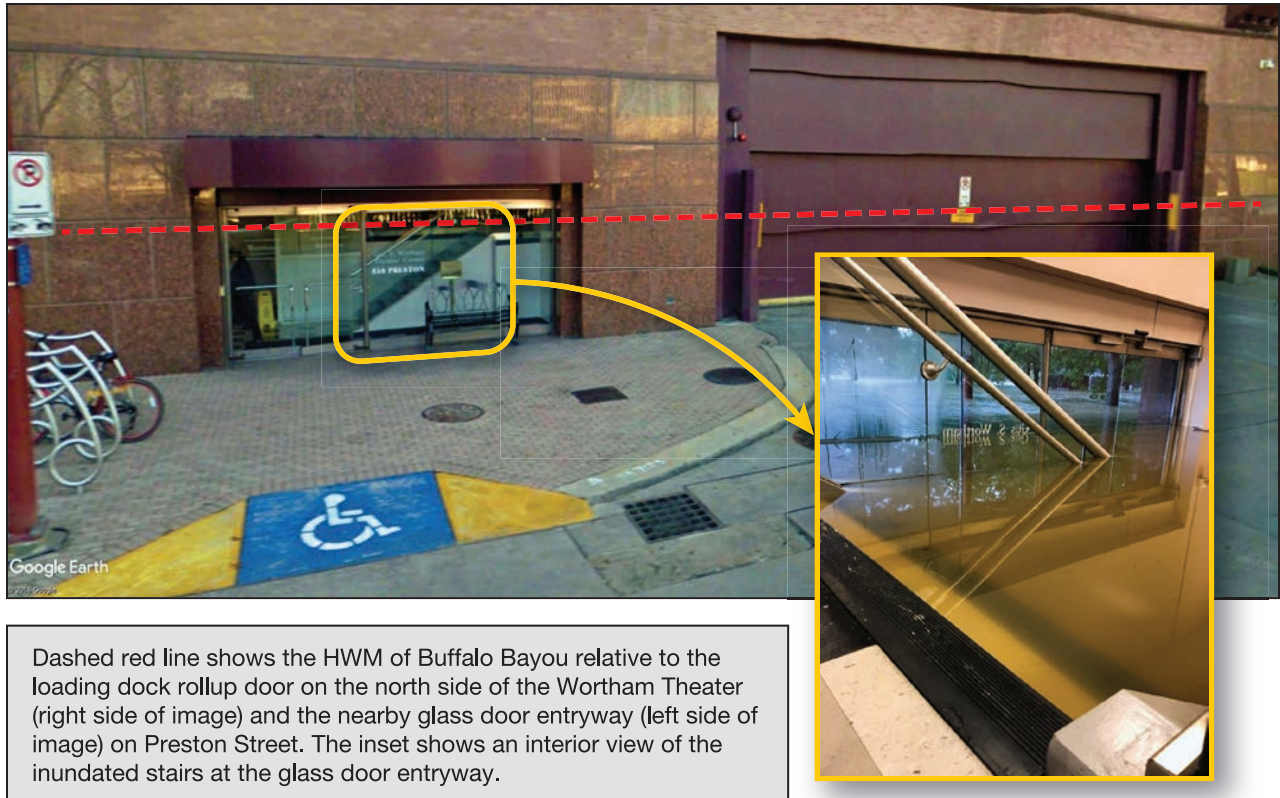
Figure 3-66: Floodwater entry point through glass door entryway

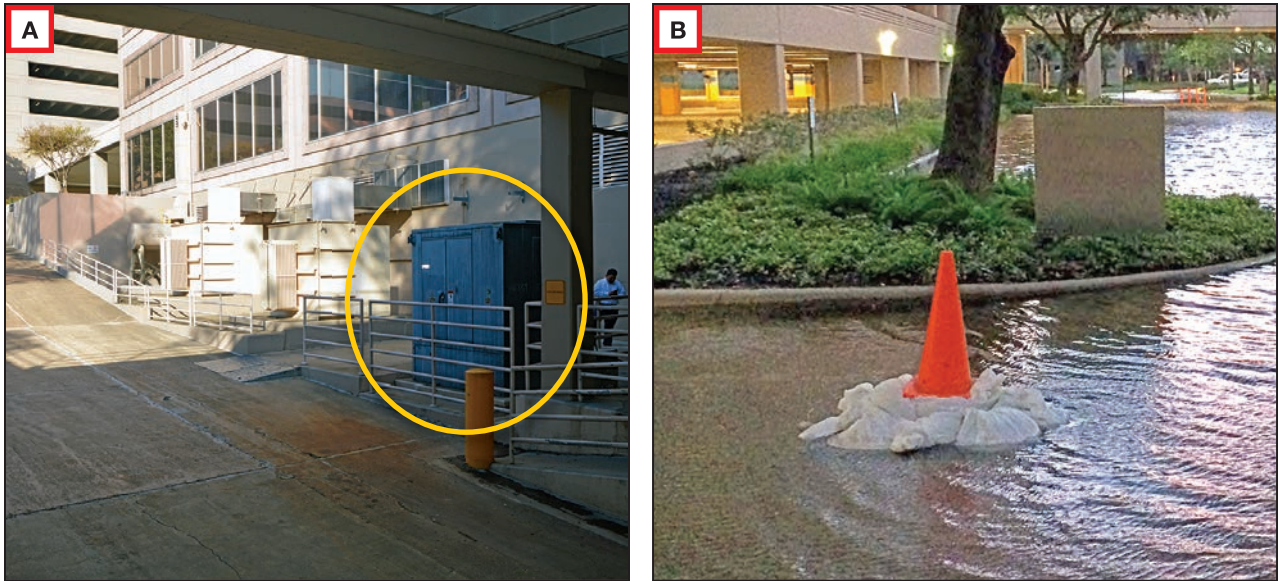
[A] Floodwater was able to enter the protected loading dock area by flowing within conduits that terminated at the utility switchgear (yellow circle). The electrical manhole in the street has conduit that connects to the utility switchgear in the loading dock.

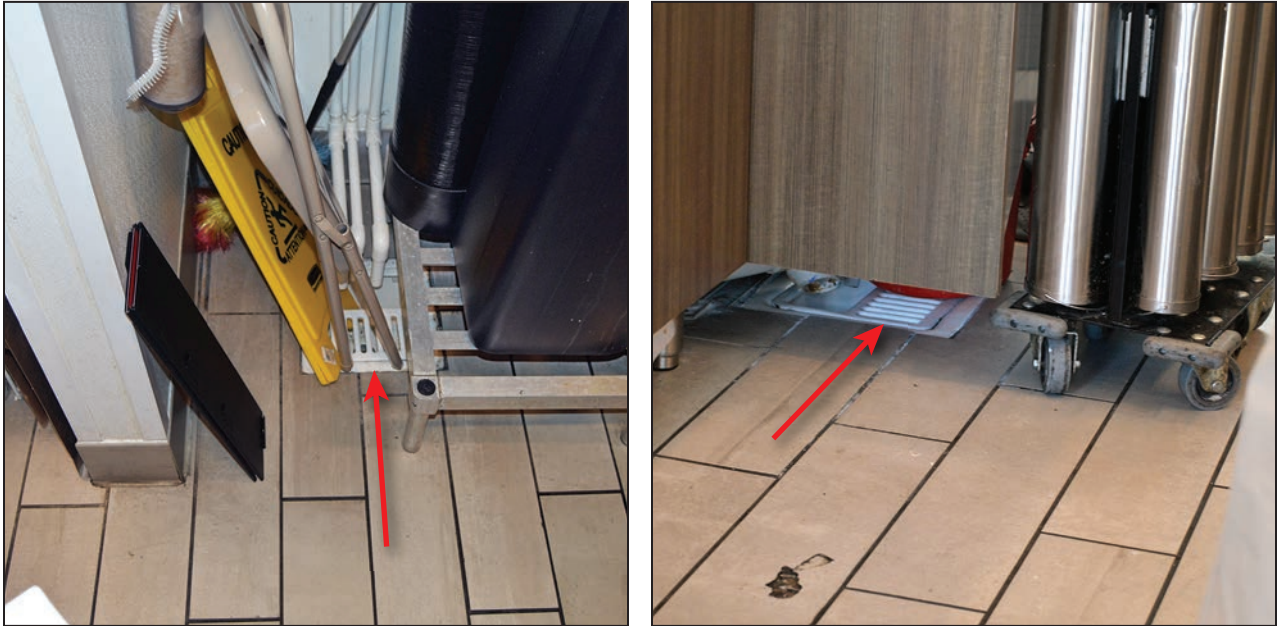
Figure 3-93: Floor drains (red arrows) where floodwater entered

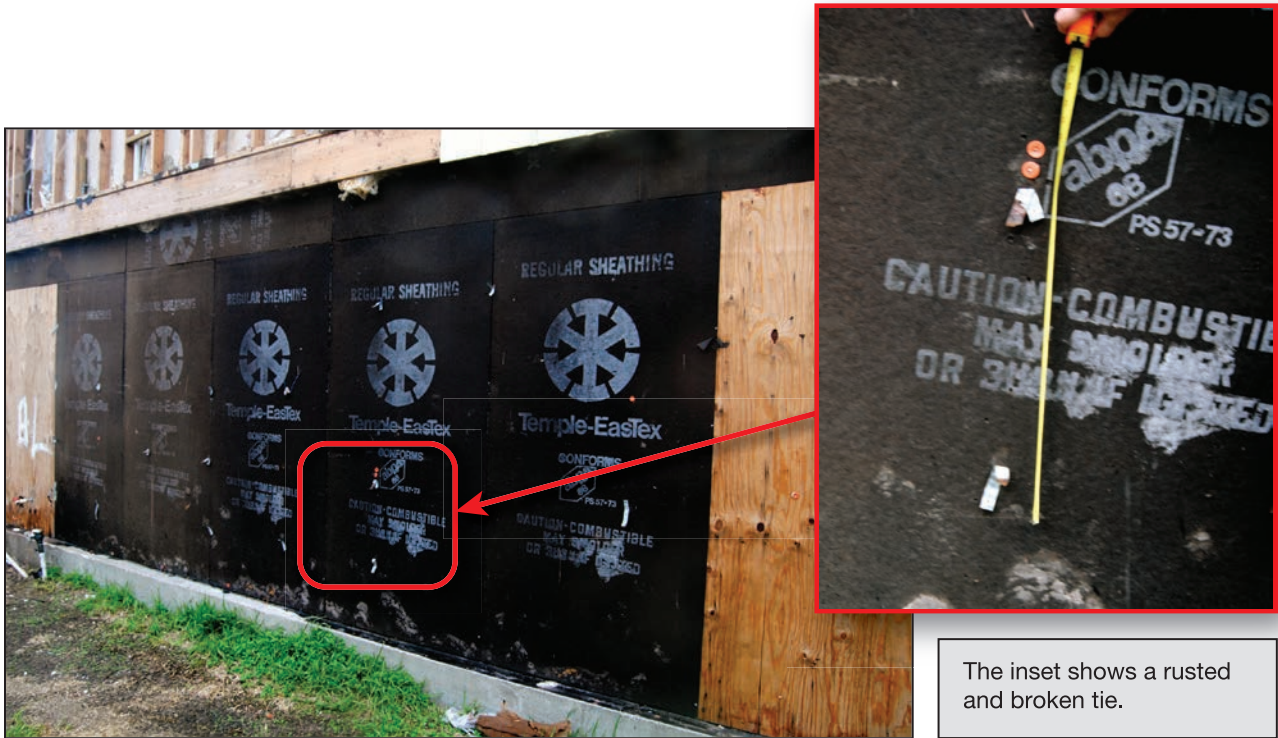
The inset shows a rusted and broken tie.

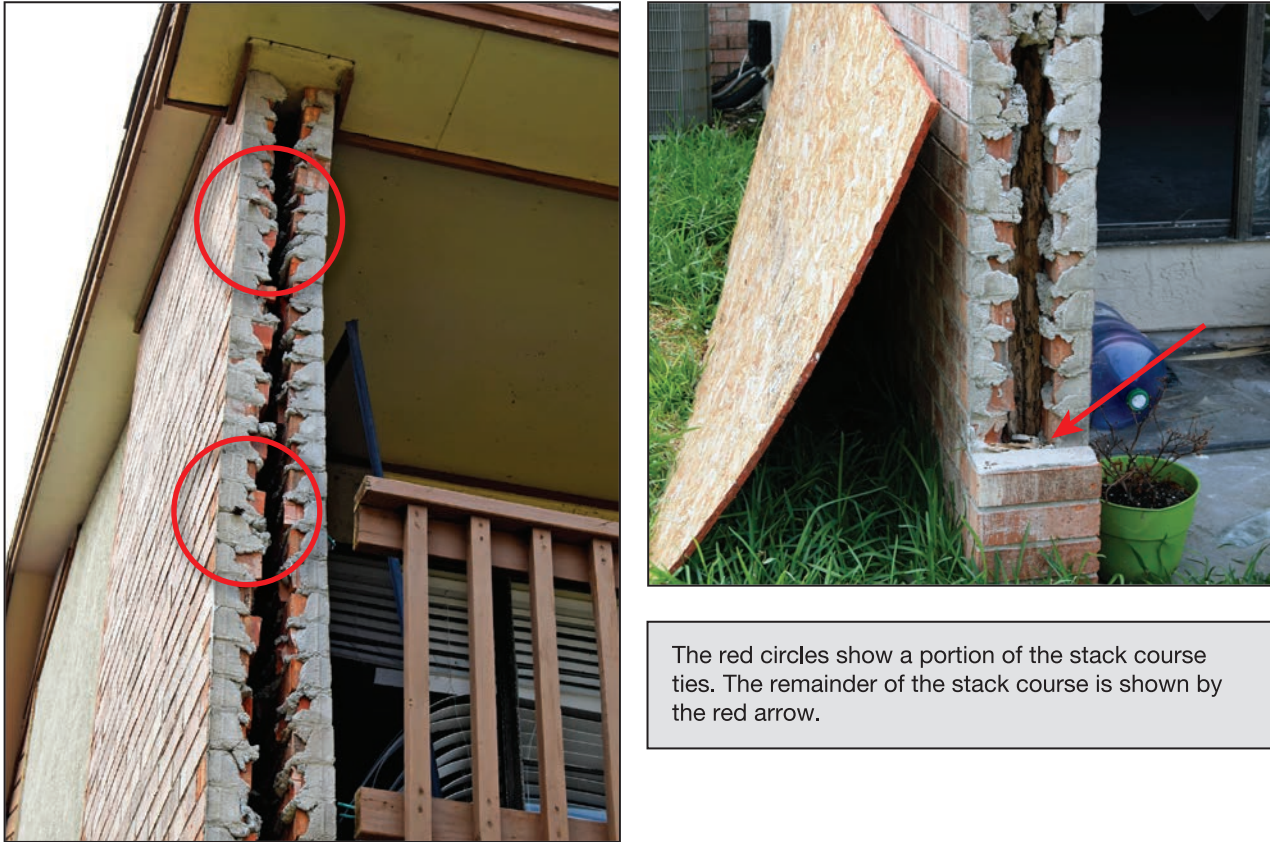
Figure 4-23: Double-wythe brick wing-wall that lost its brick stacked course (130 mph, Exposure B) (Port Aransas)

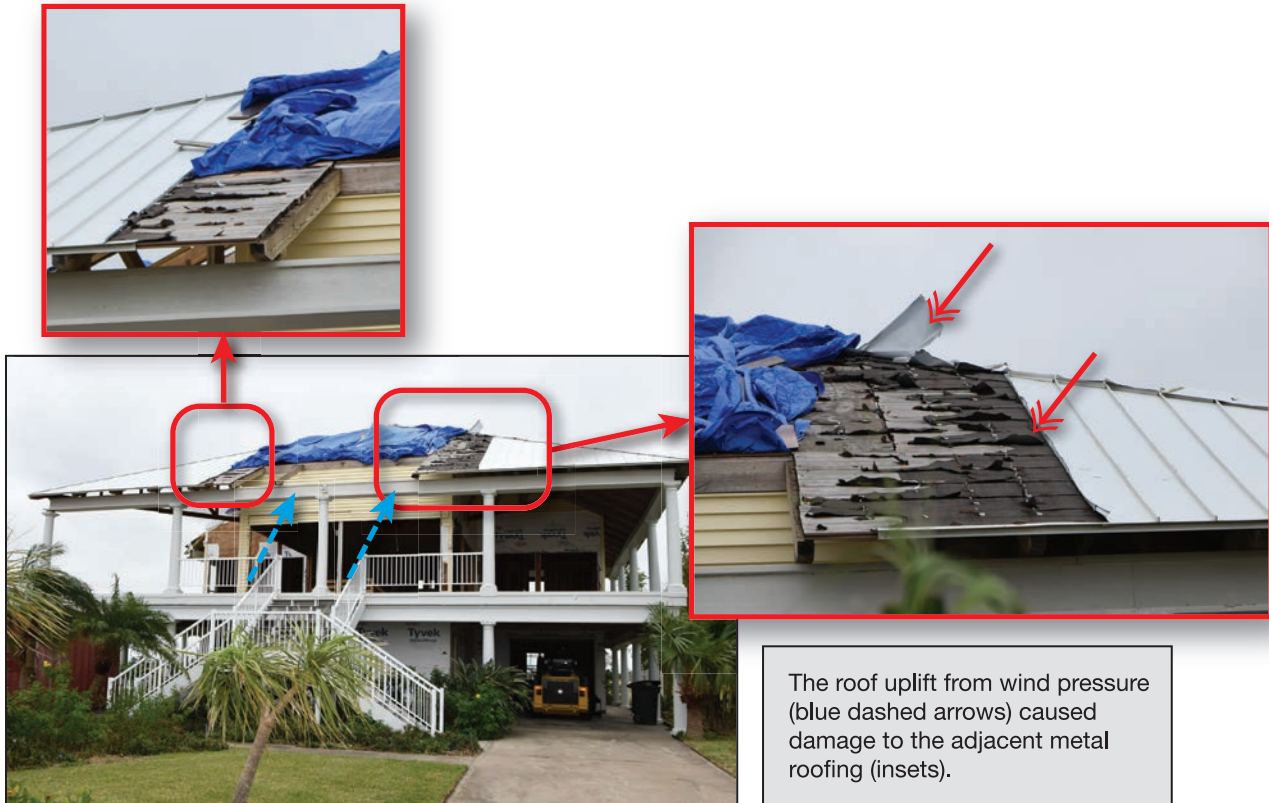
Figure 4-39: Home damaged by wind pressure (130 mph, Exposure C) (Cape Valero)

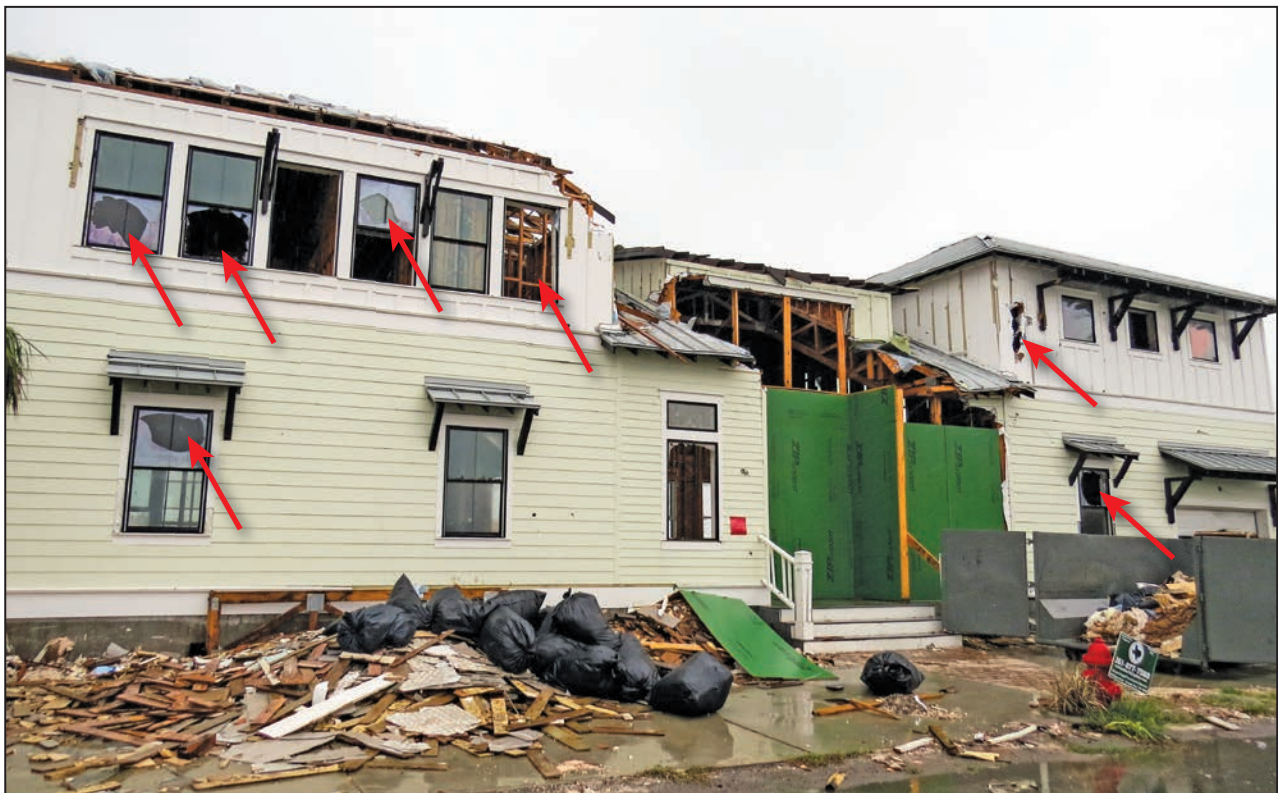
The MAT could not determine whether the windows were impact resistant, but they were still broken (red arrow). The residence received multiple debris impacts (red arrows).

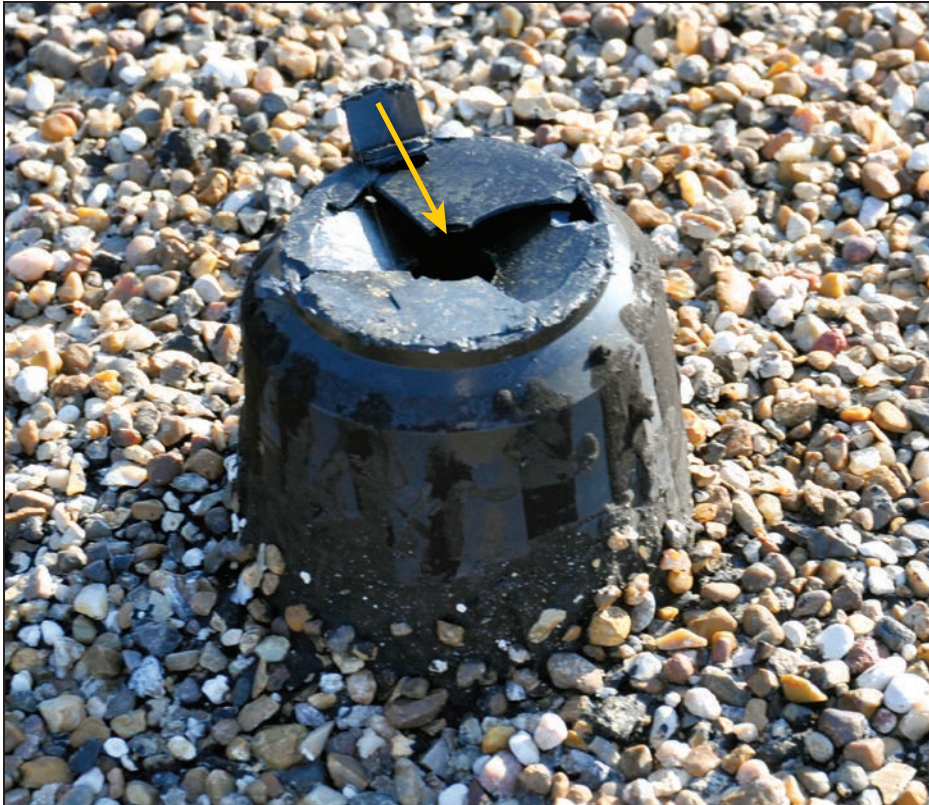
Figure 4-88:
Unprotected vent opening

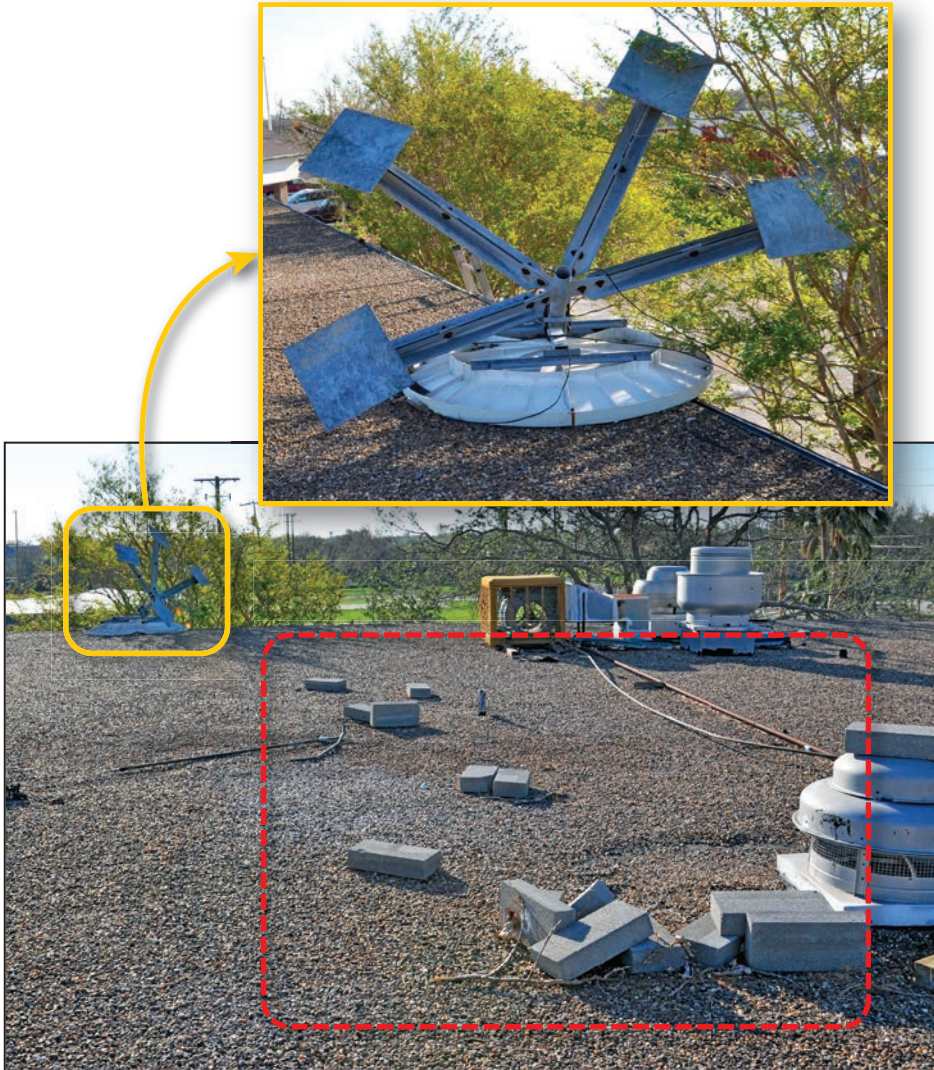
Figure 4-91:
Displaced satellite dish
(yellow box) and masonry
ballast (red dashed box)
