Mitigation Assessment Team Report

Hurricane Harvey in Texas

Building Performance Observations,
Recommendations, and Technical Guidance

FEMA P-2022 / February 2019

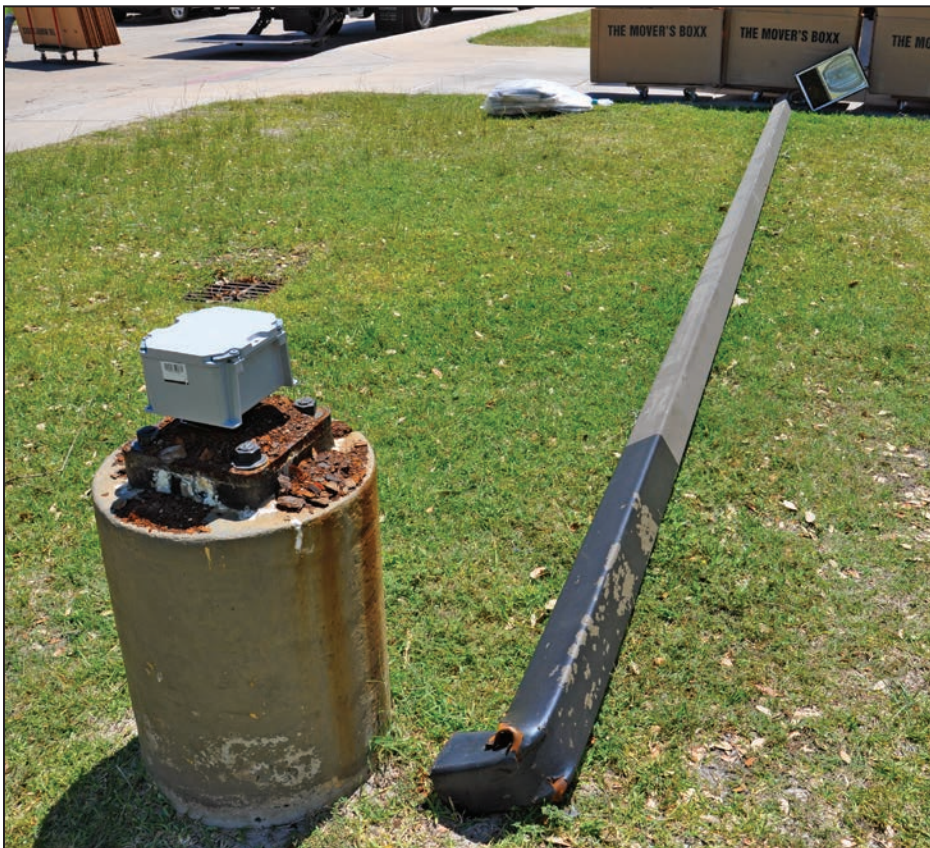
Figure 4-104:
Collapsed light fixture. There
was significant corrosion of
the tube near the base plate

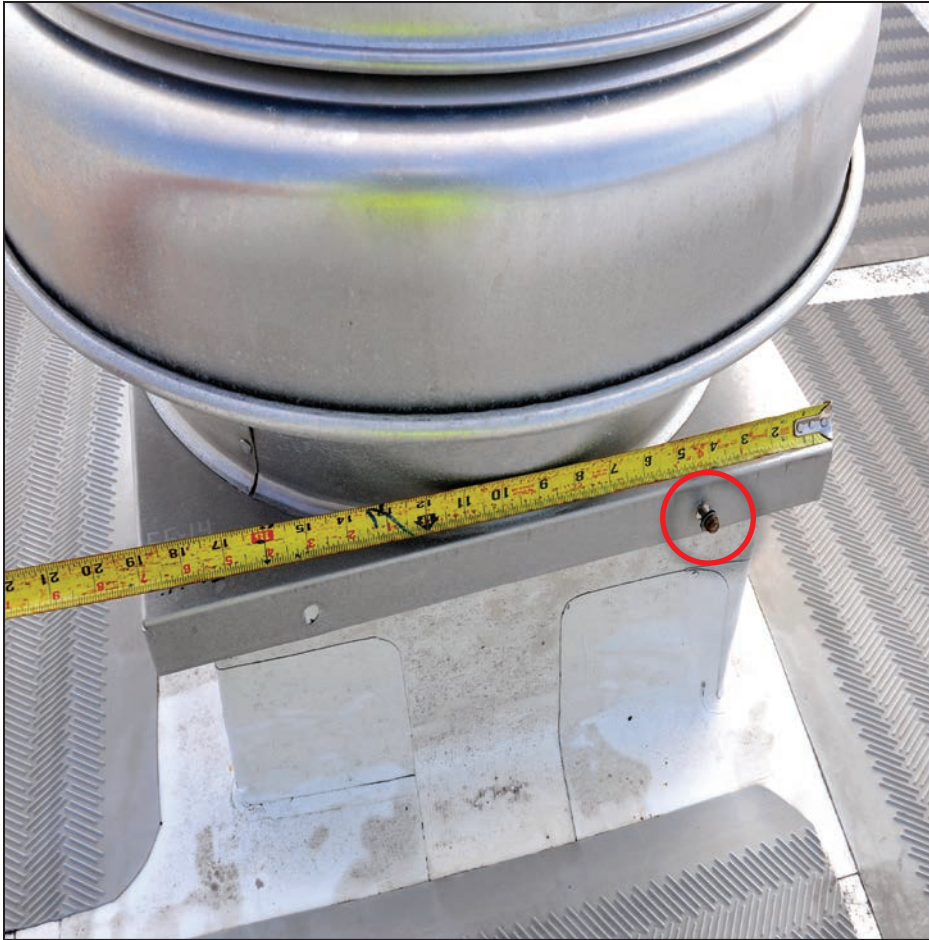
Figure 4-112: Exhaust fan attached with only two screws (red circle shows one of the screws)

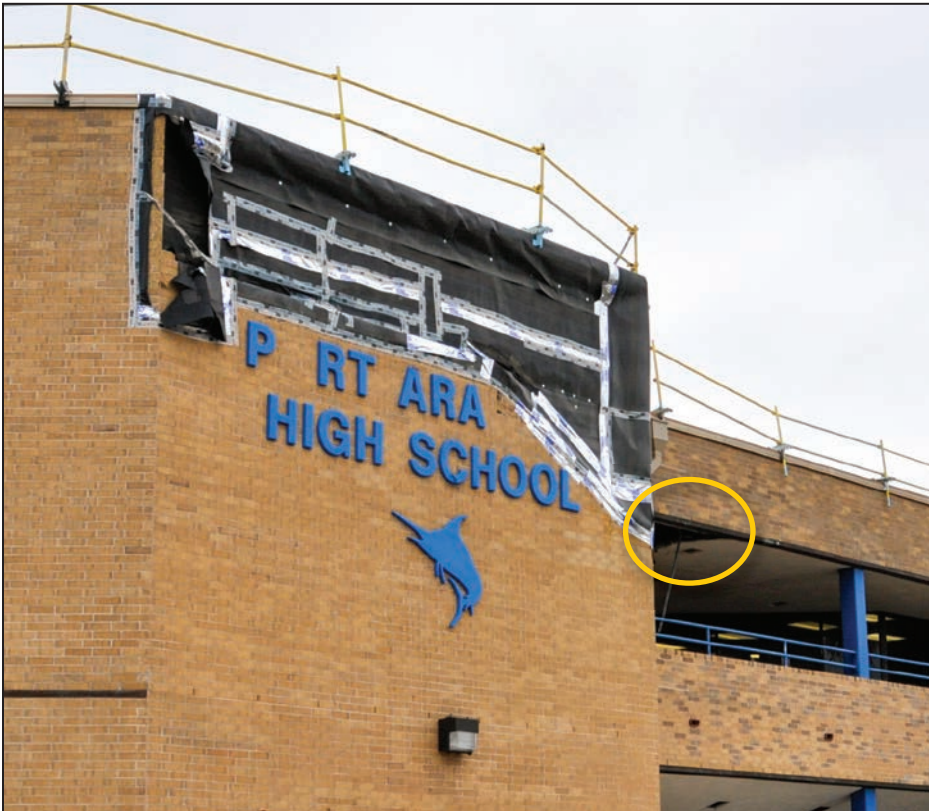
Figure 4-121:
Signage, brick veneer, and soffit (yellow oval) failure

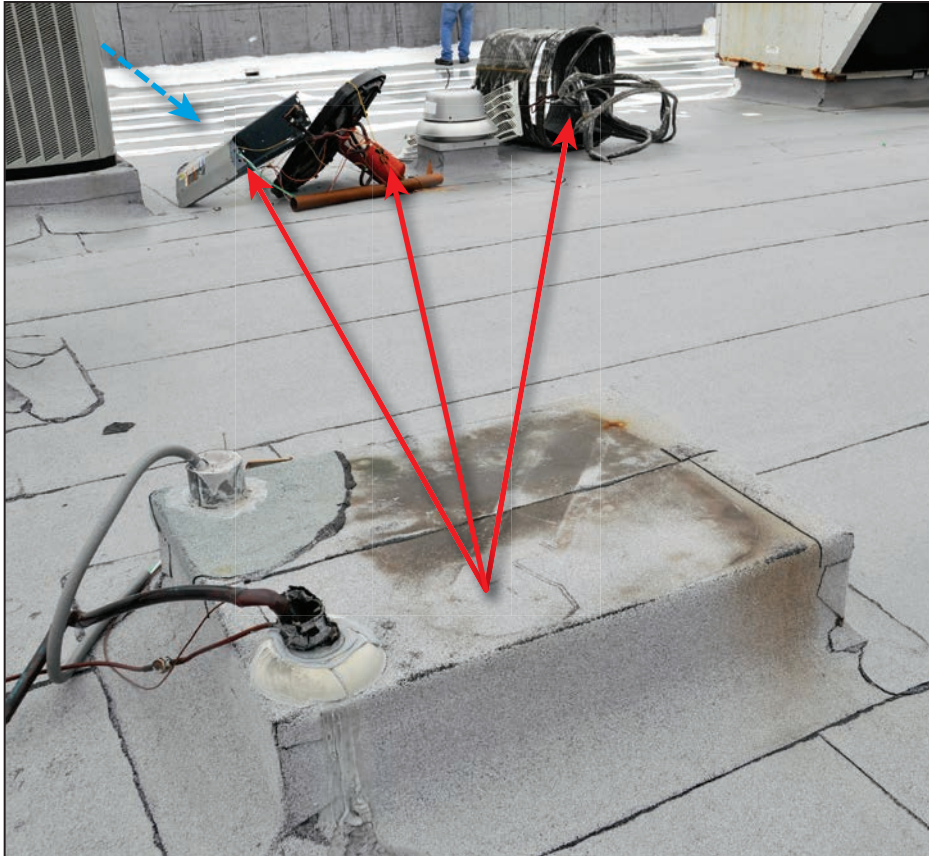
Figure 4-126:
Displaced condenser at hotel
(Rockport)

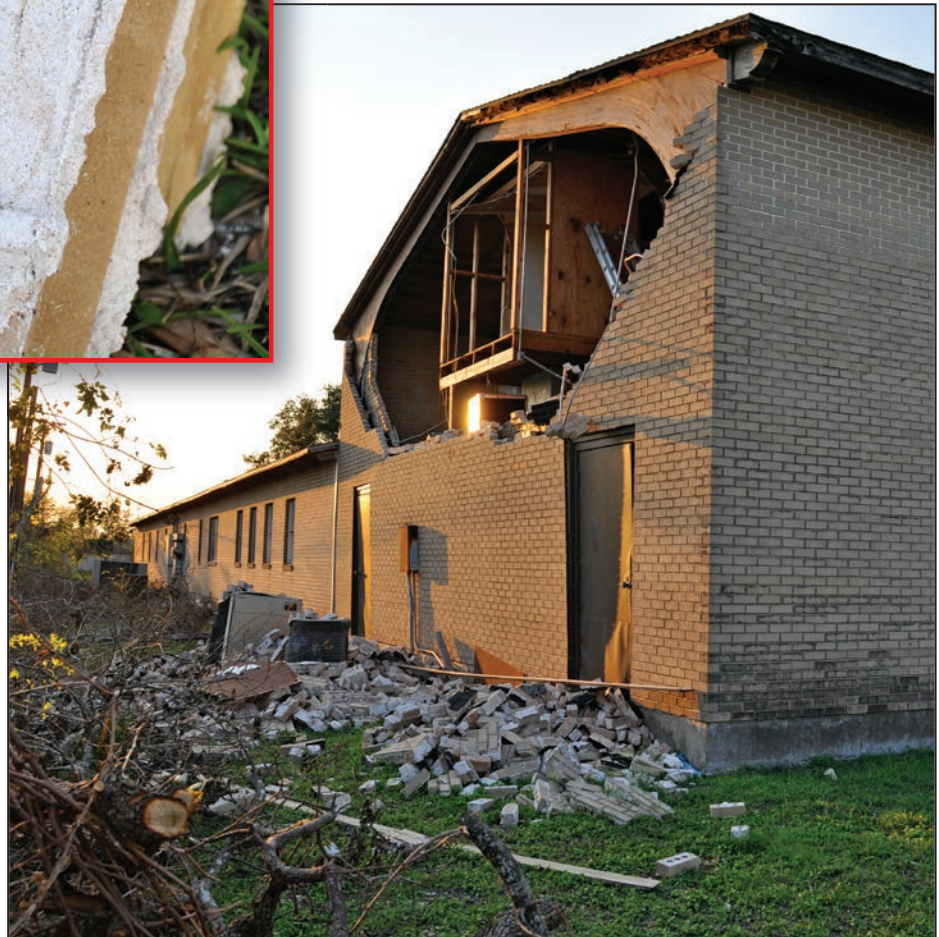
Figure 4-134: Brick veneer failure (Refugio)

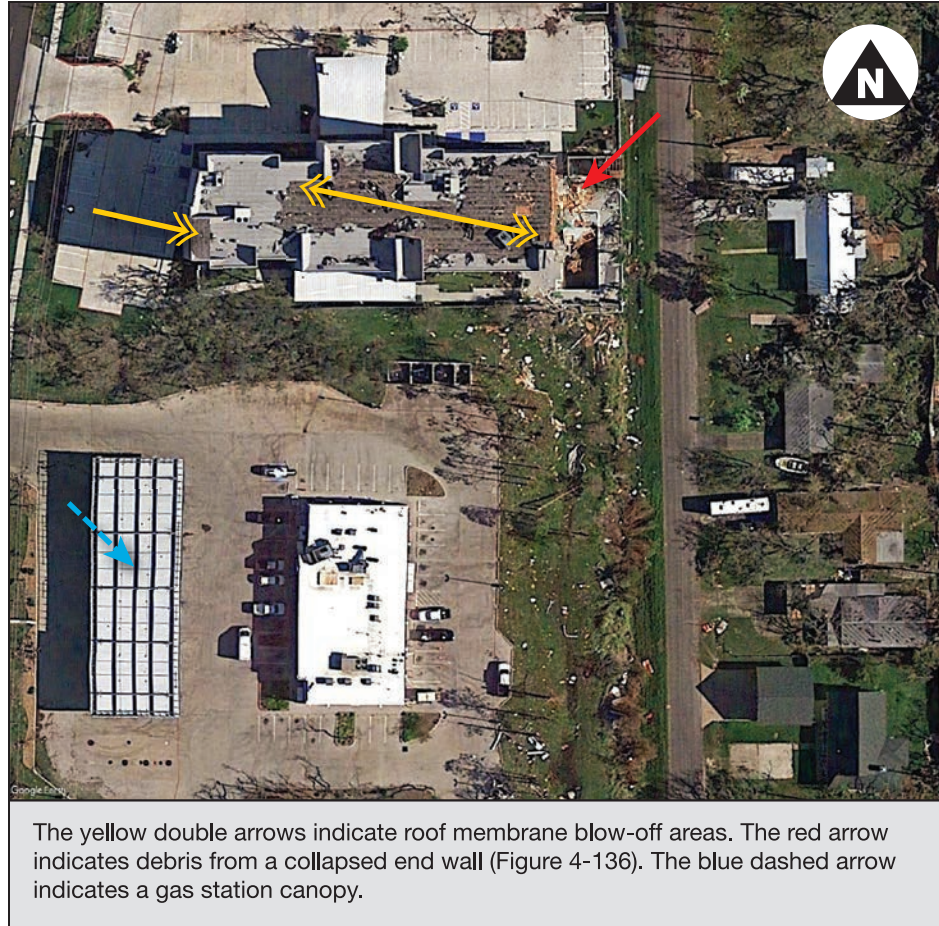
The yellow double arrows indicate roof membrane blow-off areas. The red arrow indicates debris from a collapsed end wall (Figure 4-136). The blue dashed arrow indicates a gas station canopy.

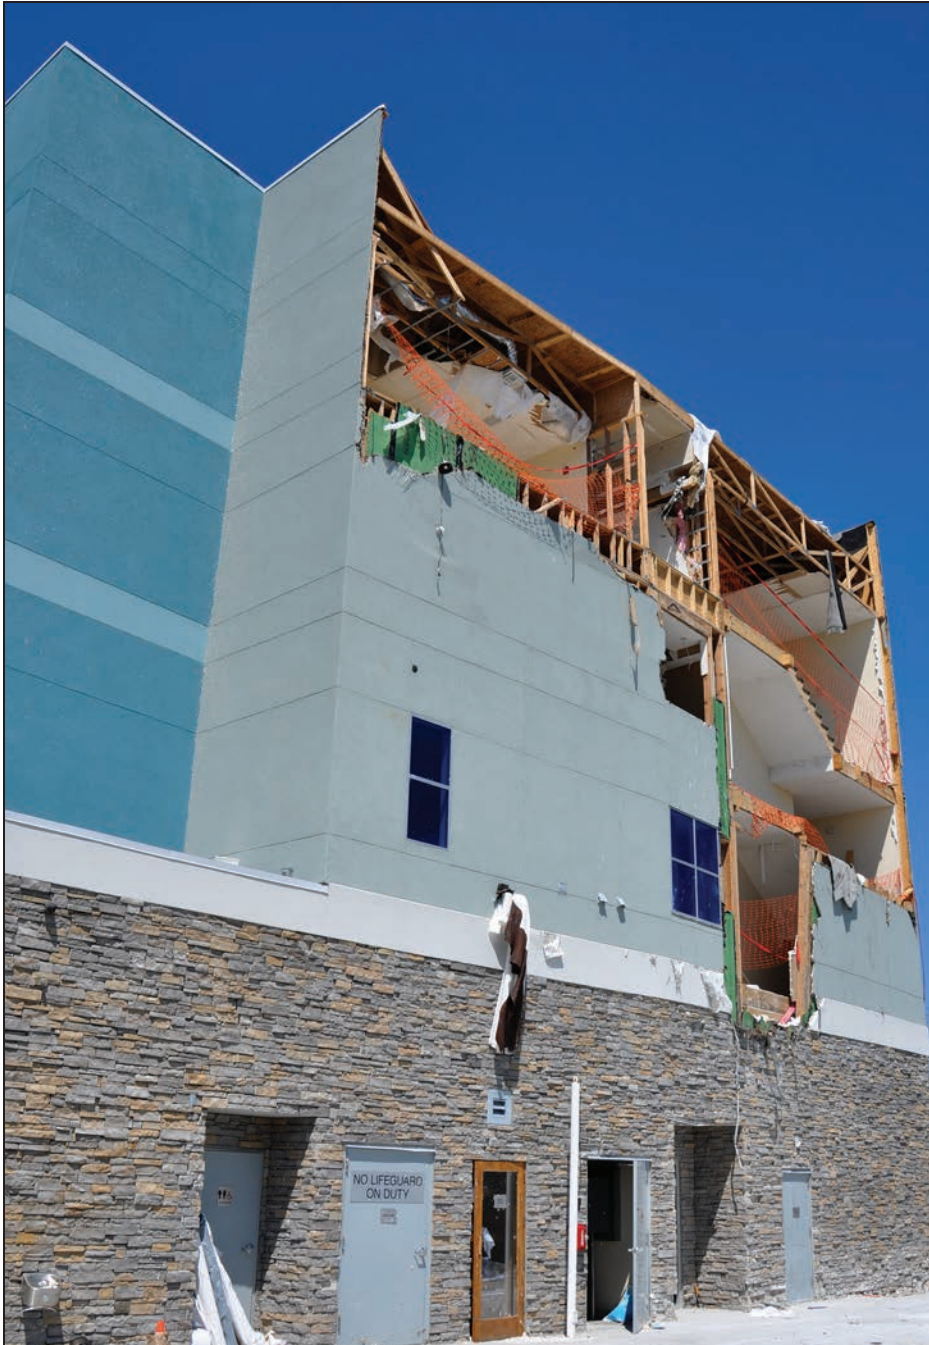
Figure 4-136:
End wall failure at hotel
(Rockport)

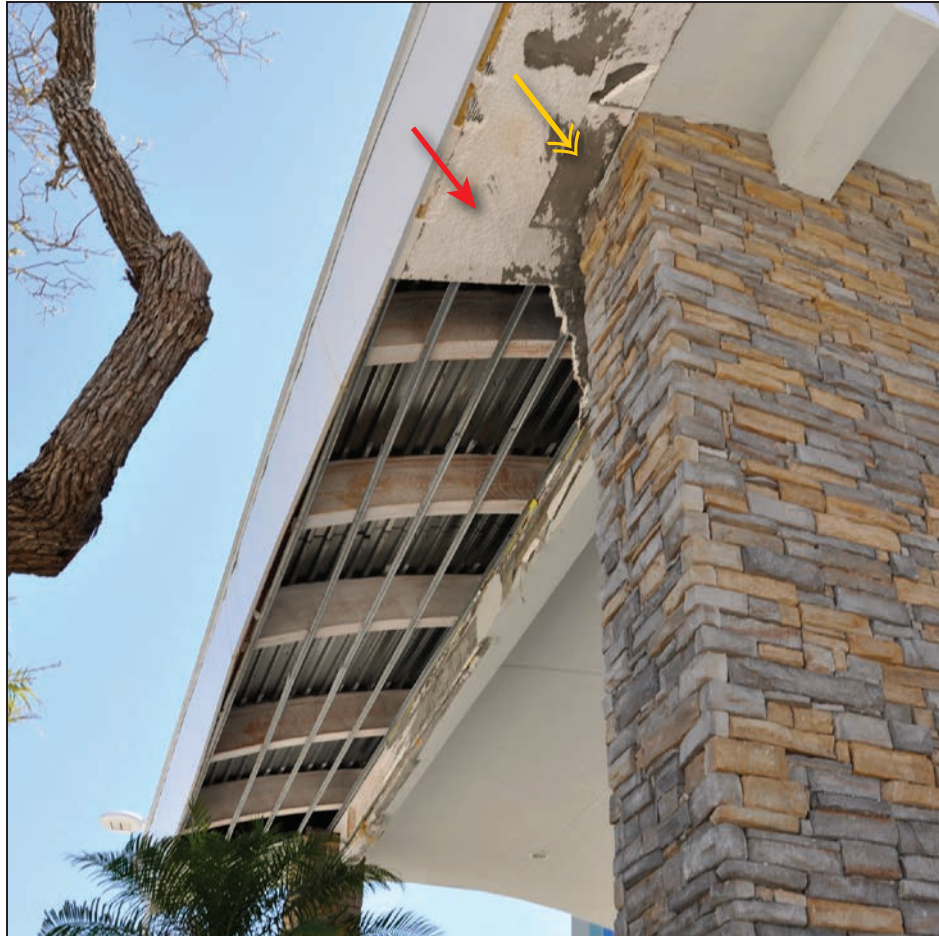
The red arrow indicates molded expanded polystyrene foam insulation. The yellow double arrow indicates gypsum board. The primary failure mode was detachment of the gypsum board from the metal framing.

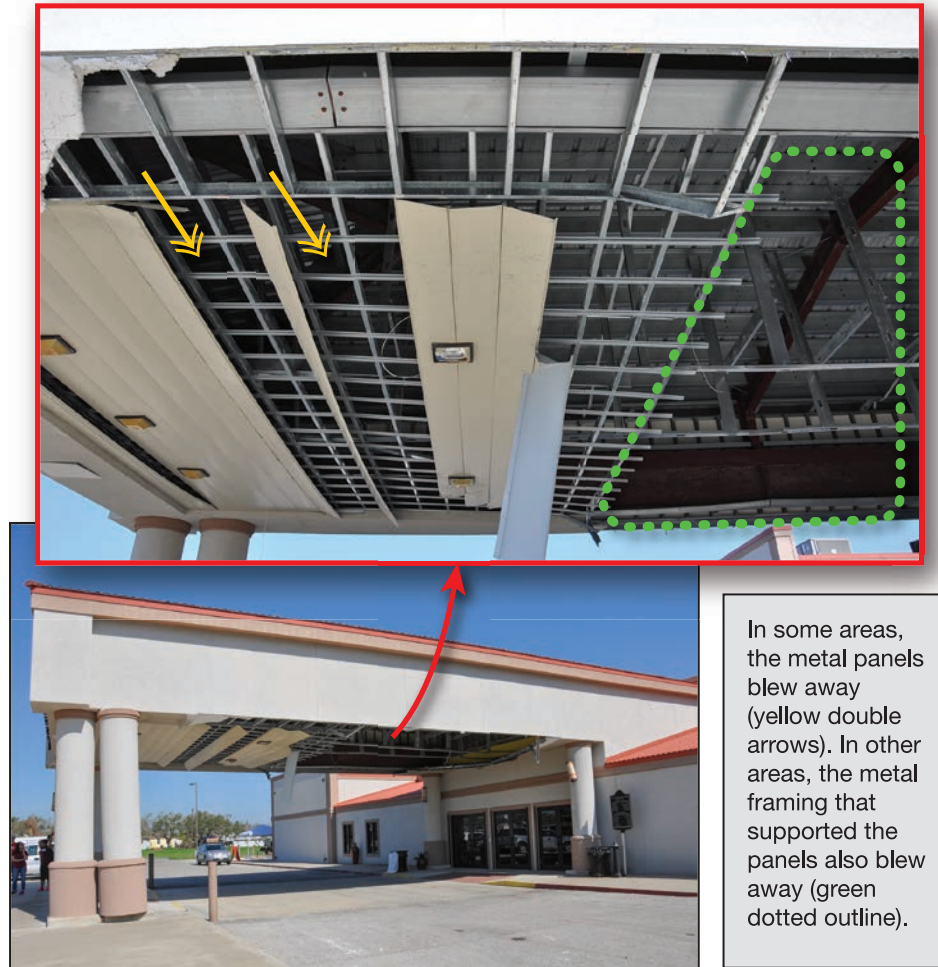
In some areas, the metal panels blew away (yellow double arrows). In other areas, the metal framing that supported the panels also blew away (green dotted outline).

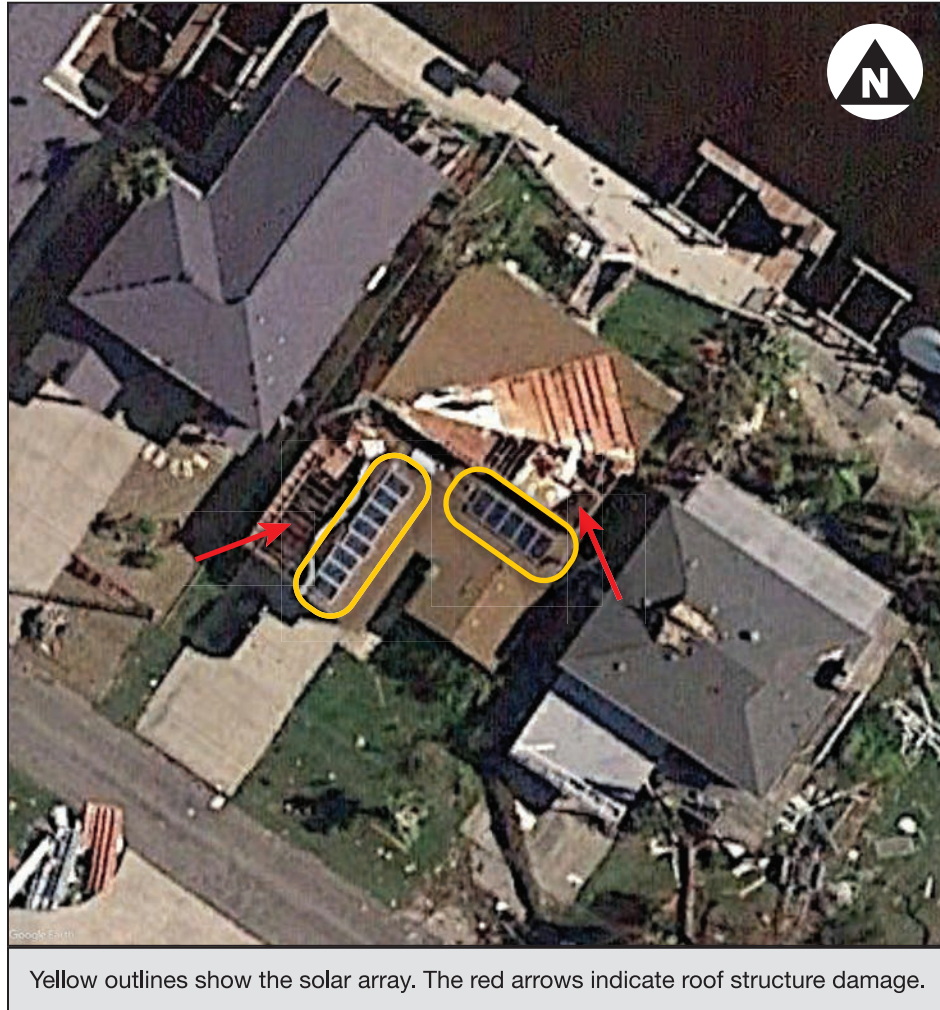
Yellow outlines show the solar array. The red arrows indicate roof structure damage.

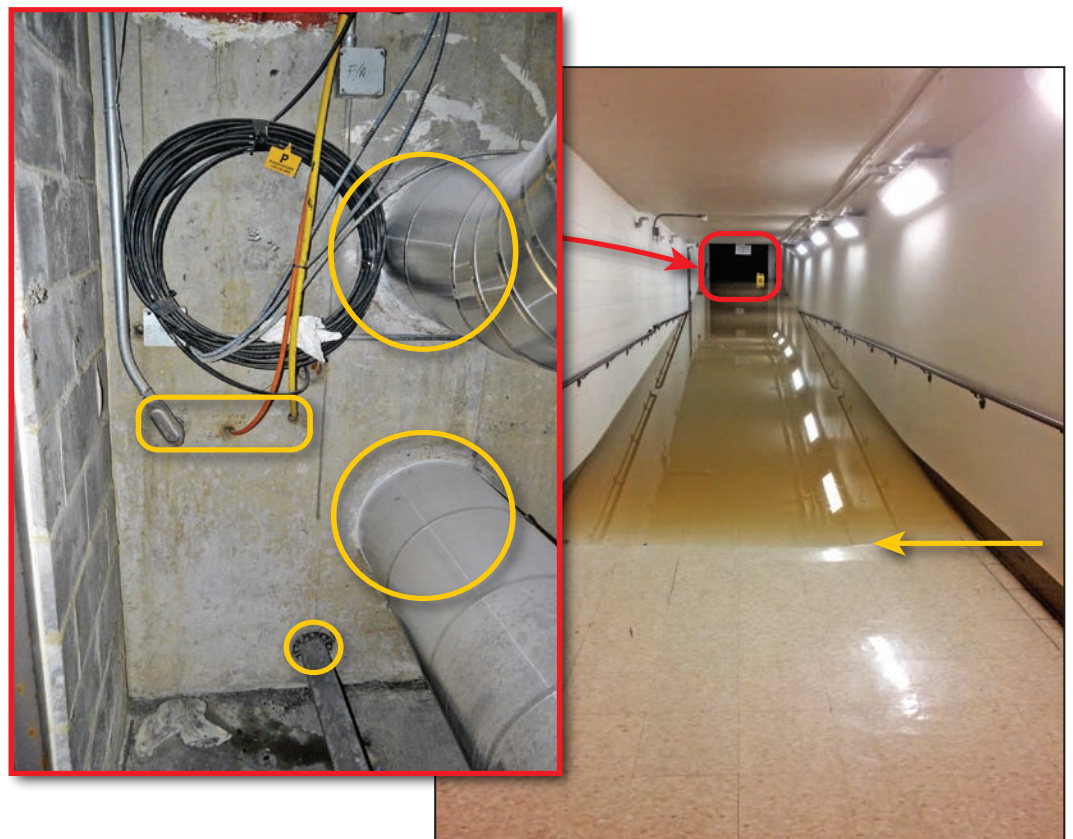
Failure to waterproof joints in the building envelope. The MAT observed numerous instances where significant water seepage originated from unsealed joints in the building envelope. Most water seepage through unsealed joints occurred where the concrete foundation wall stopped, typically 6 inches above surrounding grade, but significantly below the base flood elevation (BFE), design flood elevation (DFE), and WSE. Figure 6 shows an unsealed joint between the concrete foundation wall and the reinforced masonry wall with granite facade; if the joint is left unsealed, water can seep into the building. Another common area for water seepage was unsealed joints between the concrete foundation slab and foundation wall.
