Hurricane Opal in Florida

A BUILDING PERFORMANCE ASSESSMENT

FEDERAL EMERGENCY MANAGEMENT AGENCY
MITIGATION DIRECTORATE

August 30, 1996

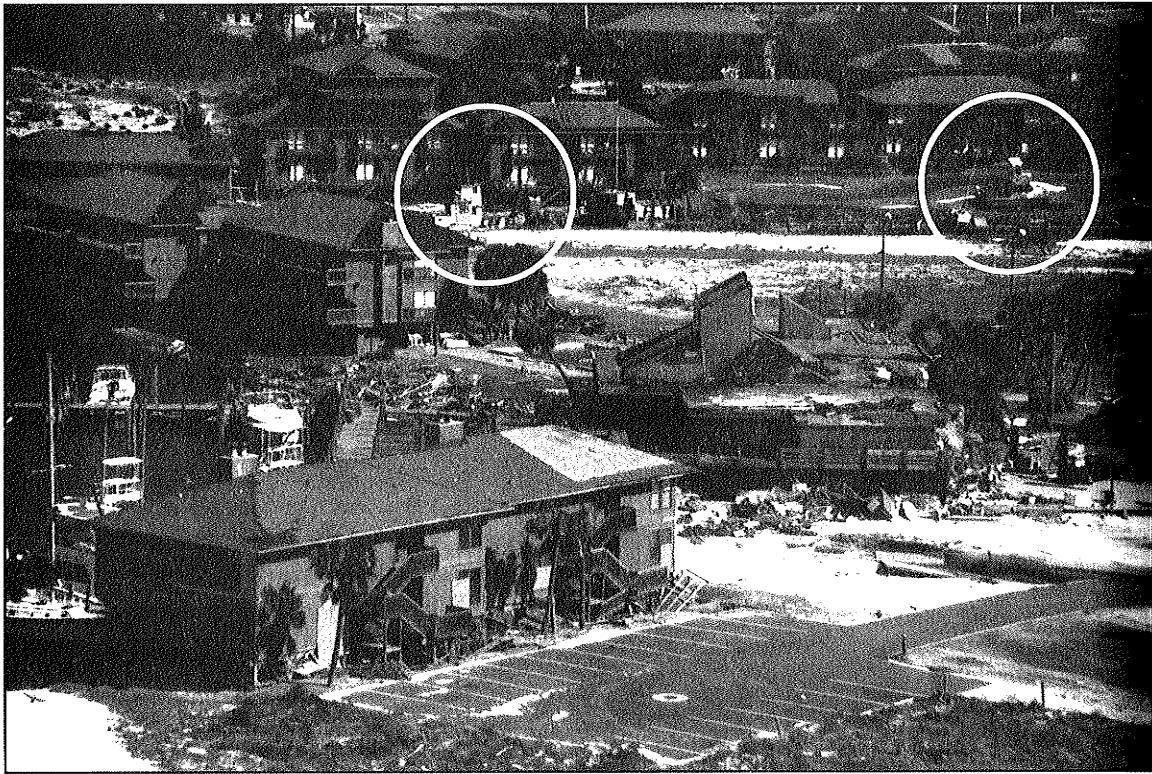
Figure 2-1 Debris washed inland as a result of surge action from Hurricane Opal (note circled boats).

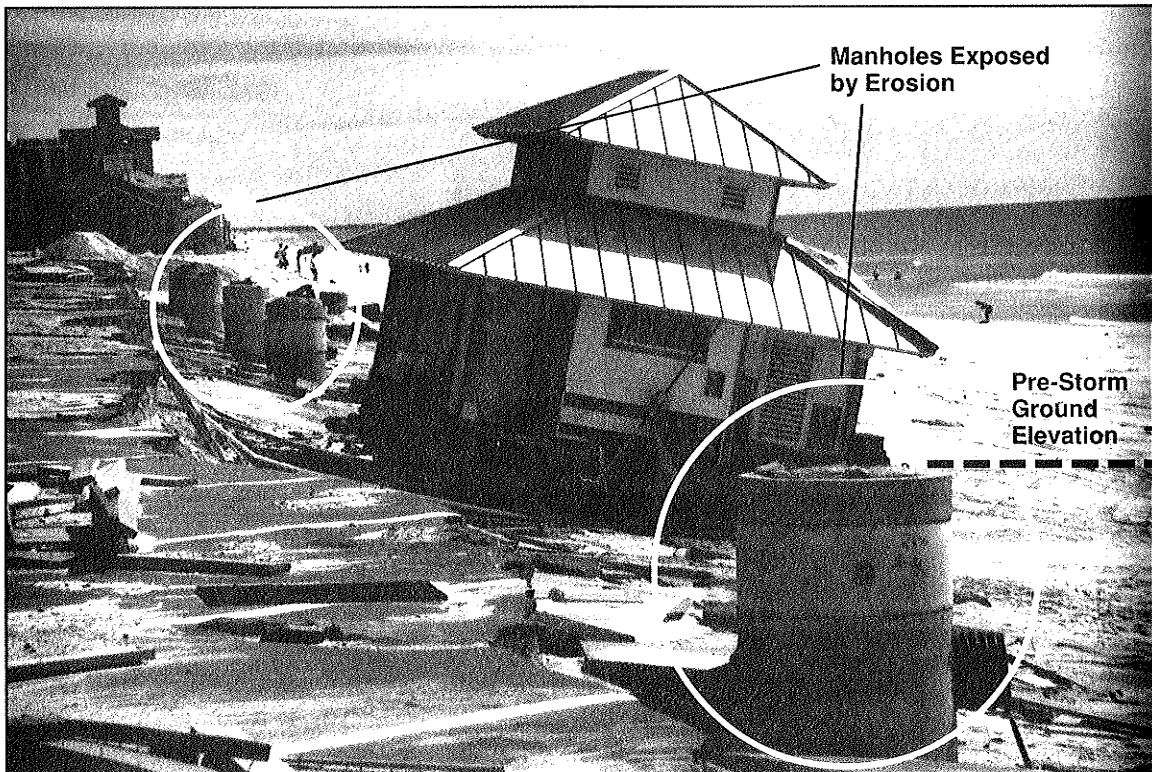
Figure 2-2 Beach erosion caused major damage to structures, as well as roads and utilities.

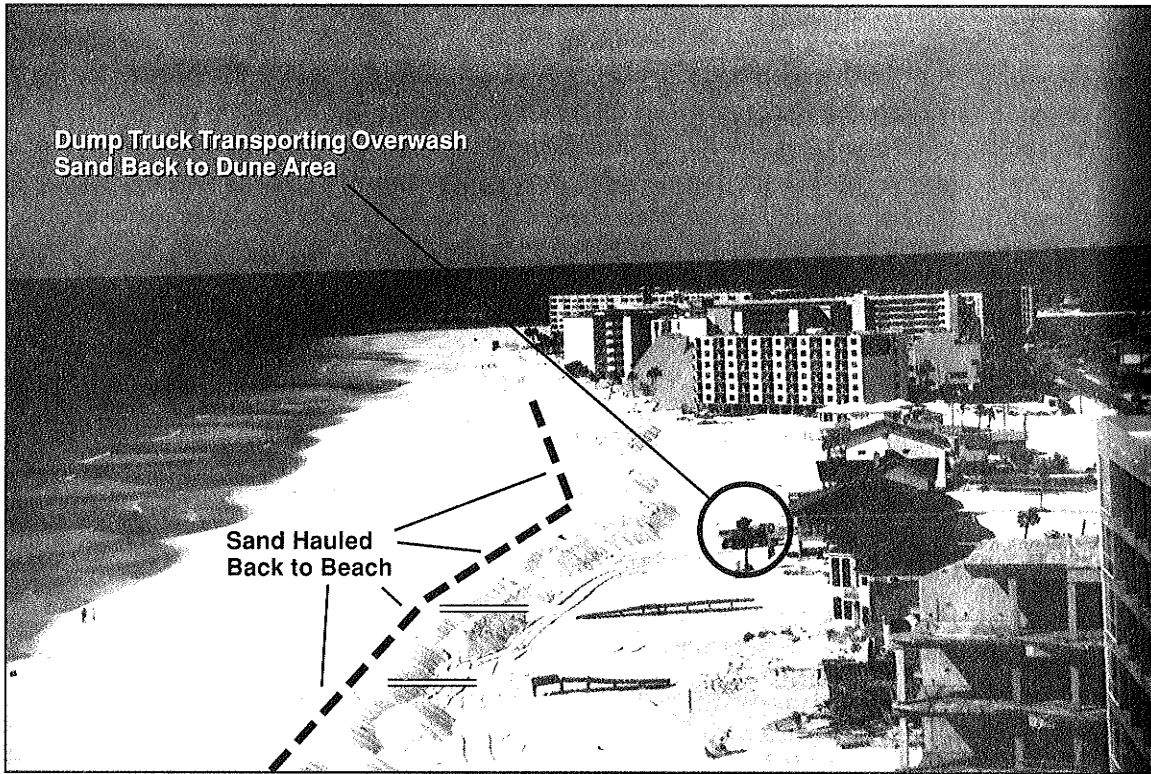
Where sand dunes existed before Hurricane Opal, significant loss of dune height and width was observed. Many dunes were breached or flattened (see Figure 2-3). Those that remained after the storm were scarped and weakened. Duneface retreat of 75 feet to 100 feet was observed in several locations. Overwash of eroded dune sediments was common, sometimes extending over 500 feet inland and causing burial of roads and at-grade construction by 1 to 4 feet of sand.

Figure 2-3 Beach erosion eliminated protection for structures. It is important that the beach and dunes be rebuilt as soon as possible. Arrows point to walkways used to traverse dune that has been washed away.

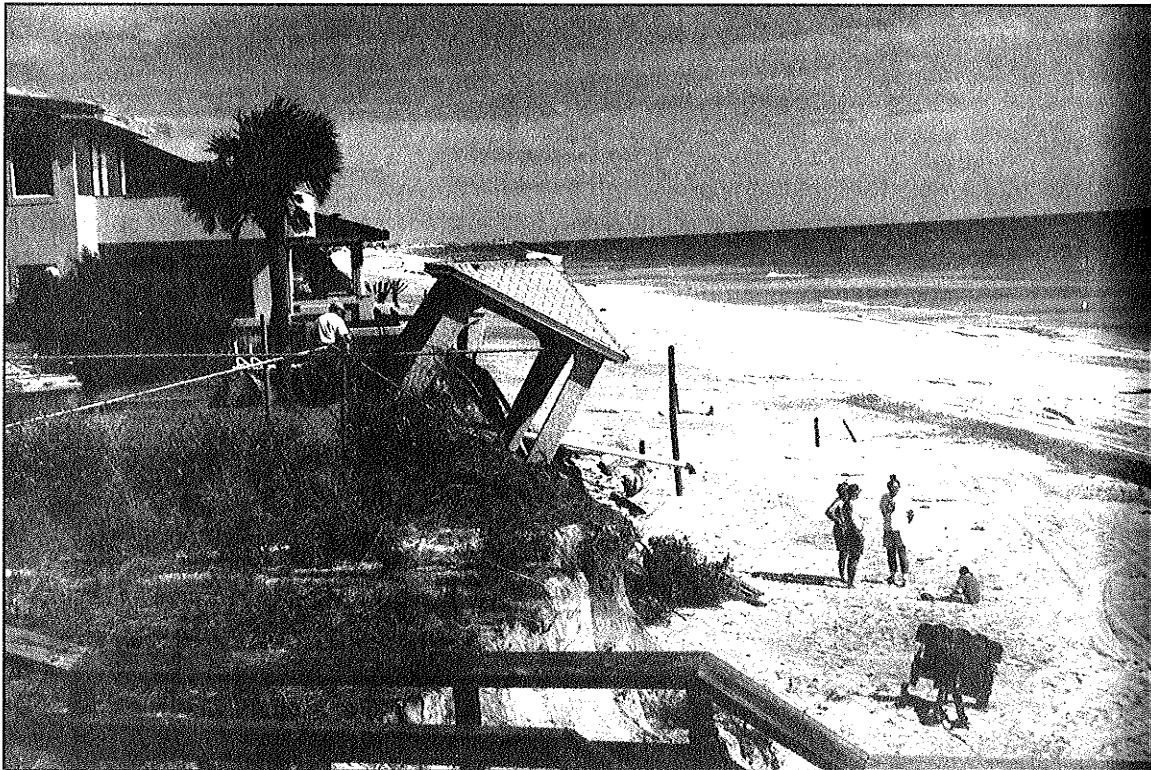
In some cases, an estimated 10 to 20 feet of vertical relief was lost at the seaward edge of high dune and bluff areas. Many structures atop high dunes or bluffs collapsed because of a loss of support, either from the undermining of slab foundations or from inadequate pile embedment (see Figure 2-4).

Figure 2-4 Erosion such as this took place along the gulf coast, causing structures to be undermined and resulting in damage.

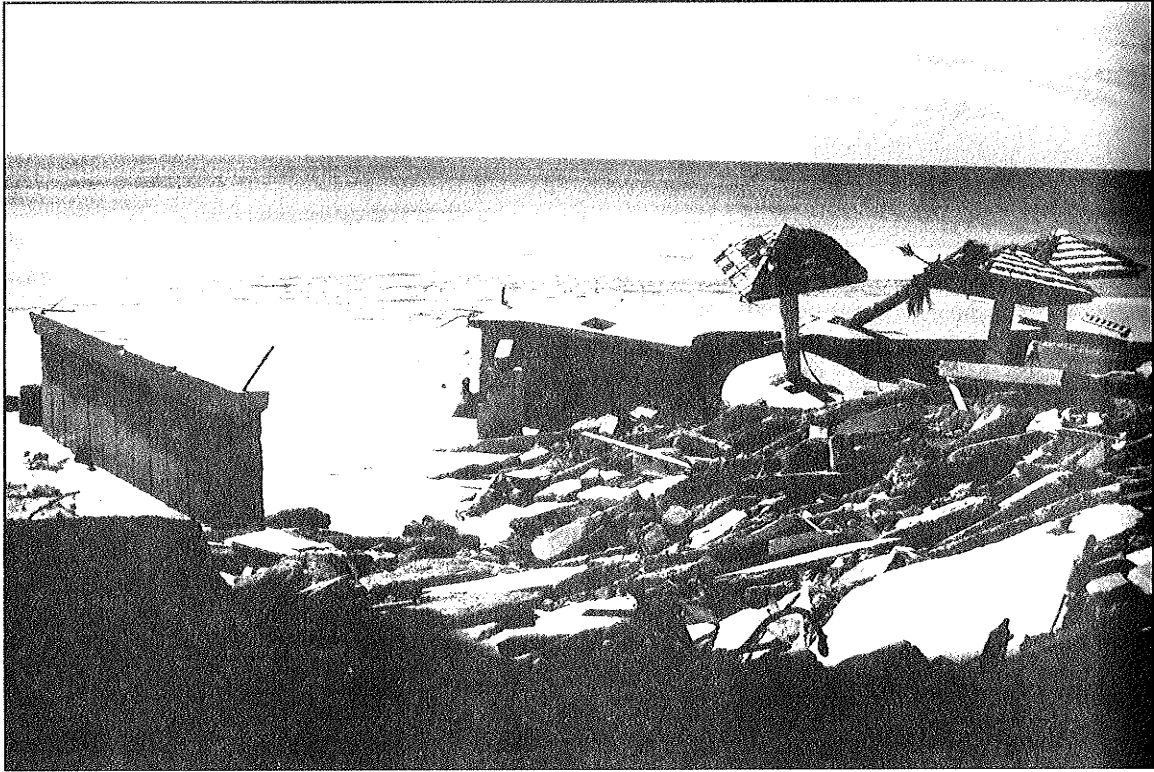
Figure 2-5 Debris, consisting of broken concrete and wood framing systems, generated by surge action.

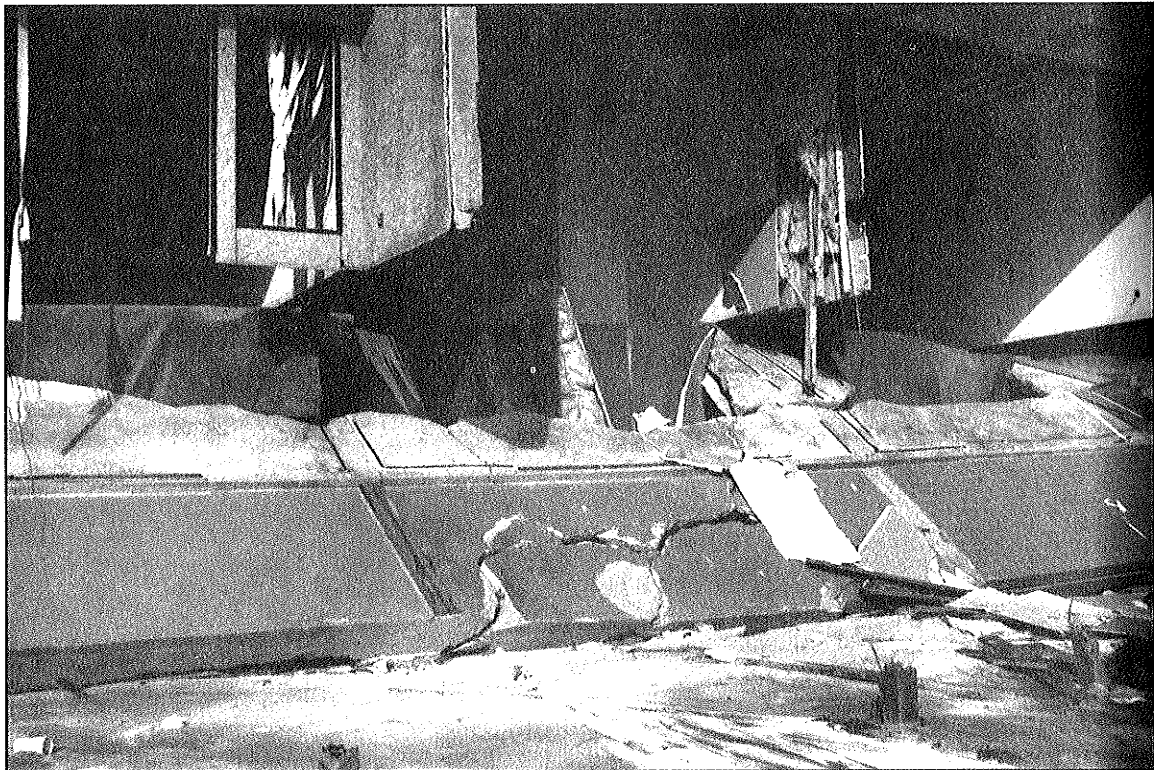
Many slab failures were noted in all types of structures (see Figure 2-6). The major reason for these failures was the loss of support coupled with a lack of reinforcing in the slabs. Welded reinforcing wire fabric was observed in many slabs but did not prevent failure of the slabs once they were undermined.

Figure 2-6 Undermining of concrete decks and floor slabs caused the failure of many unreinforced concrete structures.

- In areas subject to storm-induced erosion, regardless of the flood zone designation, any slabs serving as floors for habitable spaces should be designed and constructed as structural slabs, to withstand all anticipated erosion, scour, and storm forces, and attached to sufficient foundation systems that do not rely on underlying soil for support.

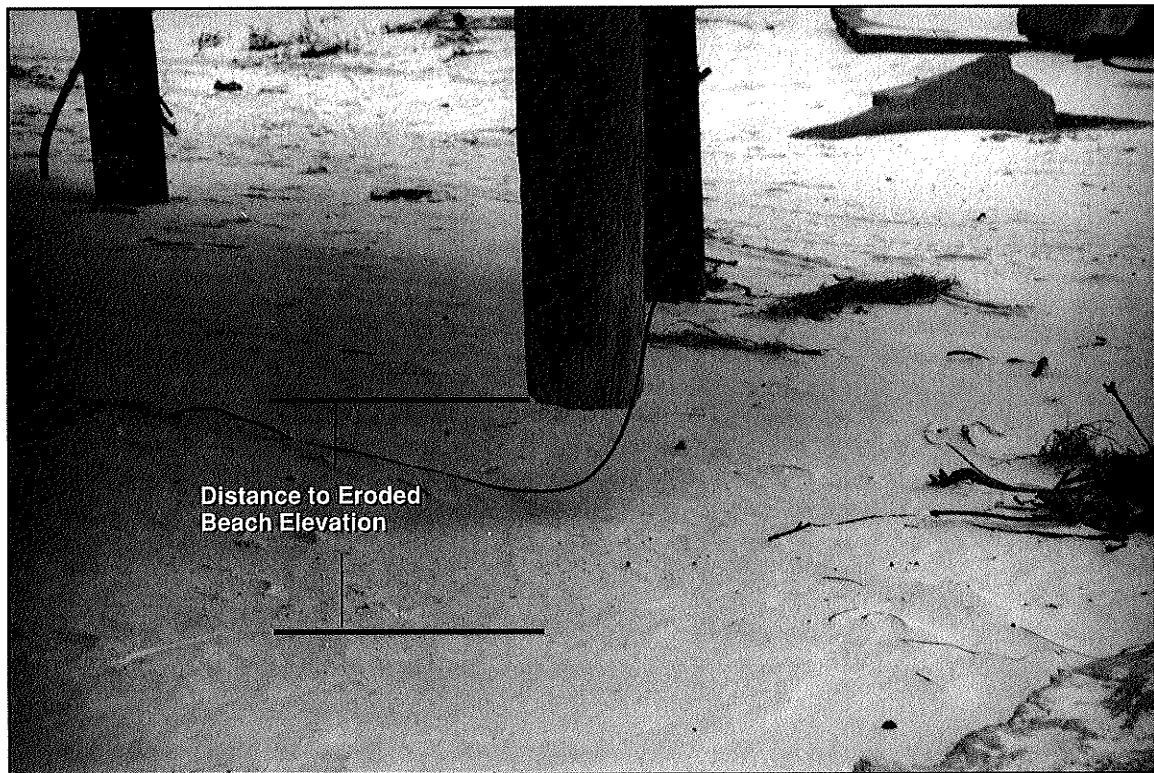
Figure 2-7 These piles were not embedded deep enough to survive the erosion of the sand. As a result, there is now a large gap between the bottoms of the pilings and the ground surface.

- For all areas known to be subject to high-velocity wave action, strong currents, erosion, or combinations thereof — regardless of flood zone designation — the embedment depths specified for pile foundations should be sufficient to ensure that the foundation will withstand anticipated erosion and storm forces. Foundations for masonry columns should be designed to withstand all anticipated flood, erosion, debris, and wind forces. Shallow footings should not be used to support masonry columns where the risk of undermining exists.

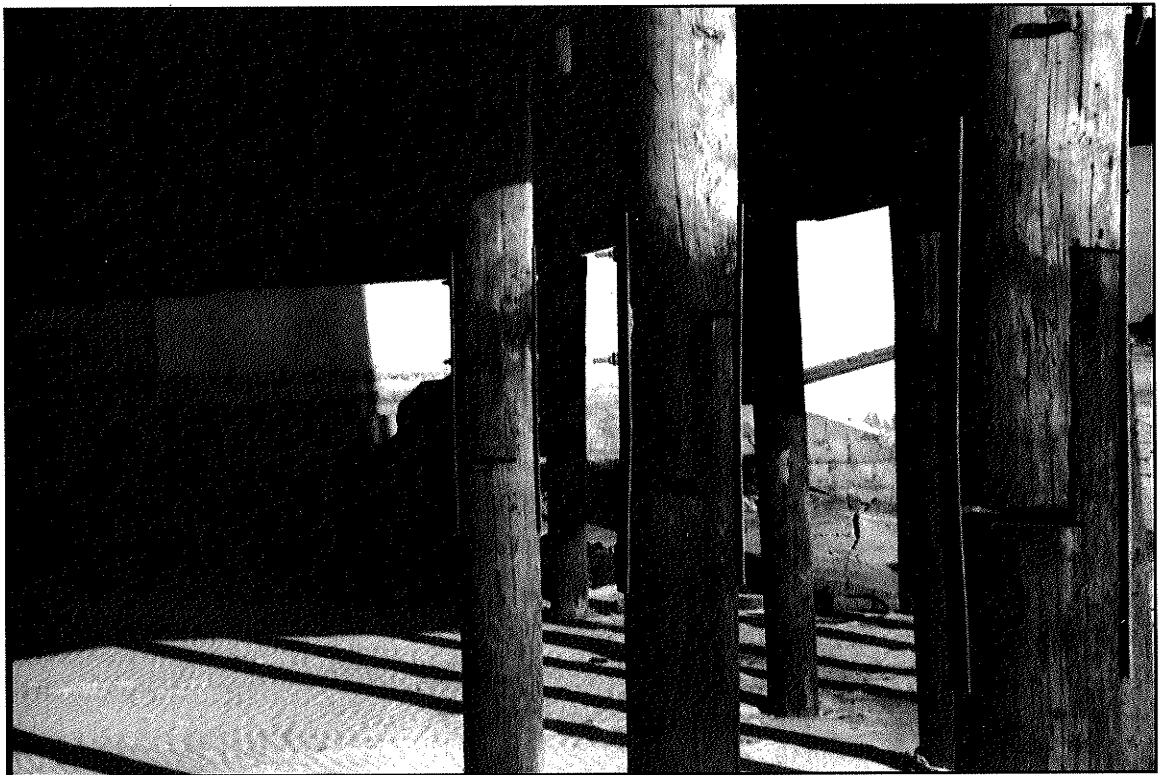
Figure 2-8 These piles were not long enough and were spliced to add depth. The splicing was exposed by storm-induced erosion.

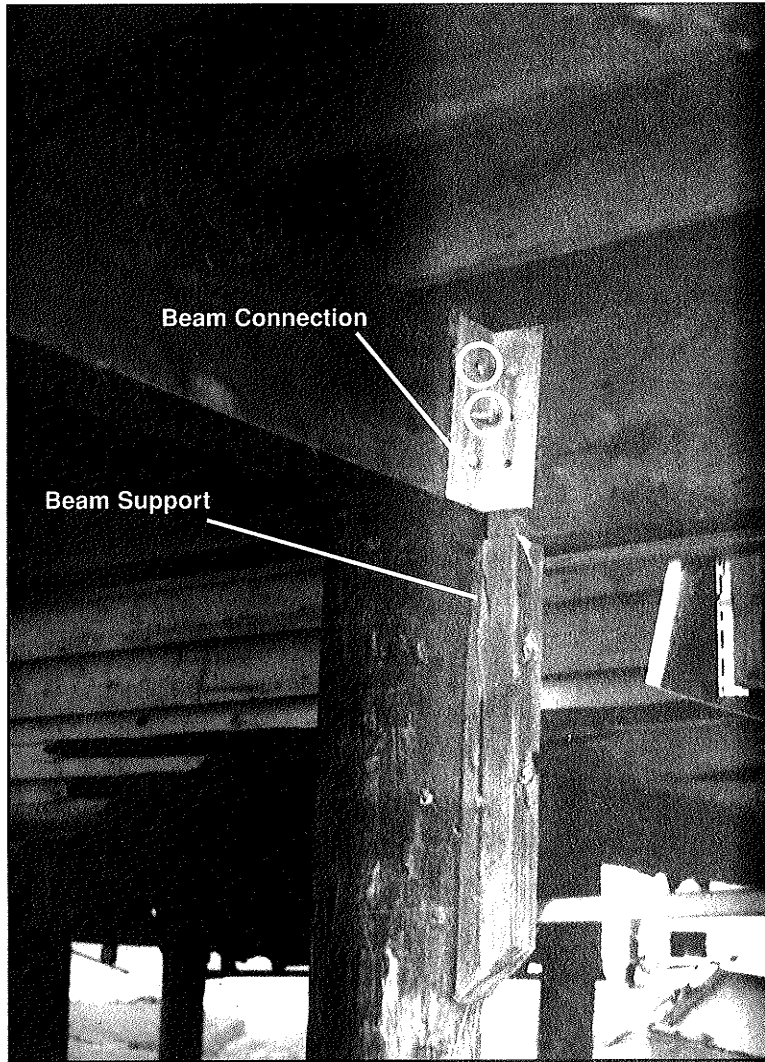
Figure 2-9
 The floor beam connection and beam support shown here illustrate the lack of design and proper construction observed on many damaged structures. Note the bolt pullouts (circled). Also, the beam support is attached to the pile with lag bolts rather than bolts that extend through the pile.

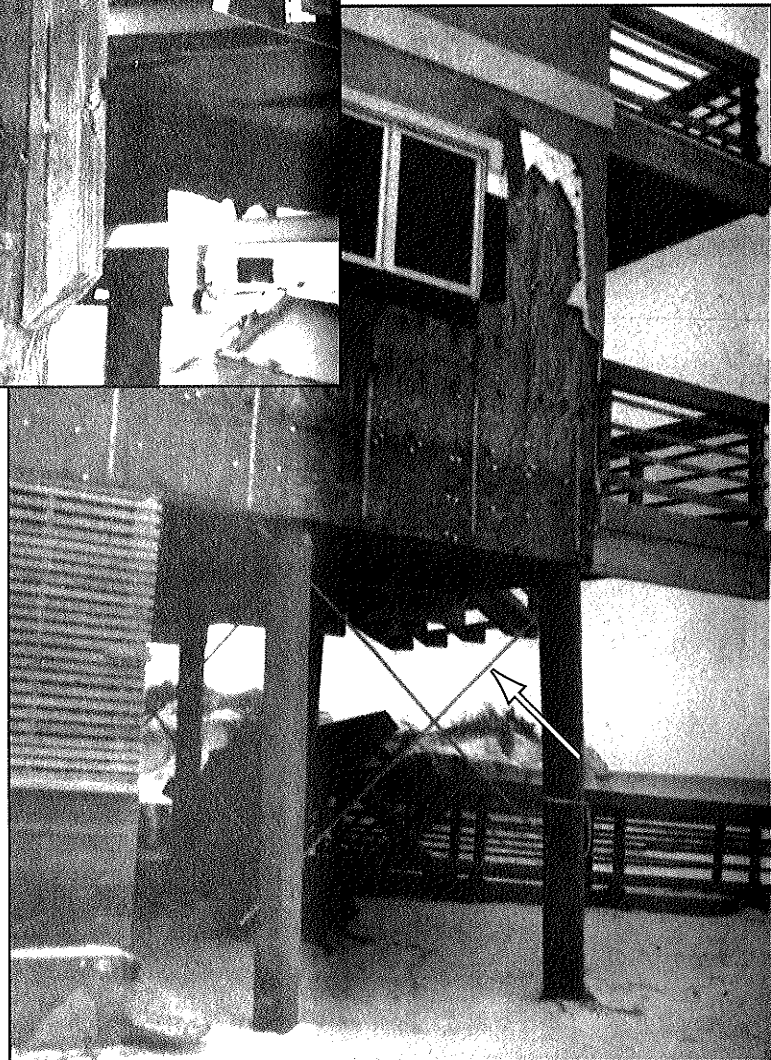
The use of 2 x 8 or similar timber cross-bracing between timber piles was common beneath elevated wood-frame structures. Some bracing failures were observed that were apparently due to horizontal loading from water, debris, or both. The use of threaded galvanized rods and turnbuckles as cross-bracing was less common (see Figure 2-10). No failures of this type of bracing

Figure 2-10
 This undamaged threaded rod & turnbuckle (arrow) cross-bracing continues to provide additional support as designed.

were noted, but debris was trapped by the bracing, and in some instances, the rods were bent by lateral loads imposed by the force of flood waters acting on the trapped debris.

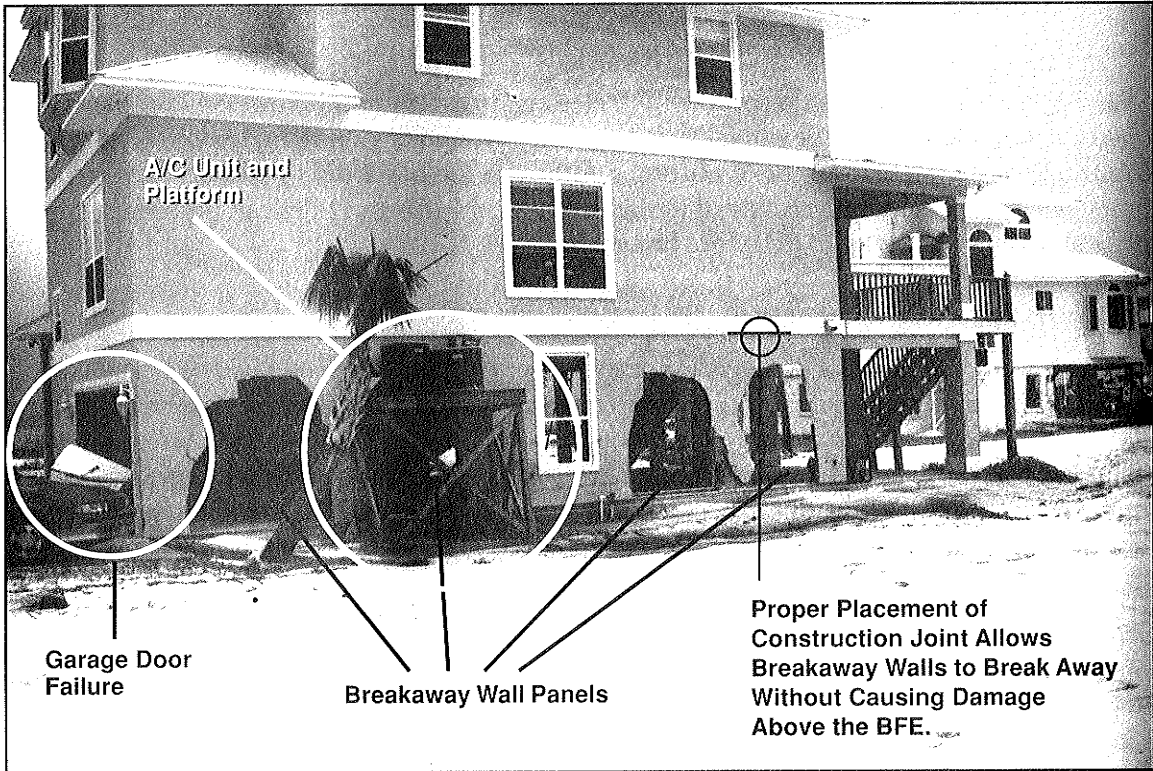
Figure 2-11 *These breakaway walls functioned as designed, lessening the pressures of water, sand, and debris on the structure.*

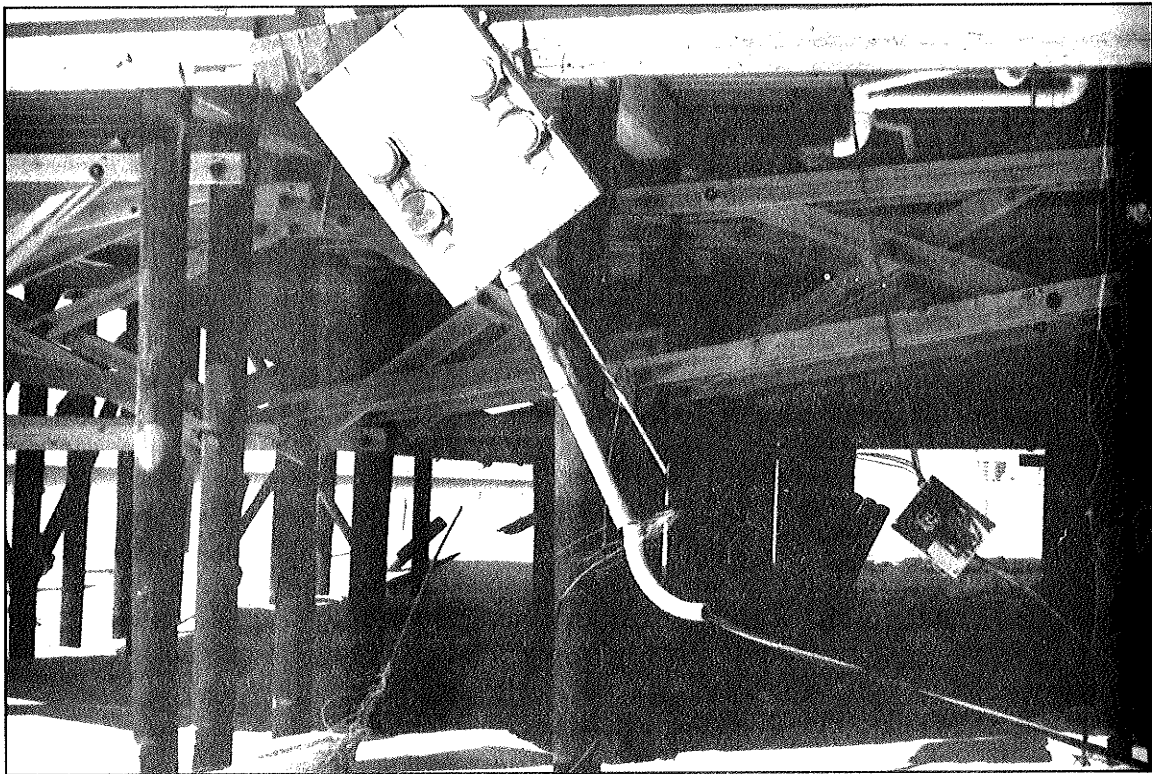
Figure 2-12 *Utility lines and boxes dislocated by hurricane forces. Note that the cross-bracing and pile support system remain in good condition after the storm.*

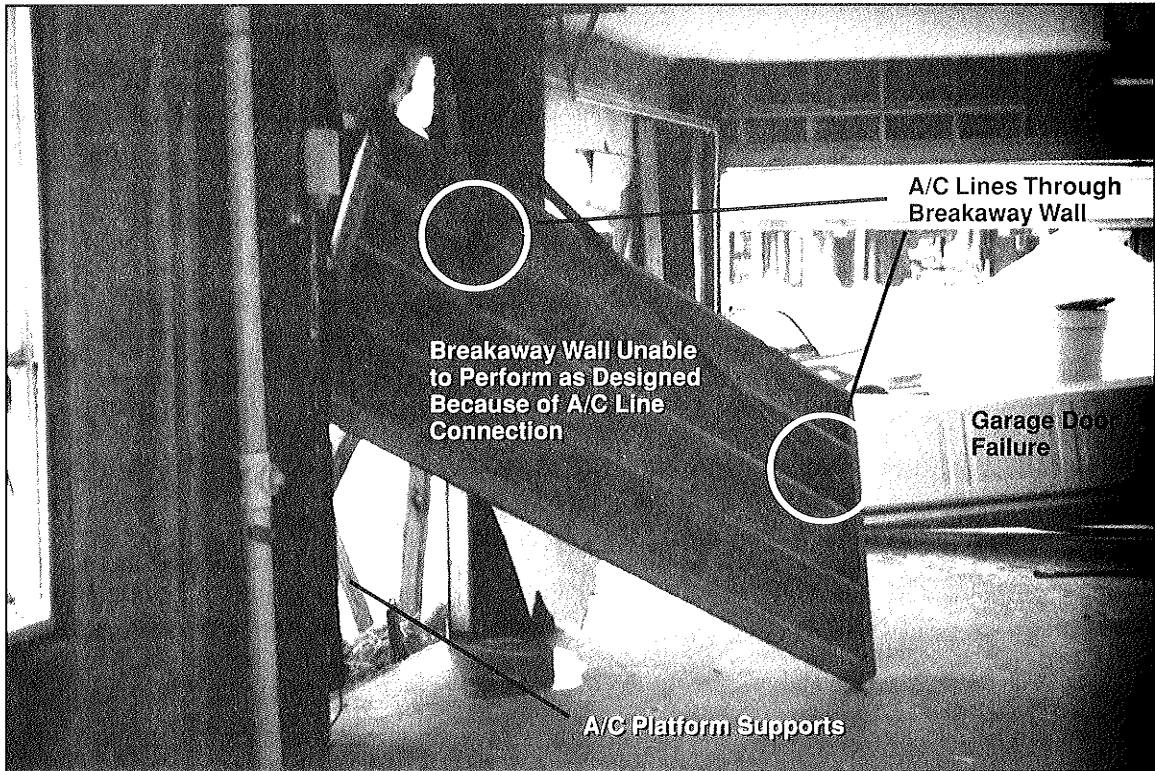
- Attachment of wiring, conduit, and electrical panels to breakaway walls (see Figure 2-13).
- Failure to adequately support and fasten air conditioning compressor units (see Figure 2-14). Many support platforms were destroyed, leading to compressor damage. Some platforms survived, while unfastened compressor units were blown or washed away. Units not properly supported and attached were also observed to have caused damage to exterior walls of some structures.

Figure 2-13 Interior view of breakaway wall blocked by air conditioning unit and support platform (see Figure 2-11). Electric and cooling lines were extended through the breakaway panel.

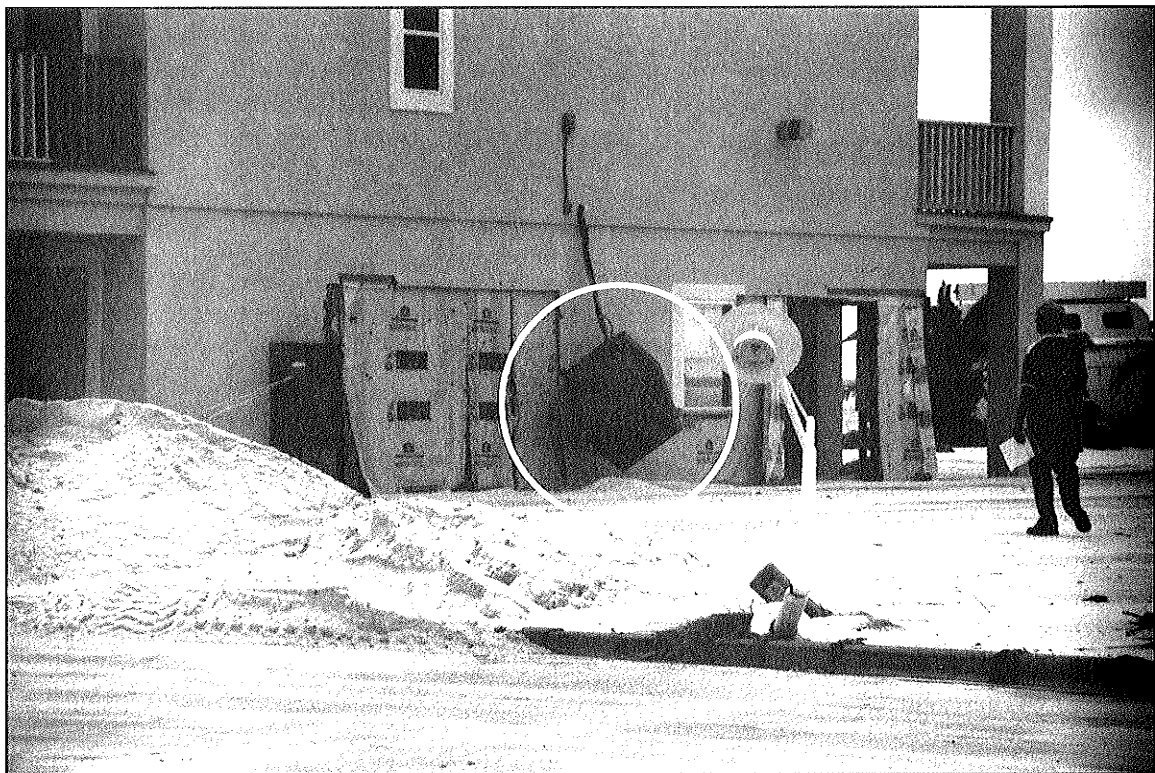
Figure 2-14 These breakaway panels functioned as designed. Note the loss of the air conditioning unit platform.

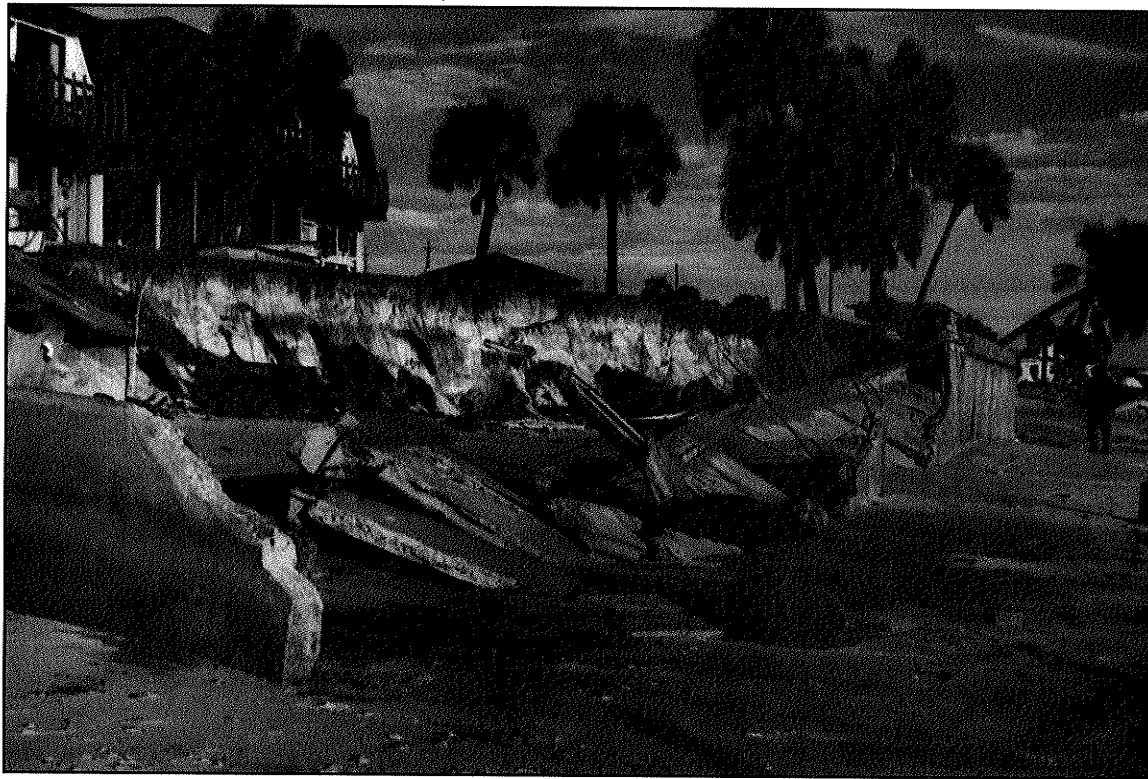
The BPAT noted that retaining walls constructed of concrete blocks were particularly vulnerable to damage by Hurricane Opal. Walls most likely to have survived were observed to have:

Figure 2-15 Fractured seawall, damaged by storm forces. Note the erosion of the bank behind the wall.

Where used, seawalls, bulkheads, and erosion control devices should be designed to resist failure due to wave and flood forces, overtopping, undermining, and debris impact. Wing walls or return walls should extend landward to a point beyond that affected by storm-induced erosion.

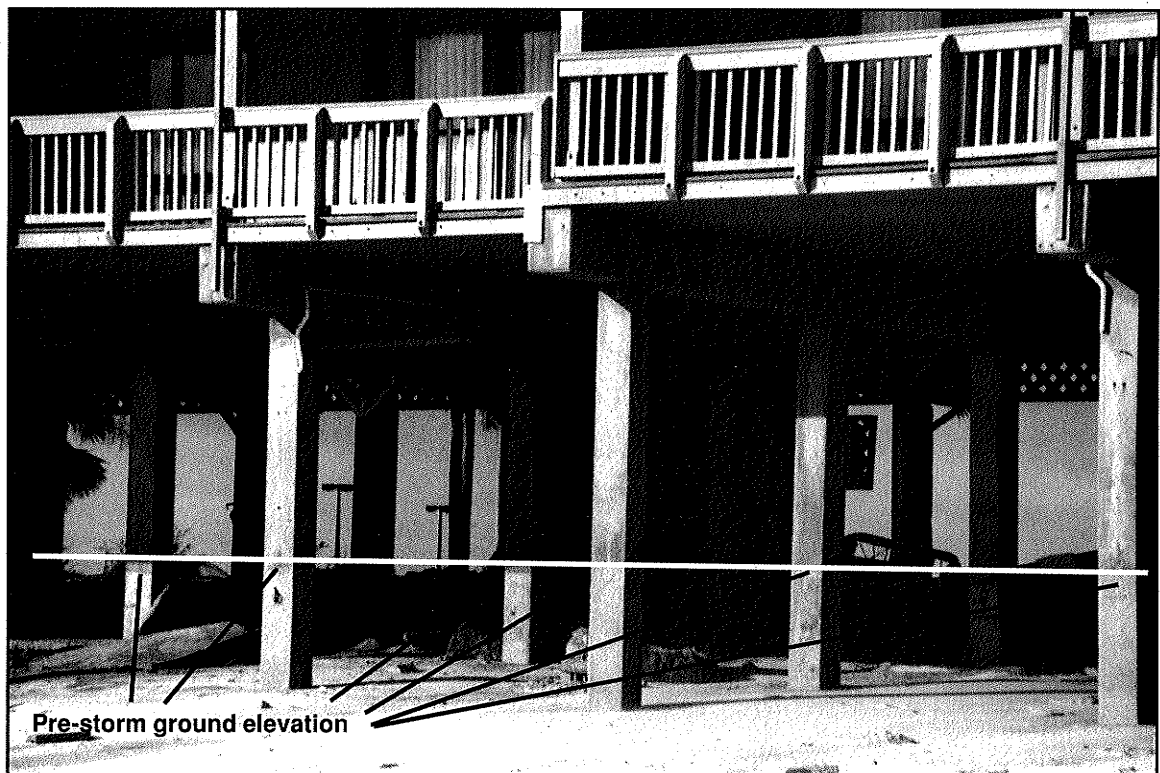
Figure 3-1 This well-constructed concrete structure survived the storm with little or no damage, even with 5 feet of erosion.
