PRE-MITIGATION ASSESSMENT TEAM REPORT

Mississippi Tornado Outbreak, April 23rd -24th

*Damage and Safe Room Performance Observations,
Recommendations, and Conclusions*

July 2010

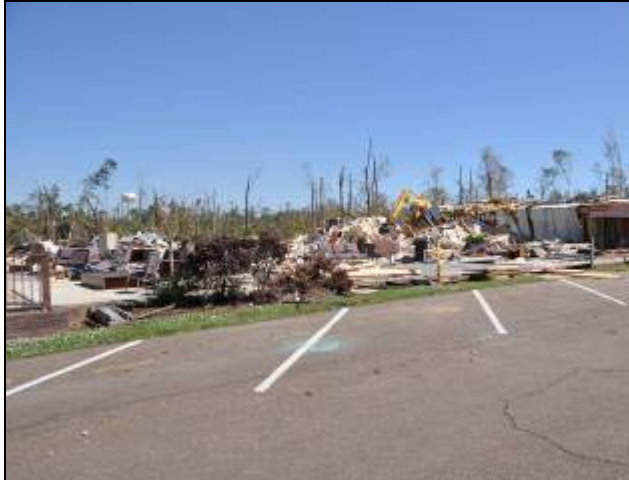
Figure 3: Hillcrest Baptist Church, Yazoo City, MS, EF-3, 157 mph

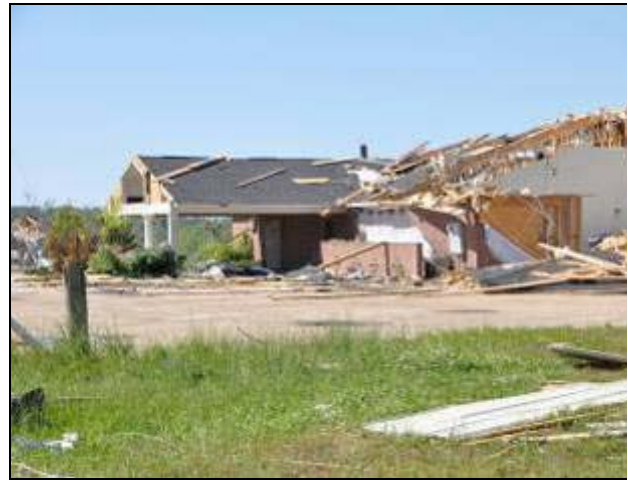
Figure 4: Roberson Funeral Home, Yazoo City, MS, EF-3, 145 mph

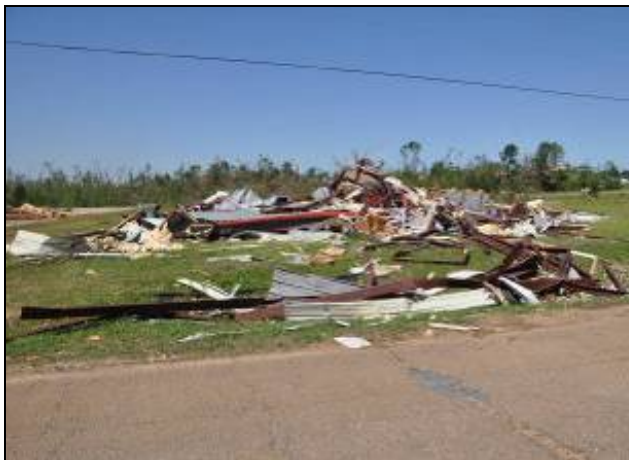
Figure 5: Massey Ferguson Implement Co., Yazoo City, MS, EF-3, 138 mph

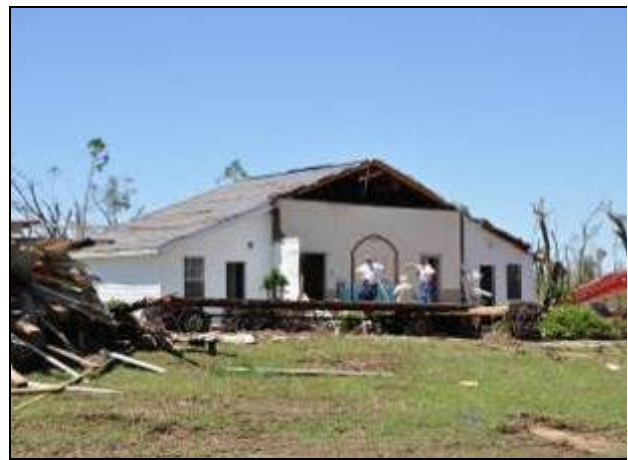
Figure 6: Remaining Portion of Ebenezer Baptist Church, Holmes County, MS, EF-3, 145 mph

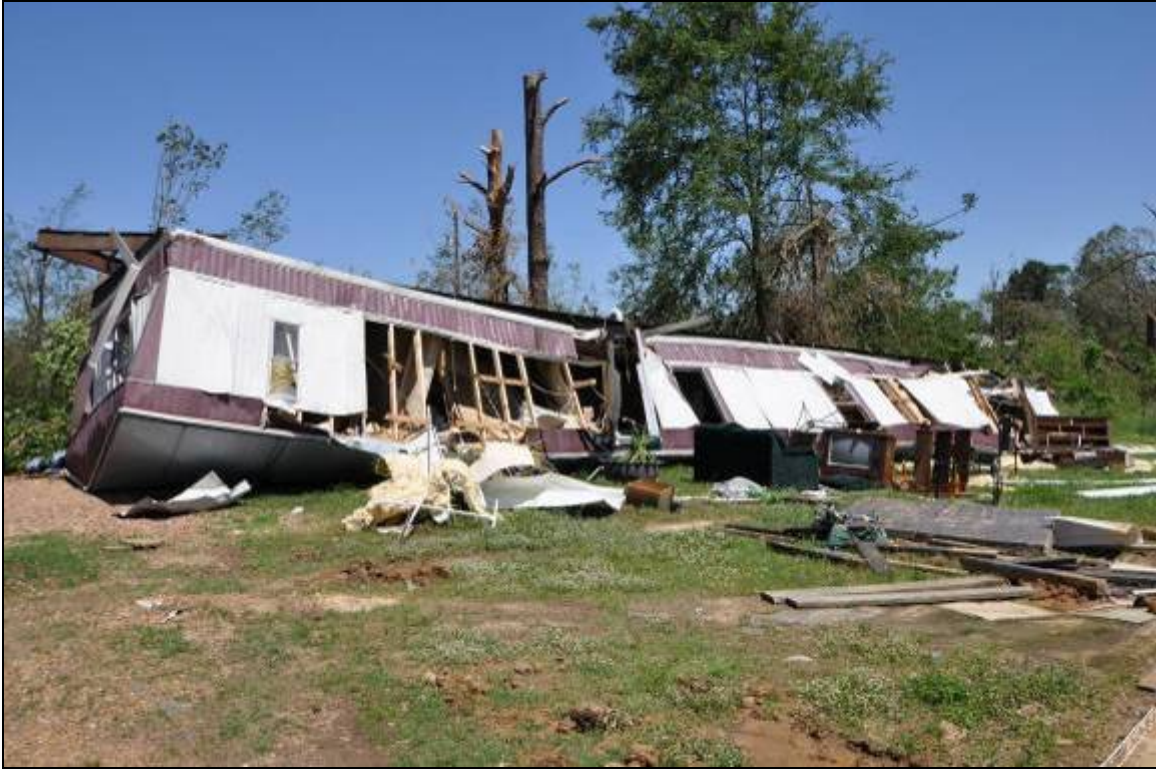
Figure 7: Rolled Manufactured Home, Ebenezer, Holmes County, MS, EF-2, 110 mph

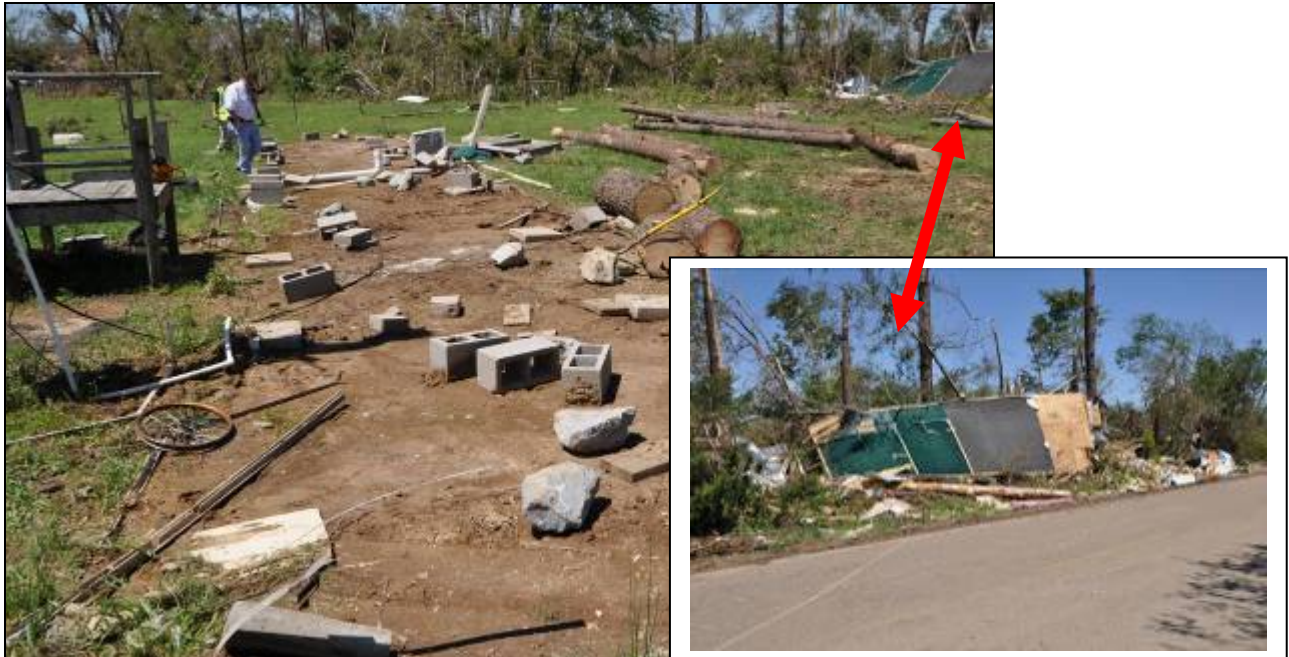
Figure 8: Vaulted Manufactured Home, Ebenezer, Holmes County, MS, EF-2, 110 mph

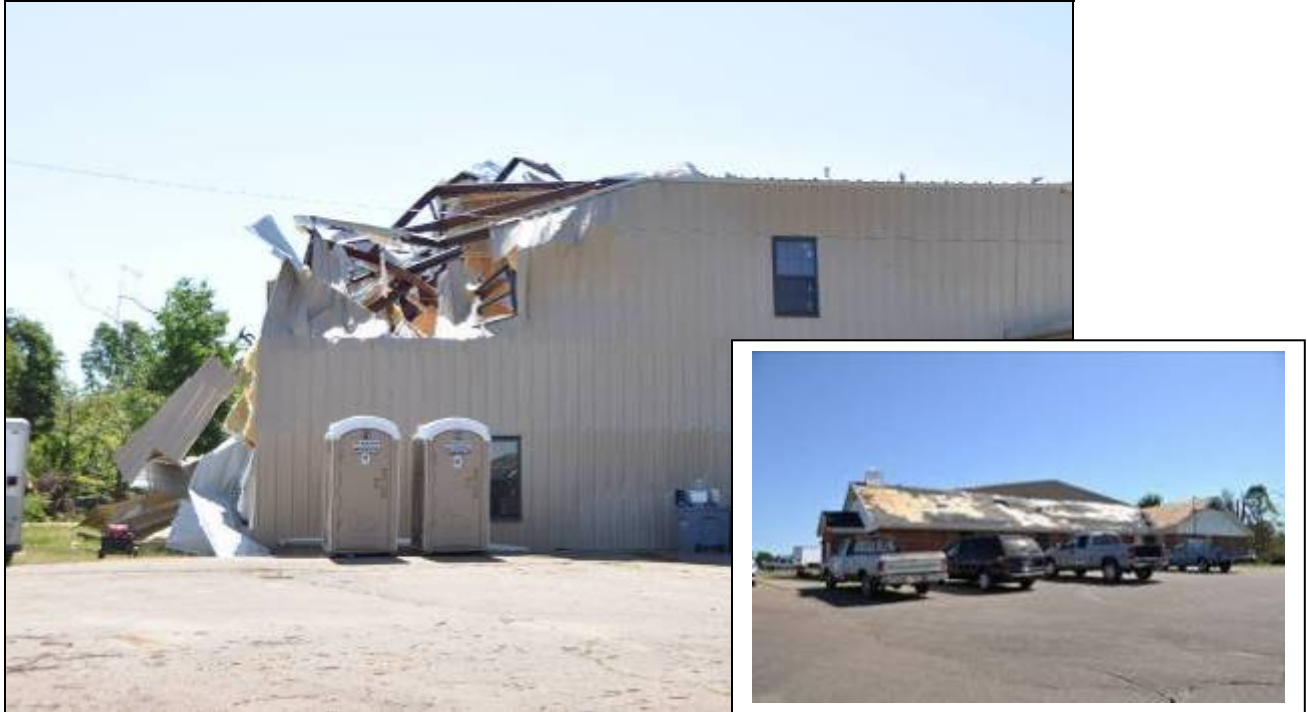
Figure 9: Sanctuary and Fellowship Hall (Left), Mills Spring Missionary Baptist Church (Bottom Right), Choctaw County, MS, EF-2, 120 mph

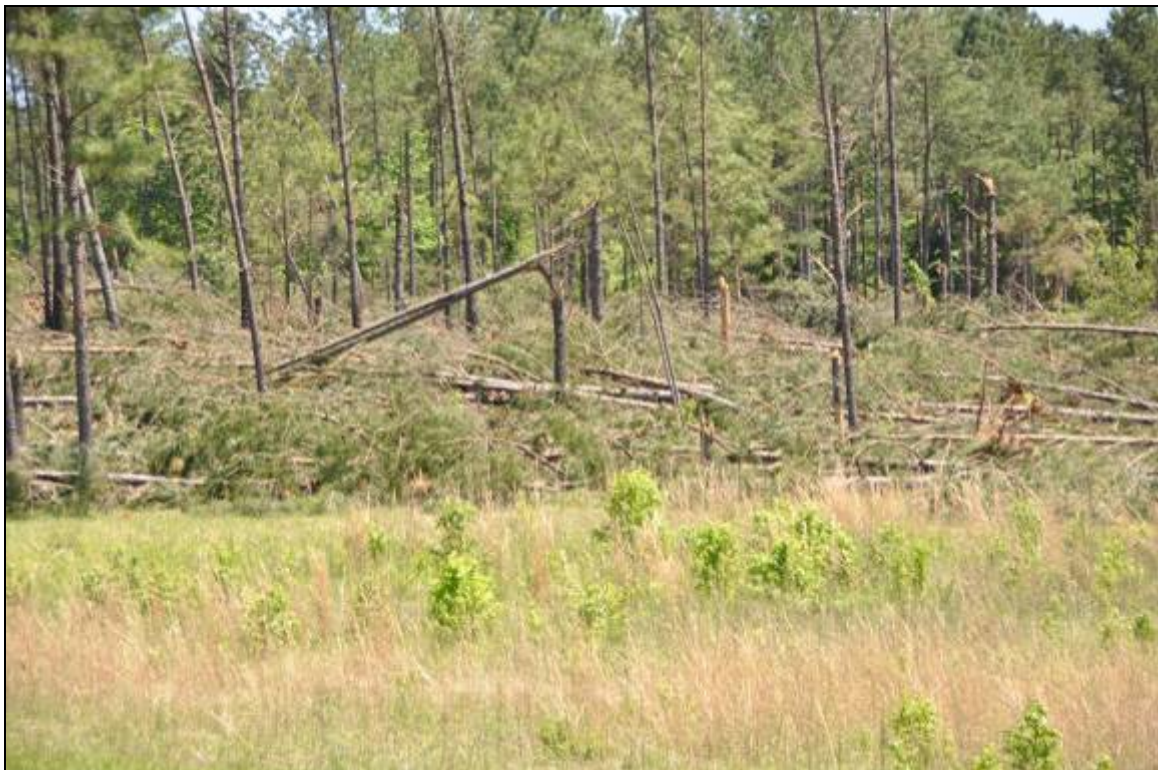
Figure 10: Typical Pine Tree Damage, Choctaw County, MS, EF-2, 100 mph

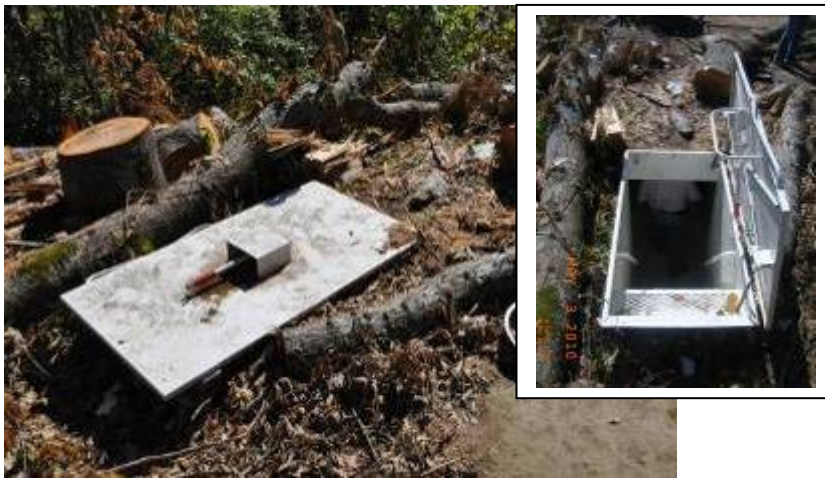
Figure 11: Safe Room #1, Yazoo County, MS

Safe Room #1: The first residential safe room (Figure 11) observed by the PMAT is located in Yazoo City, Yazoo County. The owner was unavailable for an interview, but the installer of the safe room and owner of Life Saver Storm Shelters, accompanied the team on the first day to answer questions. Life Saver Storm Shelters installed this safe room at a cost of approximately \$5,350. This safe room was unoccupied at the time of the storm event, but was in the storm path and seemed to have fared particularly well during the storm. The safe room is constructed completely of steel and includes a three-lock heavy duty door. It appeared that a tree had fallen onto the hatch to the safe room, but by the time the PMAT visited the site, the resident had already cleared the debris off the hatch. The hatch was in good working condition, despite the minimal damage. Life Save Storm Shelter claims their shelter meets or exceeds FEMA standards, and though untested, the shelter appears sufficiently robust to comply with FEMA 320 guidelines. The damage to the surrounding area was equivalent to approximately an EF-3 tornado. The safe room was funded under HMGP, DR-1604.

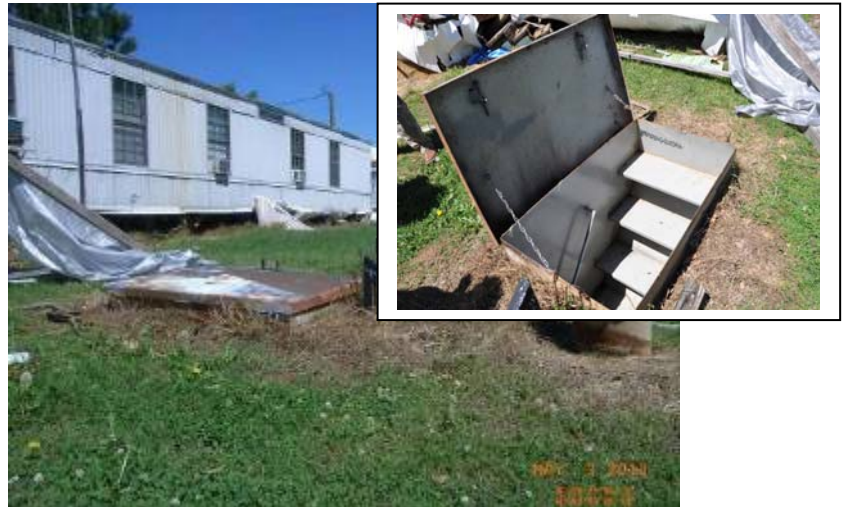
Safe Room #2: The second safe room/shelter (Figure 12) is also located in Yazoo City, Yazoo County. The owner rents out this property and was unable to recall the manufacturer, installer, or price. Through initial observations, the PMAT concluded that this shelter does not comply with FEMA 320 guidelines because the door contains only two locks, which are gate fencing latches. This shelter was unoccupied at the time of the storm event, but was in the storm path. Although the safe room appeared to be undamaged, the adjacent trees and manufactured homes were damaged. Damage included torn and removed siding and roofing materials, broken trees, and scattered debris, equivalent to an EF-2 tornado. The safe room was funded under HMGP, DR-1604.

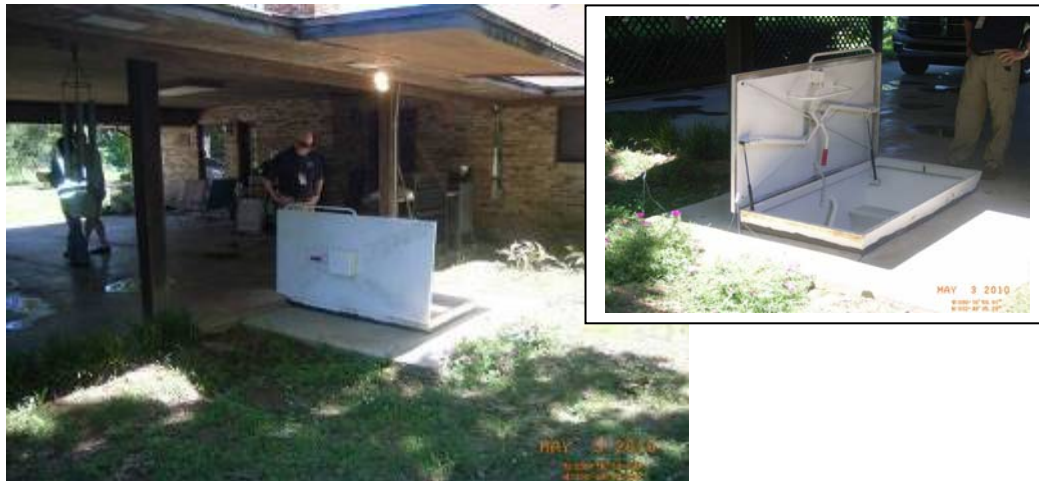
Figure 13: Safe Room #3, Yazoo County, MS

Safe Room #3: The third safe room (Figure 13) is located in Yazoo County and was manufactured and installed by Life Saver Storm Shelters at a cost of approximately \$5,350. The owner of this safe room is also one of the owners of Life Saver Storm Shelters. The safe room was constructed with steel and includes a three-lock heavy duty door. It was occupied by neighbors at the time of the storm event, but was not directly in the storm path. There was no damage to the safe room or surrounding area. The safe room was funded under HMGP, DR-1604.

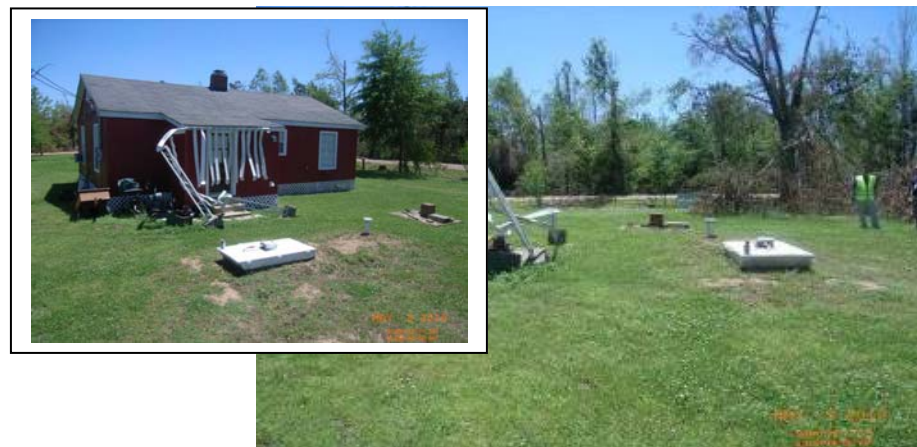
Figure 14: Safe Room #4, Yazoo County, MS

Safe Room #4: The fourth safe room (Figure 14), located in Benton, Yazoo County, was installed by Life Saver Storm Shelters at a cost of approximately \$5,350. The owner was unavailable for an interview. This belowground, steel safe room includes a three-lock heavy duty door. This safe room was in the direct path of the storm, but was unoccupied at the time of the event. The porch and trees surrounding the house were damaged, but there did not appear to be any damage to the safe room. The observed damage was equivalent to an EF-1. The safe room was funded under HMGP, DR-1604.

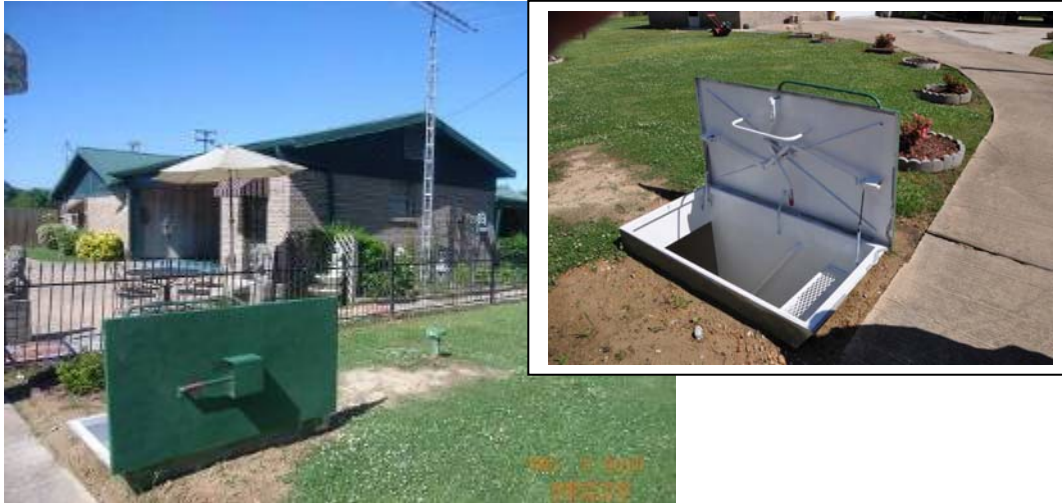
Figure 15: Safe Room #5, Holmes County, MS

Safe Room #5: The fifth safe room (Figure 15) is located in Durant, Holmes County. Life Saver Storm Shelters installed this safe room at a cost of approximately \$5,350. This belowground, steel safe room includes a three-lock heavy duty door. It was occupied at the time of the storm event by the owner and his wife, but was not directly in the storm path. The owner stated that they had approximately a 20-minute warning to access the safe room. There was no damage to the safe room, nearby houses, or in the general vicinity. The safe room was funded under HMGP, DR-1604.

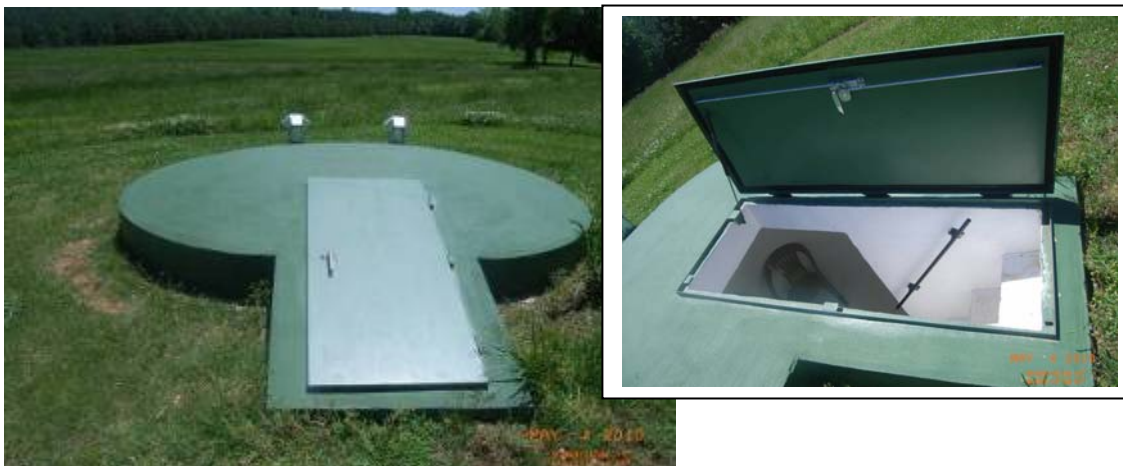
Figure 16: Safe Room #6, Choctaw County, MS

Safe Room #6: The sixth safe room (Figure 16) is located in Ackerman, Choctaw County. Best Tornado Shelters manufactured and installed this safe room at a cost of approximately \$3,500. According to the Building Inspector Shelter Checklist, the safe room meets or exceeds the FEMA 320 guidelines. This belowground, concrete, cast-in-place, three-lock safe room was occupied at the time of the storm event, but was not directly in the storm path. There was no damage to the safe room or the adjacent area. The owner stated that there had been some broken branches in their yard after the tornado. The safe room was funded under HMGP, DR-1604.

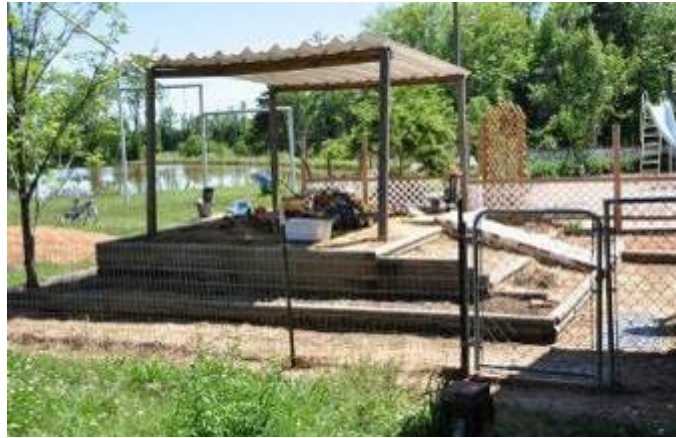
Figure 17: Safe Room #7, Oktibbeha County, MS

Safe Room #7: The seventh safe room (Figure 17) is located in Starkville, Oktibbeha County. The safe room was manufactured by Domes International and installed by the homeowner, who was also the dealer for the safe room company. The door assembly was tested by Texas Tech in 2001. The cost of manufacturing and installing this type of safe room is approximately \$4,700. This belowground, fiberglass safe room includes a three-lock steel door. The safe room was unoccupied at the time of the storm event and was not directly in the storm path. The homeowner was not available for an interview and access to the safe room was limited due to fencing. The safe room was funded under HMGP, DR-1360.

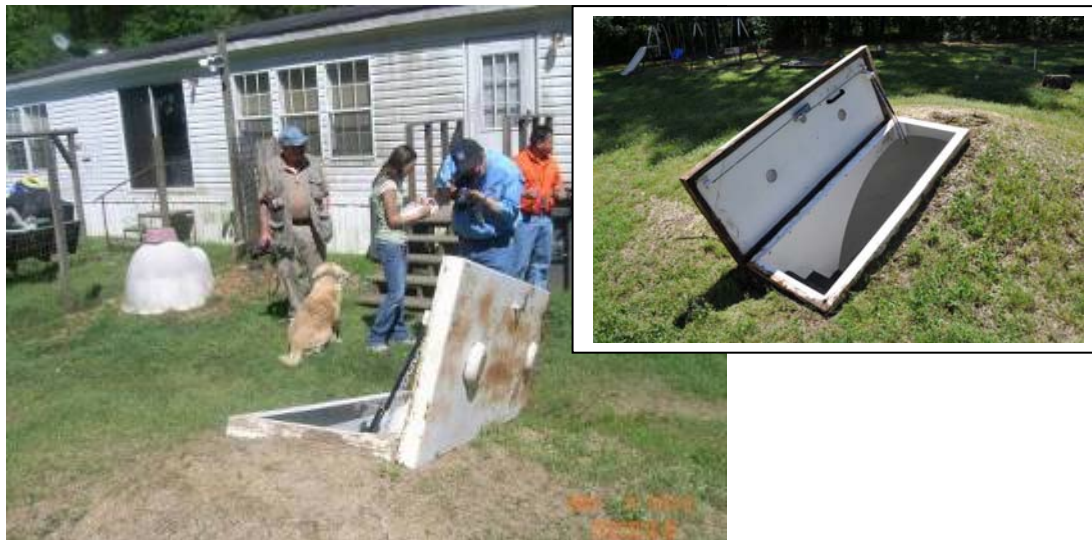
Figure 18: Safe Room #8, Starkville, Oktibbeha County, MS

Safe Room #8: The eighth safe room (Figure 18) is located in Starkville, Oktibbeha County. The safe room was manufactured by Domes International, and the door was tested by Texas Tech in 2001. The cost of manufacturing and installing this type of safe room is approximately \$4,700. This belowground, fiberglass safe room includes a three-lock steel door. The safe room was unoccupied at the time of the storm event and was not directly in the storm path. There was no damage in the nearby vicinity of the safe room. The owner was at work at the time of the tornado and his wife stayed at a relative's home since one of the hinges on the safe room door was broken. The owner stated that he is very pleased with his safe room and has used it multiple times during other tornados. The safe room was funded under HMGP, DR-1360.

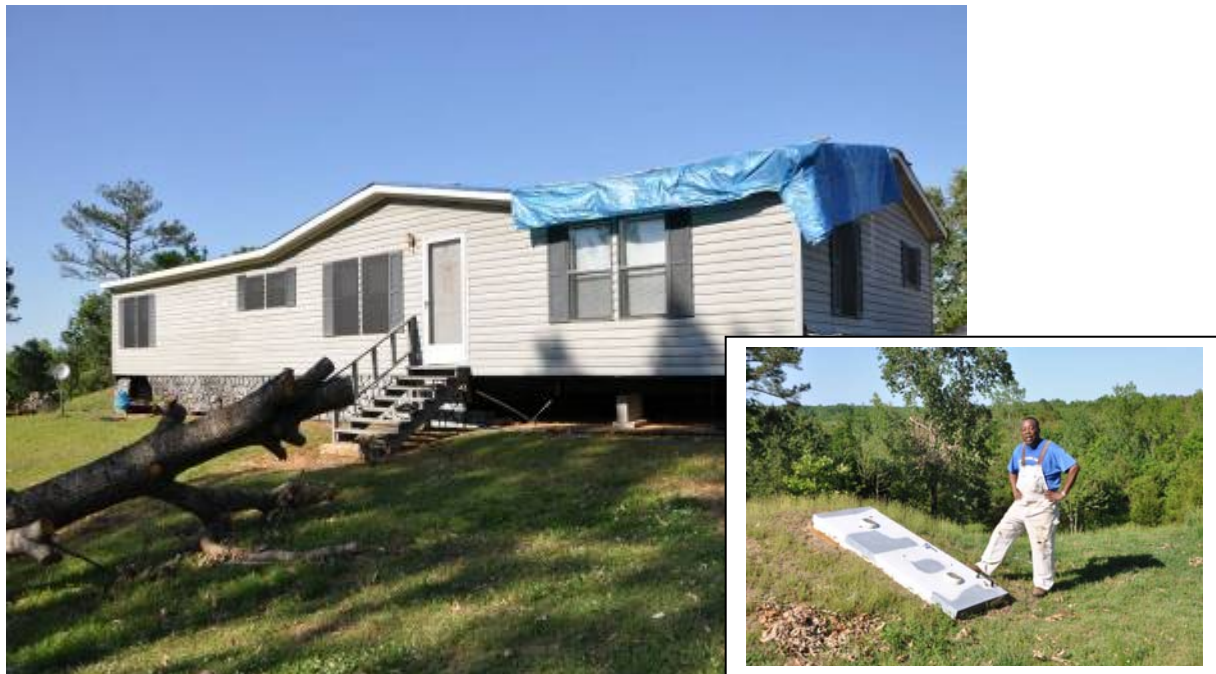
Figure 19: Safe Room #9, Oktibbeha County, MS

Safe Room #9: The ninth safe room (Figure 19) is located in Starkville, Oktibbeha County. The safe room was manufactured by Domes International, and the three-lock steel door was tested by Texas Tech in 2001. The cost of manufacturing and installing this type of safe room is approximately \$4,300. This belowground, fiberglass safe room was occupied by the homeowner at the time of the storm event and was in the path of a weakening tornado. The homeowner survived a direct hit by the tornado. The safe room was funded under HMGP, DR-1360.

The owner stated that news reports indicated that the tornado was approximately 1 mile away, but less than a minute later the wind picked up and he “heard the familiar sound” of a tornado. At that time, he and his girlfriend ran to the safe room just as a tree fell on his manufactured home. There was significant damage to the surrounding trees and nearby homes. The owner’s home appeared to have shifted on its foundation in addition to receiving damage from the fallen tree. The observed damage was equivalent to an EF-1. Originally, the homeowner was going to install a concrete safe room, but the necessary equipment could not access the site so he opted for a lighter, belowground safe room instead.

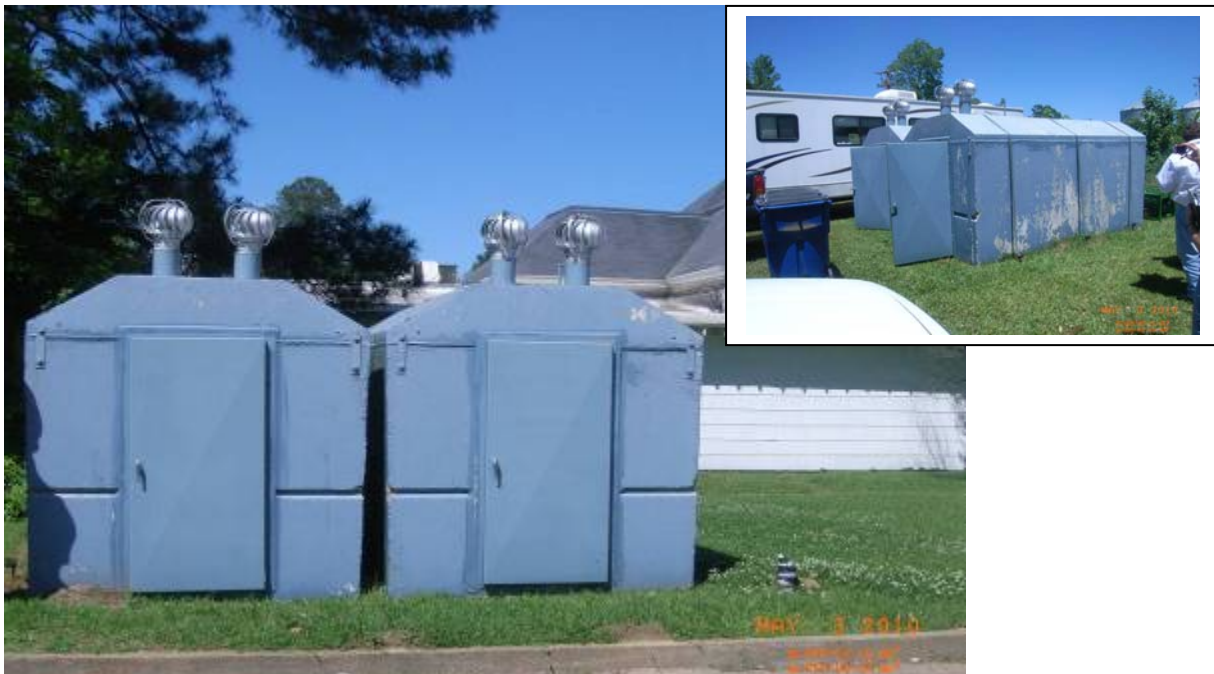
Figure 21: Durant Police Station (Left) and Ebenezer Fire Department (Top Right), Holmes County, FEMA 361 Community Safe Rooms

The PMAT located two community safe rooms: one community safe room was located at the Ebenezer Fire Department and the other was located at the Durant Police Station (Figures 21 and 22). The two community safe rooms are identical. According to Ebenezer Fire Department, people were afraid to use the safe room, and instead took refuge in the fire department building; a pre-engineered metal building. Both these community safe rooms appear to be two FEMA 320 residential safe rooms positioned directly next to one another for the purposes of providing safe space for more than 16 occupants. Since each location has two residential safe rooms, as a pair they were considered as community safe rooms by MEMA.

Both safe rooms consist of a pair of 6-foot, 6-inch wide x 12-foot long x 6-foot tall concrete septic tanks adapted for use as safe rooms. The safe rooms were anchored to the ground with ties and anchors typically used to secure manufactured housing units. The adequacy of this anchor system was not verified or documented. Neither of the safe rooms contained backup lighting and the steel doors and locking system did not appear very robust. Recent impact testing by Texas Tech of an identical door and locking system failed. Neither safe room locations were in the direct path of the storm or sustained any damage. However, the town of Ebenezer sustained significant damage at a nearby church; manufactured home damage and tree damage was also prevalent.

7. Community shelters installed with Federal funding should meet the FEMA 361 criteria. FEMA 361 community safe rooms should be accessible, have proper lighting, and have locking devices that are easily operated. Citizens should be informed by MEMA and local communities of the location and availability of community safe rooms they can use.
