# Performance of Residential Buildings

Mitigation Assessment Team Summary Report and  
Recommendations

State of Hawai'i  
Maui Wildfires

Revised April 2025

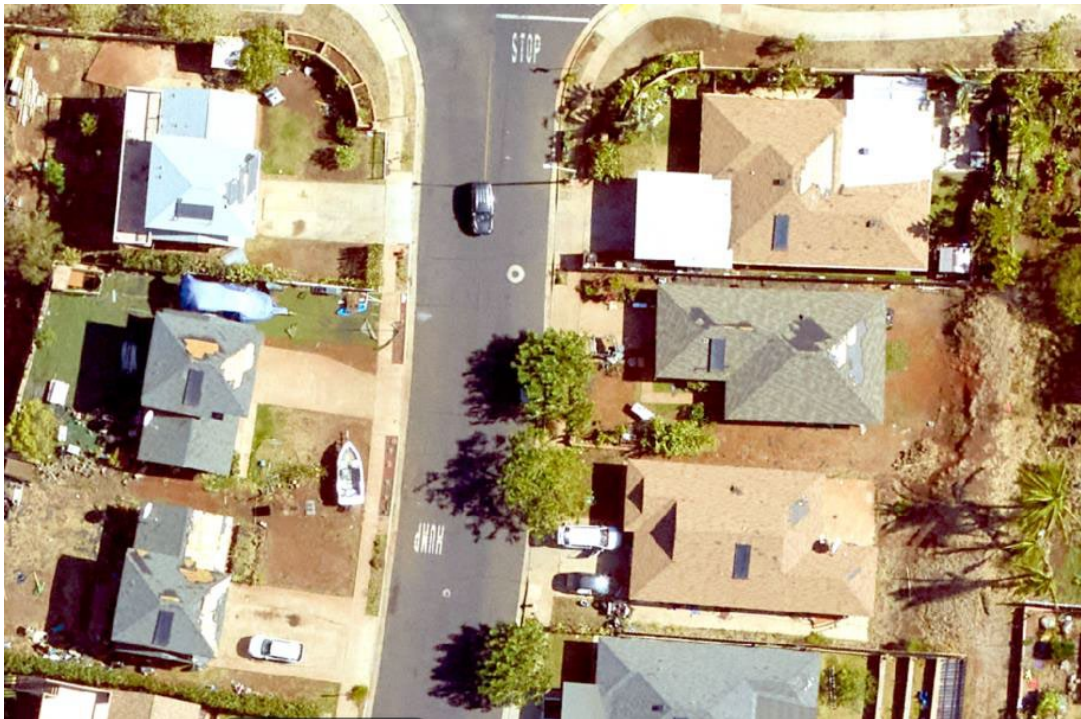
Kula during the fires, it was difficult to determine if roofs were damaged by wind prior to ignition. It was uncertain how roofing systems contributed to structure-to-structure fire spread. However, in reviewing immediate post-damage aerial images, it appears that significant roof damage occurred due to wind (Figure 6) both inside and outside of the fire footprint. The wind damage to roofs included missing roof shingles as well as limited photovoltaic (PV) panel and limited structural damage. Specifically, the MAT observed that many asphalt shingle roofs lost shingles along the centers of the roof surface rather than along roof edges and ridges (Figure 7). The observed pattern of roof shingle damage differed from the loss of roof shingles along roof edges and ridge lines traditionally associated with high wind uplift pressures from hurricanes and severe storms. This could be evidence of localized wind turbulence produced by the fires, but additional research is necessary to verify this hypothesis. Removal of shingles revealed that many residential roofs were not protected by an underlayment, exposing combustible wood sheathing making the roof deck and other roof materials vulnerable to ignition as well as water damage from heavy rains. Coupled with the presence of complex roof shapes trapping embers against combustible roof decks and underlayments, the probability of roof ignition and interior water damage was high in Lahaina.

**Figure 6. Maui post-fire aerial image of roof cover damage to buildings.**

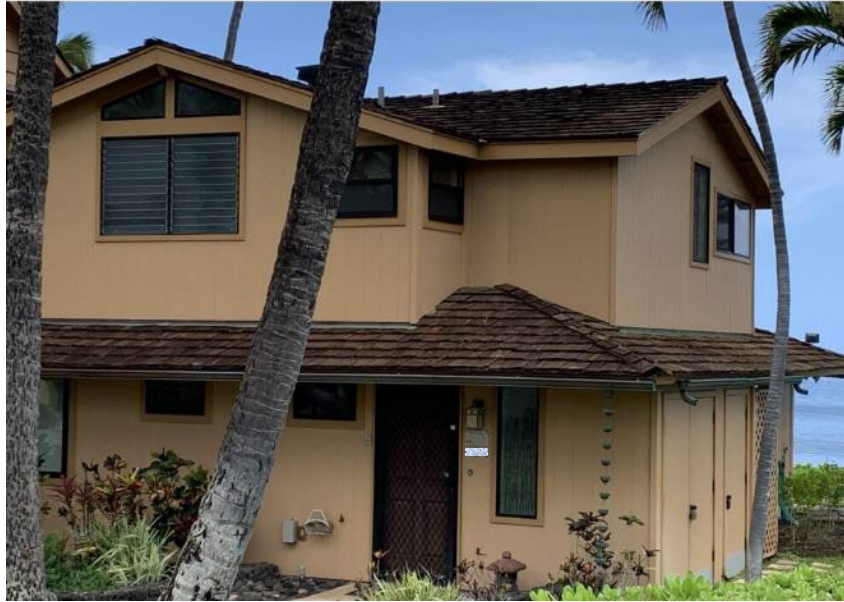
The few metal roof coverings observed by the MAT appeared to perform well. The MAT also observed several single and multi-family residential buildings with wood shake roof coverings. These roof coverings were composed of two or more layers of 3/4- to 1-inch wood shakes and showed evidence that some top surface shakes were charred but not consumed by the fire (Figure 9). Although this could suggest positive performance on selected structures, most current fire research discourages the use of wood shake roof coverings in fire-prone areas.

**Figure 9. Wood shake roof on a residential building in Lahaina, showing evidence of some surface shakes charred by fire.**

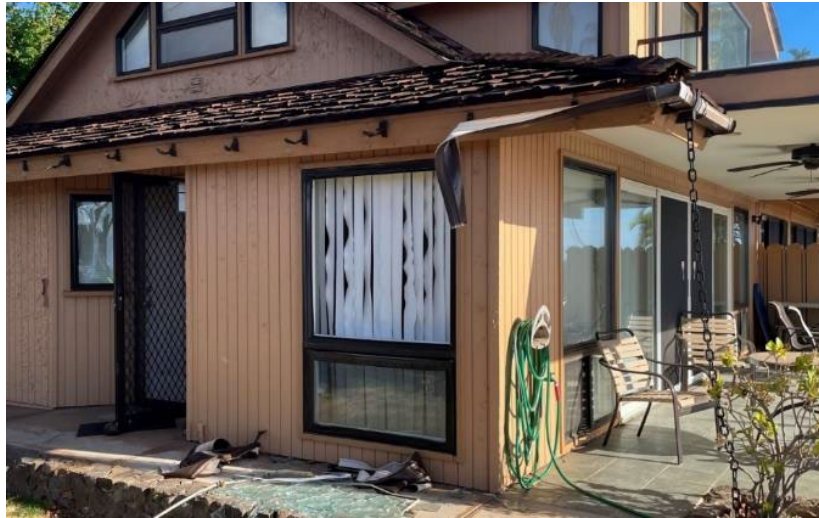
**Figure 10. Melted vinyl gutters and melted window frame with lost glass pane on a residential building in Lahaina.**

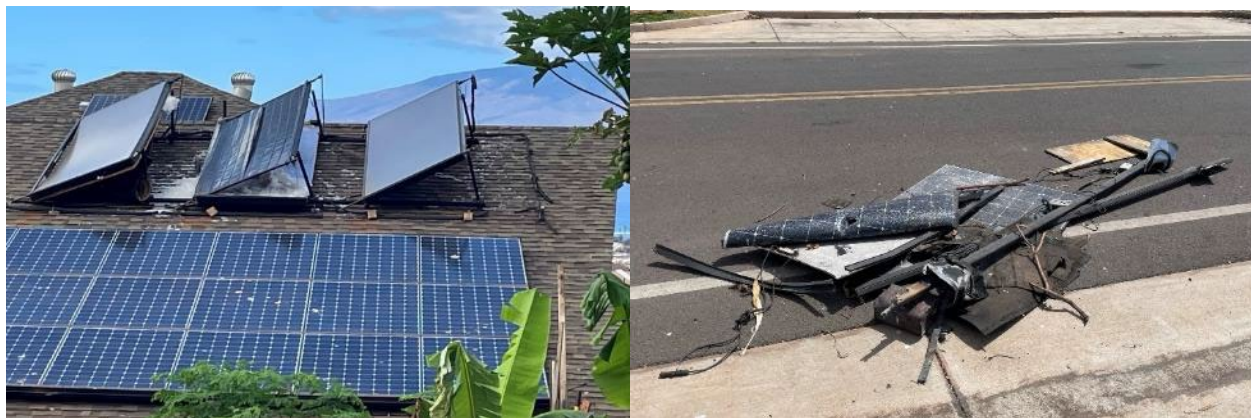
**Figure 11. Damaged solar water heaters observed on a residential building in Lahaina (left). PV panels found on the ground along a street lined with single-family residential buildings in Lahaina (right).**

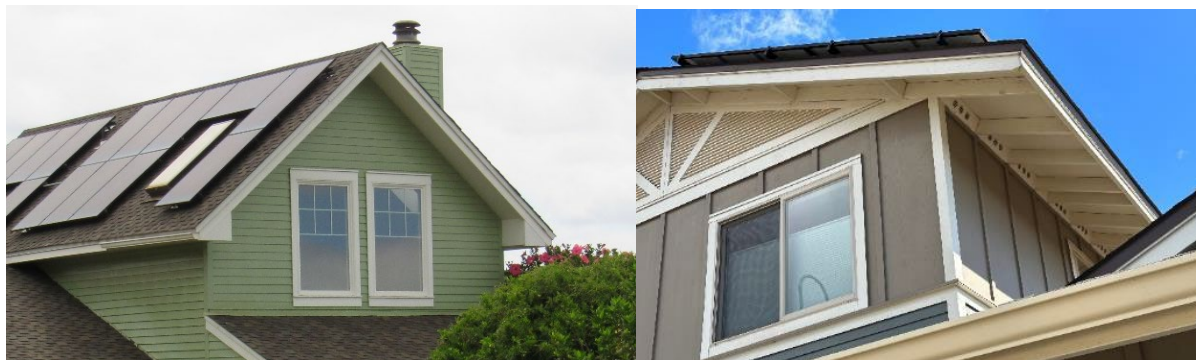
**Figure 12. Typical closed Soffit on Maui residential building (left). Open soffits with small “birdhole” vents on residential units in Lahaina created by an extension of roof framing (right).**

| # | Recommendation | Leader for Implementation |
|---|---|---|
| 3c | Limited eave overhangs, enclosed with noncombustible materials, are recommended for new construction. Regardless of size, enclosed eave overhangs should feature a corrosion-, flame- and ember-resistant soffit of 1/8-inch mesh. | Designers and Property Owners |

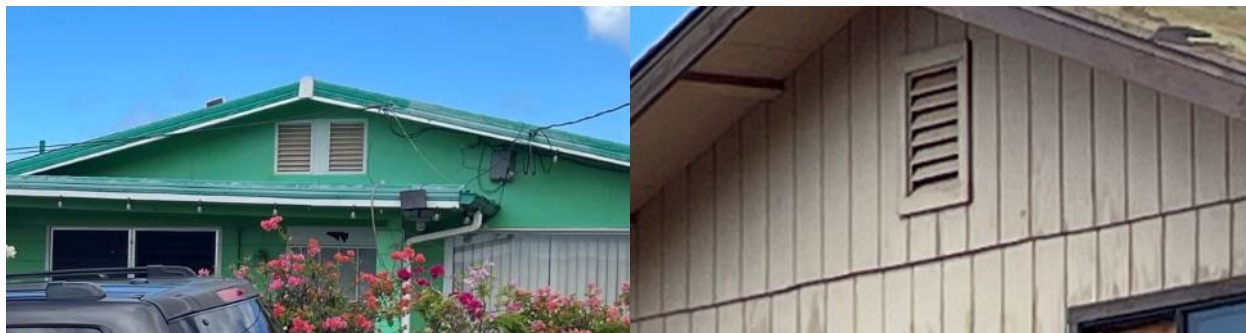
Vent openings covered by louvres were observed near the top of walls and along the gable ends of residential buildings (Figure 13), but fewer soffit or eave vents were observed. However, given the widespread destruction of buildings on Maui, the susceptibility of the vents trapping embers cannot be determined. Additionally, there were no indications that the louvred vents observed by the MAT were protected by noncombustible mesh to prevent ember intrusion.

**Figure 13. Examples of gable end louvred vents.**

| # | Recommendation | Leader for Implementation |
|---|---|---|
| 3b | The Maui County Residential Code should be amended to require corrosion resistant, noncombustible exterior vents covered with 1/8-inch corrosion-resistant noncombustible mesh. | Maui County |

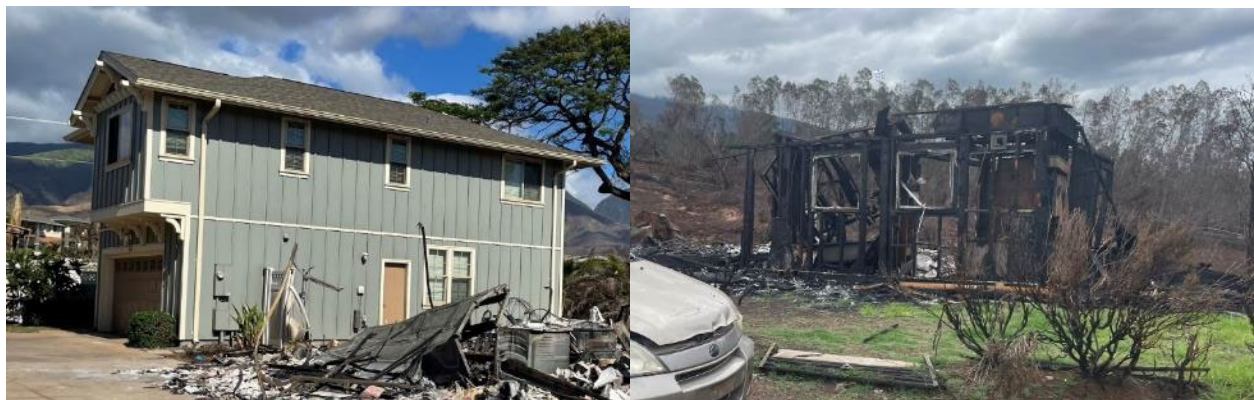
Buildings that had exterior walls covered with noncombustible exterior siding performed better than buildings sheathed with combustible wood or vinyl siding (Figure 15). This was especially critical in Lahaina, where many residential buildings were spaced closely together. The MAT observed combustible exterior cladding present throughout residential neighborhoods on Maui.

**Figure 15. Comparison of residential buildings with noncombustible exterior siding (left) vs combustible exterior siding (right).**

| # | Recommendation | Leader for Implementation |
|---|---|---|
| 5b | Where existing combustible cladding is present, replace combustible exterior wall covering with noncombustible material for the bottom two feet from ground. | Designers and Property Owners |

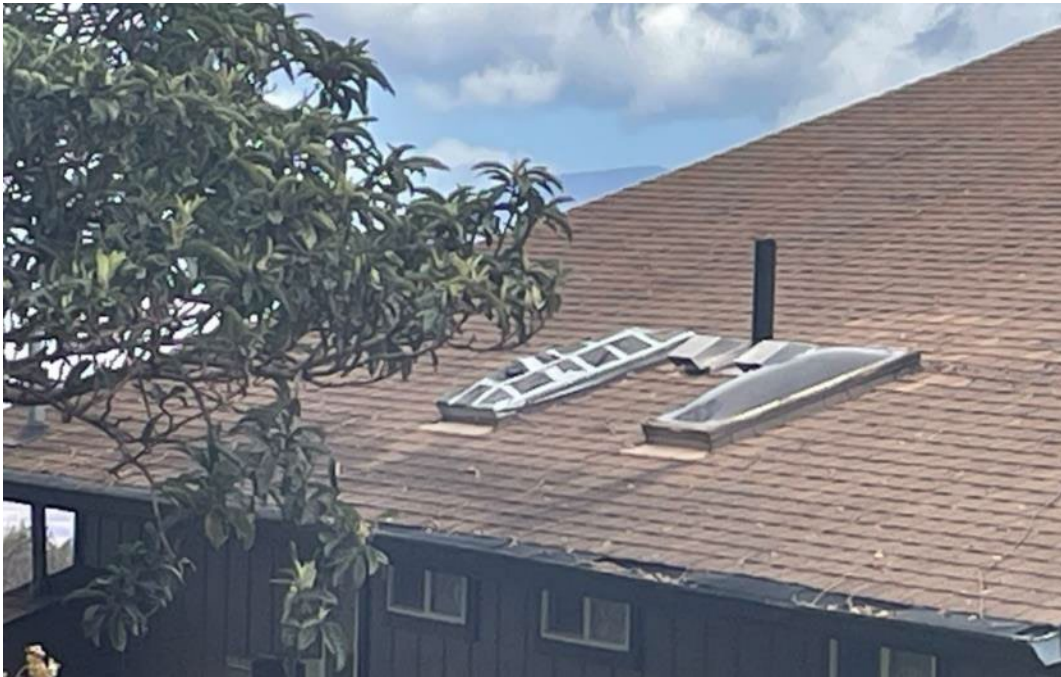
The MAT observed skylights in some residential buildings. Of the damaged skylights that were observed, it is unclear if they were properly designed to limit ember intrusion, if they may have been operable and left open, or if the frames failed and caused the skylight to fall out. A few older plastic skylights appear to have been damaged, but it is unclear if the damage was caused by radiant heat, windborne debris, or firebrands (Figure 18).

**Figure 18. Older plastic skylight on a residential building in Kula damaged by wildfire.**

| # | Recommendation | Leader for Implementation |
|---|---|---|
| 8a | Old plastic “bubble” skylights with wood or vinyl framing should be replaced with tempered glass pane skylights surrounded by non-flammable flashing sealed with noncombustible caulk. | Homeowners |

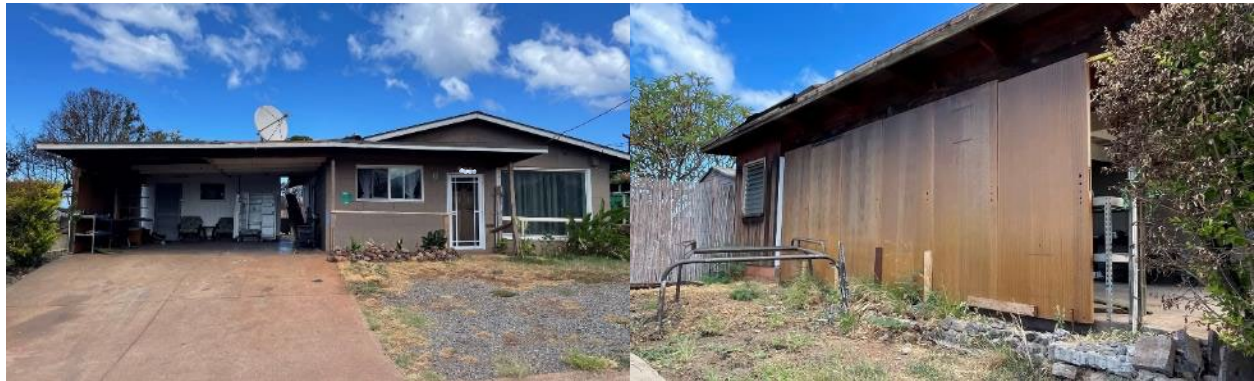
Maui County allows carports to have zero separation between carport and adjacent properties. This allows for the carport to be directly adjacent to a neighbor's fence or structure, thereby reducing the spacing between buildings. The *Lahaina Incident Fire Analysis Report (Phase 2 Report)* released by the Hawai'i Attorney General in September 2024 noted that the density of buildings in Lahaina contributed to rapid fire spread, which is consistent with the MAT fire observations in Lahaina.<sup>26</sup>

**Figure 20. House with attached carport in Lahaina, with carport side support wall constructed or repaired using leftover door panels.**

| # | Recommendation | Leader for Implementation |
|---|---|---|
| 9d | New or replacement carports should feature Class A roof assemblies and noncombustible floors, walls and ceilings with 1-hour fire-resistance ratings. | Architects, Designers and Property Owners |

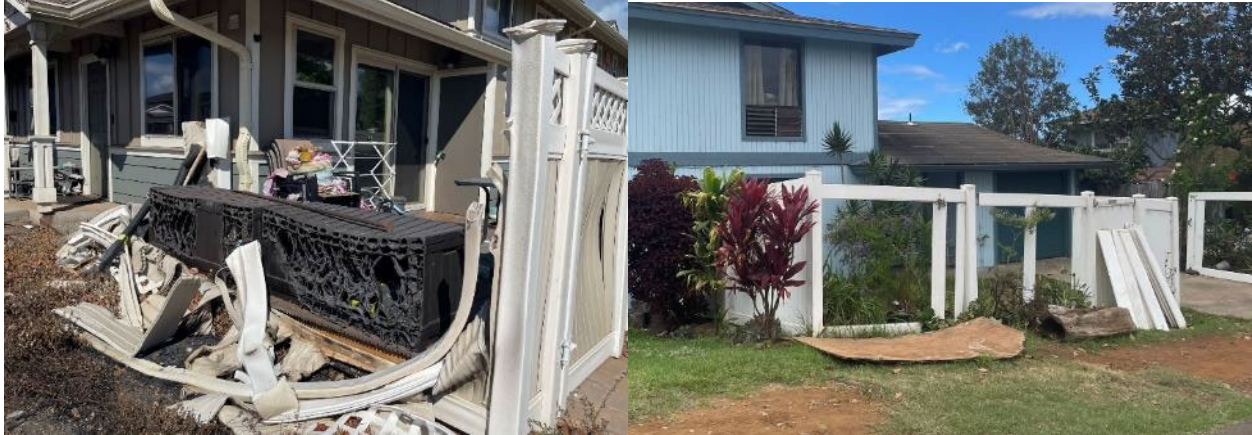
**Figure 21. Residential buildings with vinyl property fences melted or warped by wind-driven wildfire.**

| # | Recommendation | Leader for Implementation |
|---|---|---|
| 10 | Remove or replace existing combustible fencing with noncombustible fencing within five (5) feet of the house (also known as Zone 0) consistent with recommended defensible space requirements. | Homeowners |

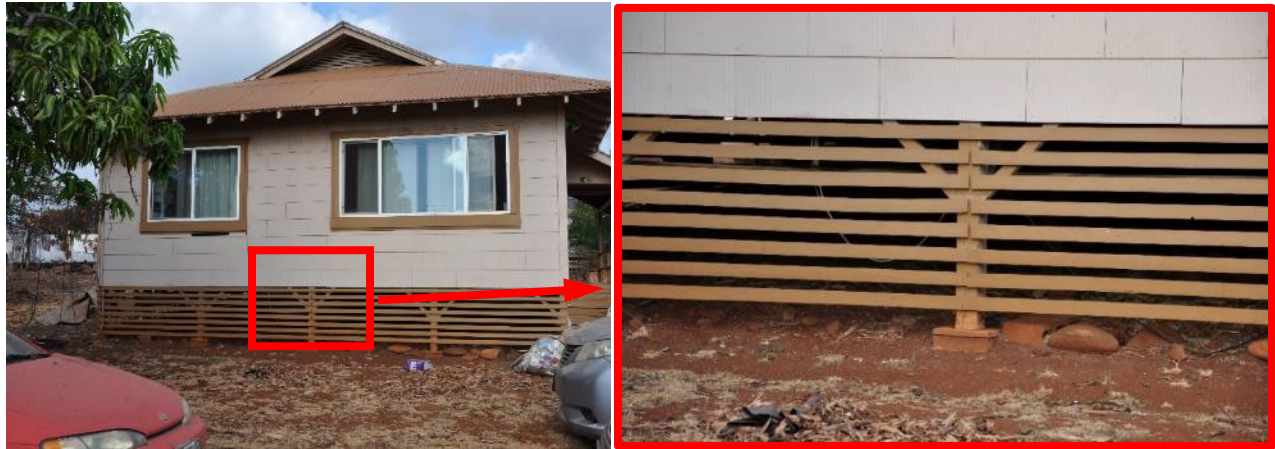
The MAT also observed several homes elevated with post and pier foundations consisting of timber posts resting on a foundation block at grade without connectors or fasteners between posts and the foundation block or between the foundation block and the ground other than the weight of the supported structure. These post and pier foundations were traditionally used to support old plantation-style modest dwellings throughout Hawai'i, but many remain on Maui and have been adapted over the years to support single-family homes (Figure 23). While post and pier foundations can resist gravity (dead and live) loads and small lateral and uplift forces, the lack of lateral support connections in these foundations make them highly vulnerable to damage or collapse during flood, high wind, or seismic events.

**Figure 23. Maui residential building supported by post and pier foundation.**

| # | Recommendation | Leader for Implementation |
|---|---|---|
| 12b | The 2018 State of Hawai'i Residential Code Section R401.5 requires post and pier foundations for new construction designed with accepted engineering practice. Homes with this foundation type should be retrofitted with lateral support connections to resist flood, wind, and seismic forces consistent with building codes and standards. | Homeowners |

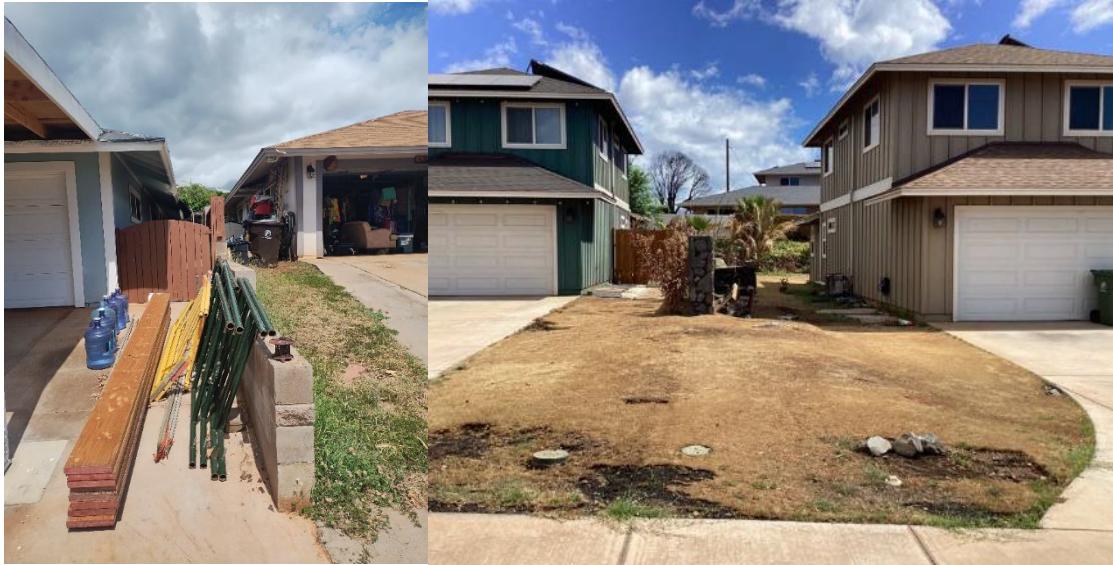
**Figure 27. Examples of limited separation distances between residential buildings in Lahaina.**

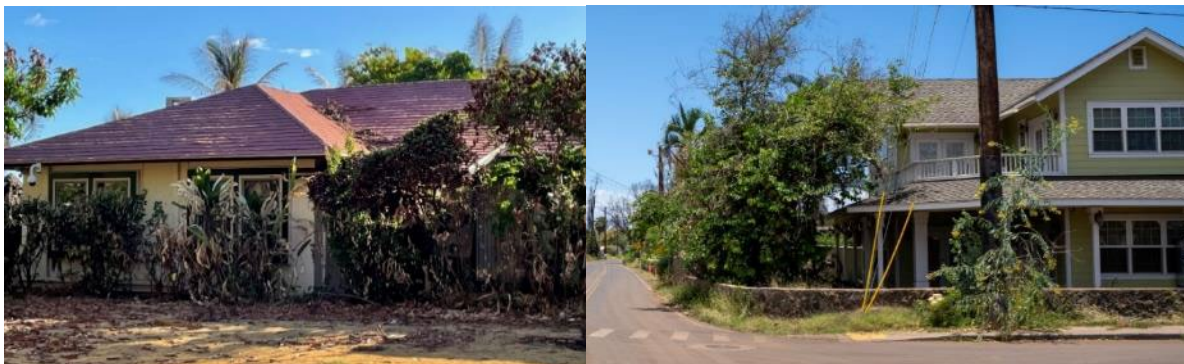
Observed overgrown vegetation between residential structures increases the risk of spot fire ignition from embers (Figure 28). This circumstance may lead to structure ignition and structure-to-structure fire spread. Non-native and invasive plants are prevalent in Maui County. During MAT interviews, it was noted that there is a lack of specific resources (and knowledge of existing resources) regarding fire-resistant plants recommended for use in Hawai'i.

**Figure 28. Examples of homes in Lahaina with overgrown vegetation directly adjacent to the building.**

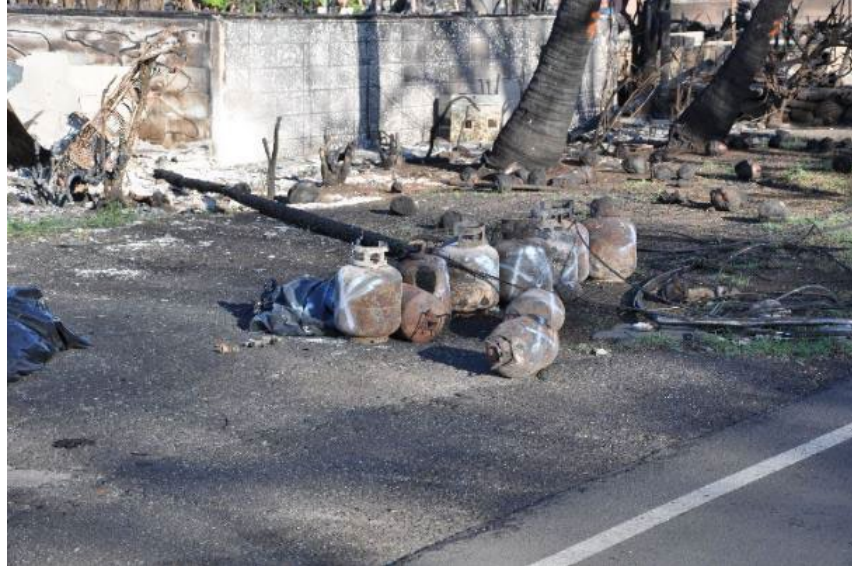
**Figure 29. Propane tanks are commonly used in and around residential buildings.**

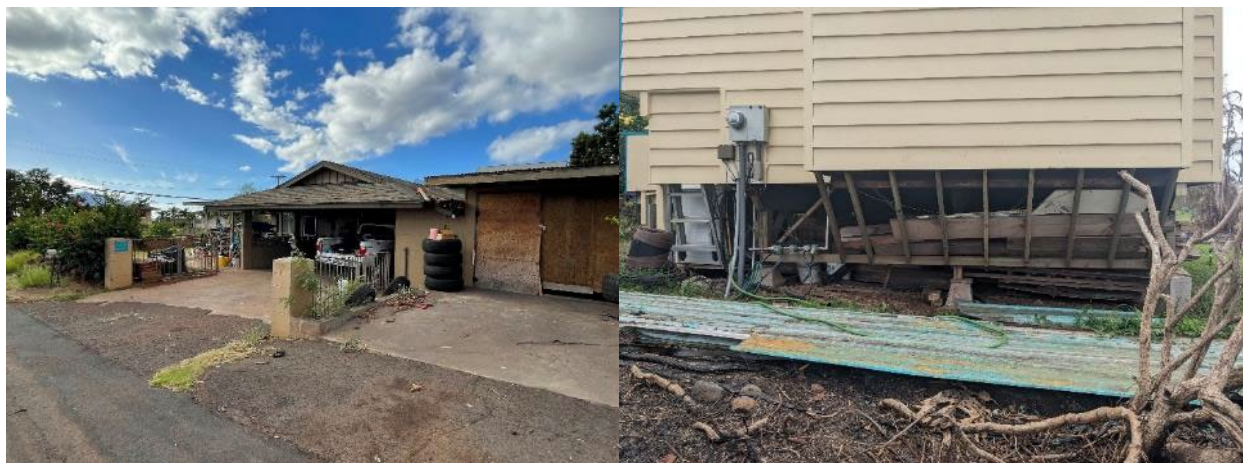
Open foundation areas under the floor and open carports were commonly used storage areas for household items (Figure 30). Storage or placement of potentially combustible outdoor furniture was common in yards, patios, and against the sides of homes (Figure 31).

**Figure 30. Examples of open storage of household items in carports and underneath floors.**

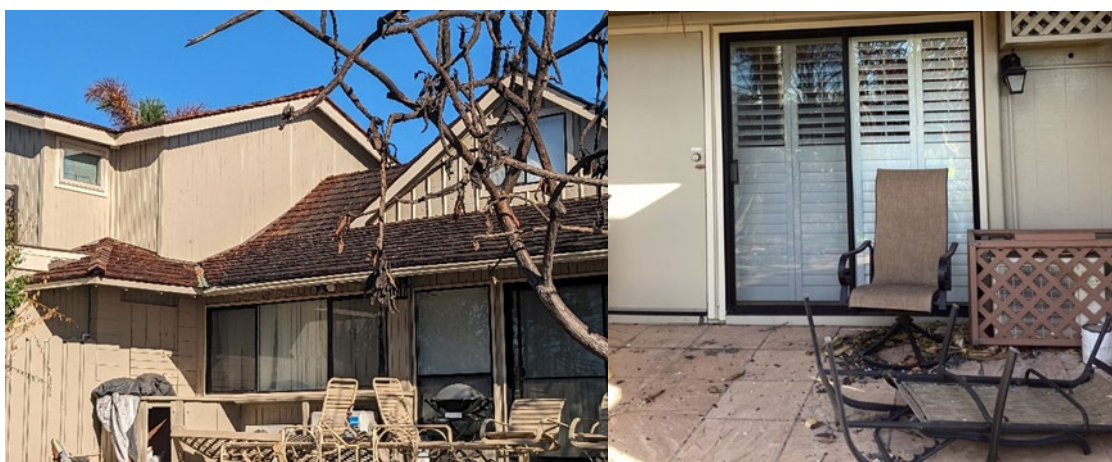
**Figure 31. Examples of homes with outdoor furniture or other potentially combustibile material stored on patios and in yards.**

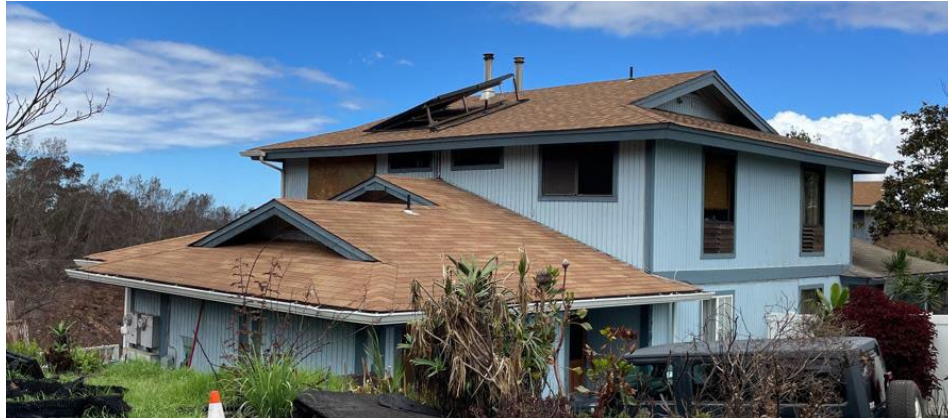
- Deferred home maintenance increased the risk of fire exposure. This included loose or missing roof shingles or tiles that were not repaired or replaced to help prevent embers from getting trapped, and gutters filled with vegetative debris (due to a lack of gutter covers) that may have ignited by embers and spread to the structure. Homes with complex roof shapes (Figure 34) or upcountry homes with chimneys can be particularly vulnerable to debris or ember accumulation.

**Figure 34. Example of Maui home with complex roof shape subject to debris or ember accumulation.**
