Rapid Visual Screening of Buildings for Potential Seismic Hazards: A Handbook

Third Edition

FEMA P-154 / January 2015

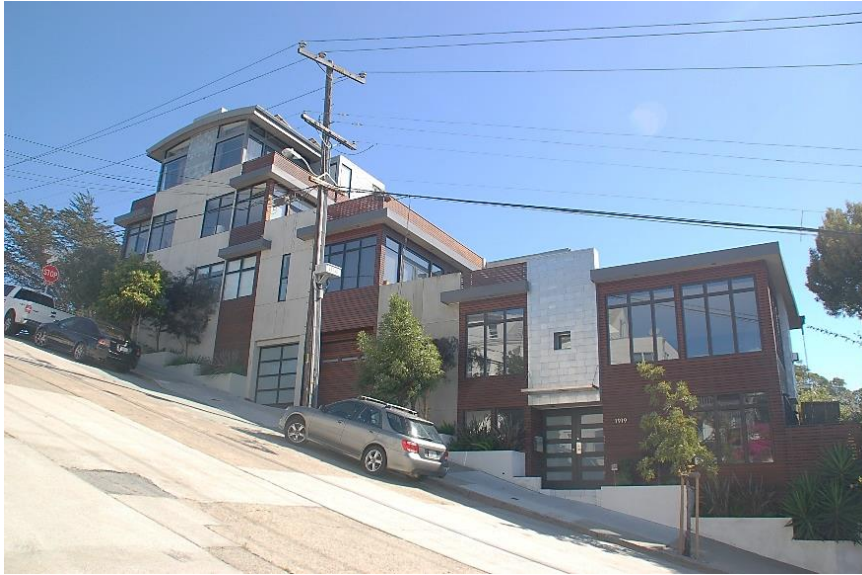
Figure 3-16 Illustration of a building on a sloping site.

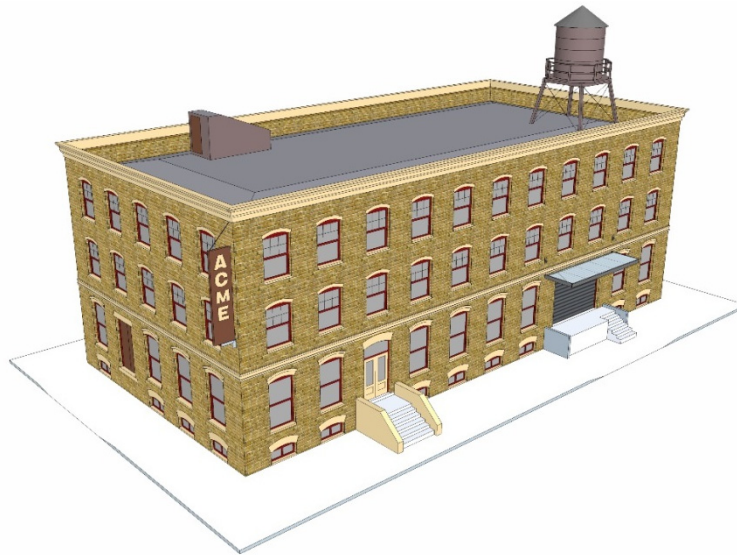
Figure 3-37 Illustration of a building with parapets and other potential falling hazards, including canopy over loading dock and water tank on roof.

Although the basic seismic force-resisting system for the building may be adequate and require no further review, if the presence of such hazards may still be a danger to building occupants and passersby. Several boxes are provided in the Exterior Falling Hazards portion of the Data Collection Form to help the screener identify potential hazards (see Figure 3-38).

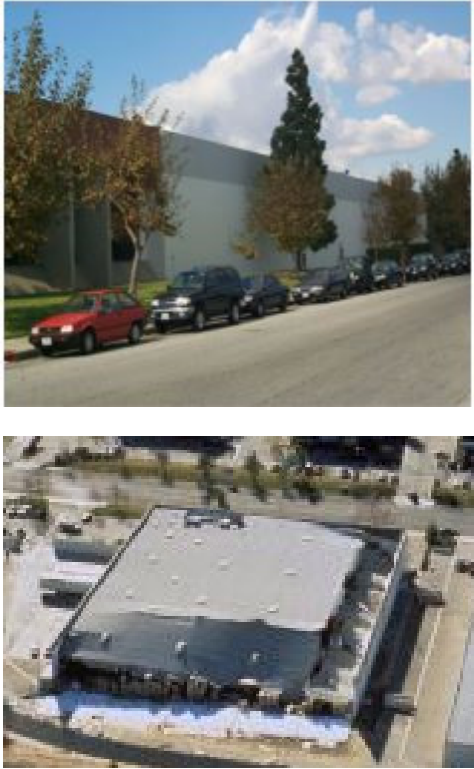
<p>Partial roof collapse due to failed diaphragm-to-wall connection</p>	<p>(VH) = 1.1 (H) = 1.6 (MH) = 1.8 (M) = 2.1 (L) = 3.8</p>	<ul style="list-style-type: none"> • Tilt-ups are typically one or two stories high and are basically rectangular in plan. • Exterior walls were traditionally formed and cast on the ground adjacent to their final position, and then tilted up and attached to the floor slab. • The roof can be a plywood diaphragm carried on wood purlins and glulam beams or a light steel deck and joist system, supported in the interior of the building on steel pipe columns. • Weak diaphragm-to-wall anchorage results in the wall panels falling and the collapse of the supported diaphragm (or roof).

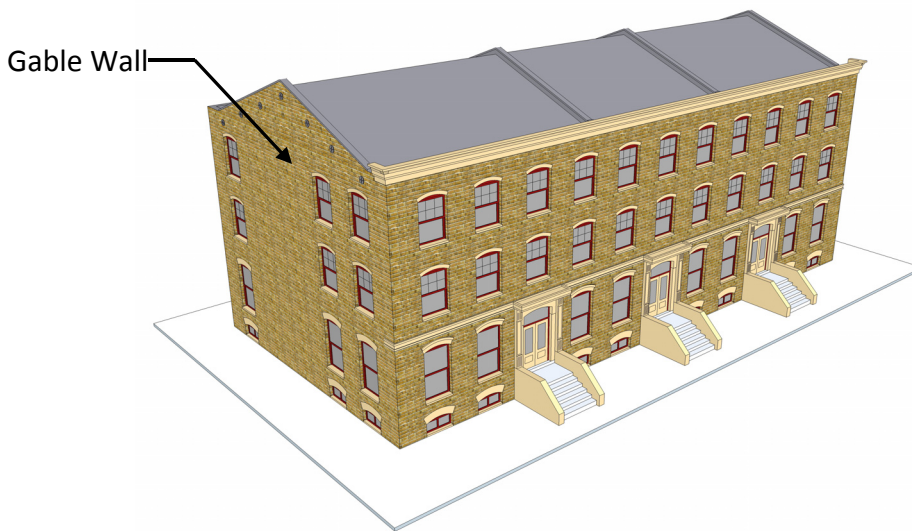
Figure 4-13 Illustration of a URM building with a gable end wall.

- “*URM: Gable walls are present.*” URM gable walls are normally not braced and are often vulnerable to out-of-plane failure. Because these walls often provide vertical support for the roof, failure of the gable wall can result in partial collapse. An illustration of a building with a gable wall is provided in Figure 4-13.

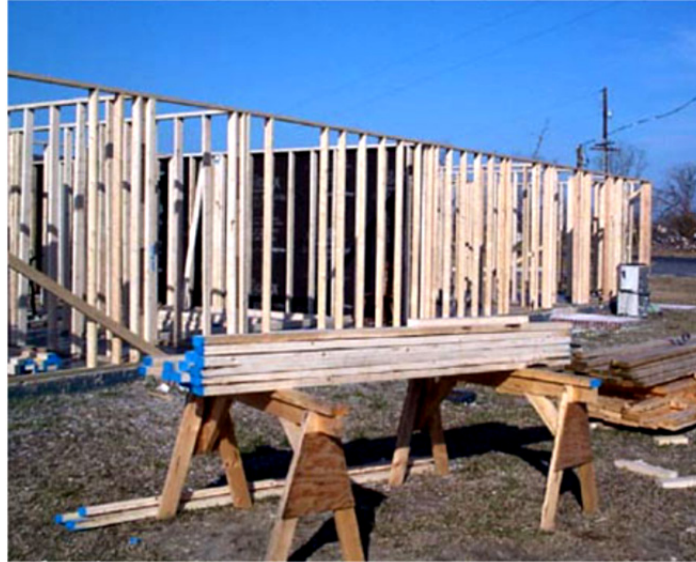
Figure E-5 Stud wall, wood framed house.

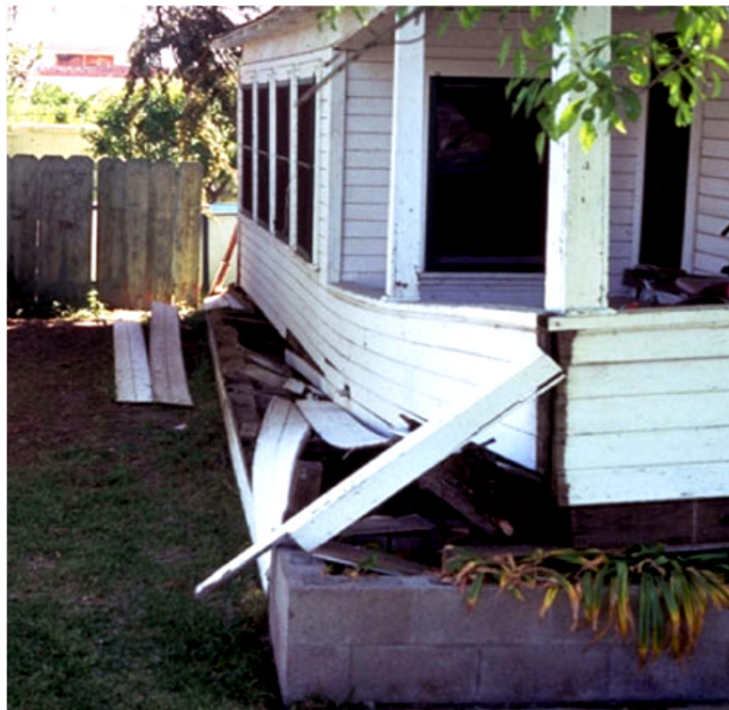
Figure E-8 House off its foundation, 1983 Coalinga earthquake.

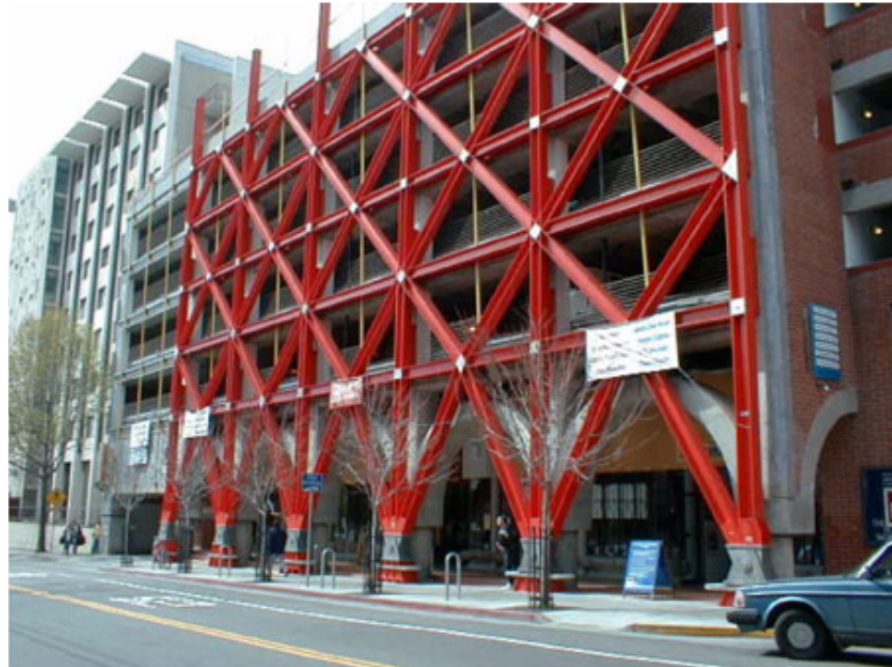
Figure E-15 Retrofit of a concrete parking structure using exterior X-braced steel frames.

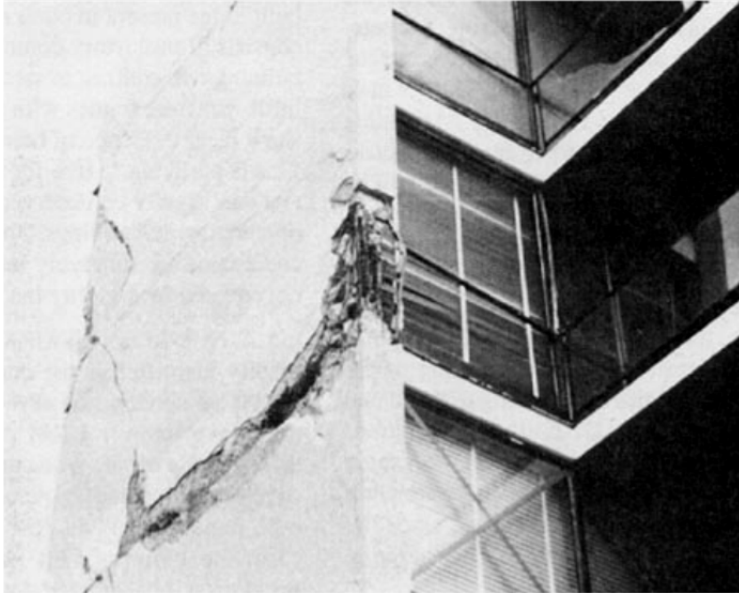
Figure E-21 Close-up of exterior shear wall damage during a major earthquake.

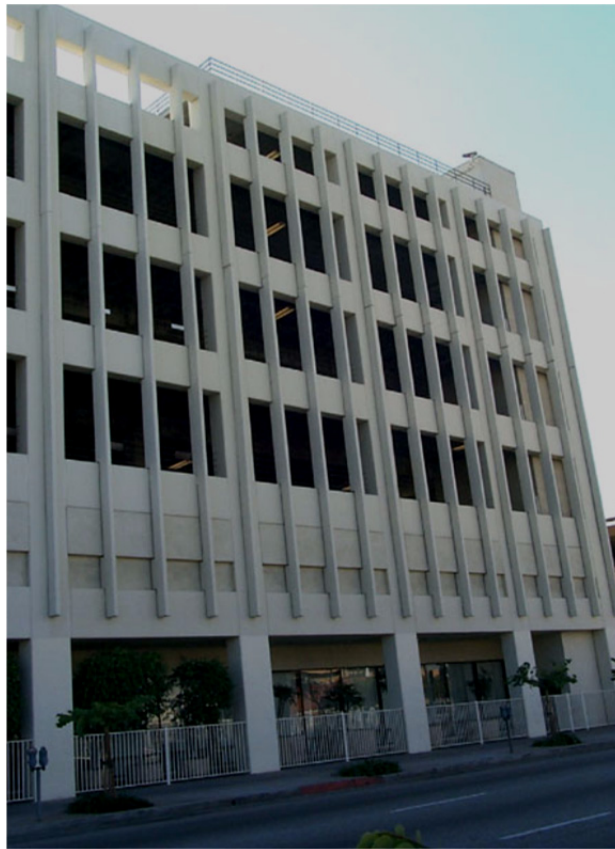
Figure E-27 Concrete moment-resisting frame building (C1) with exposed concrete, deep beams, wide columns (and with architectural window framing).

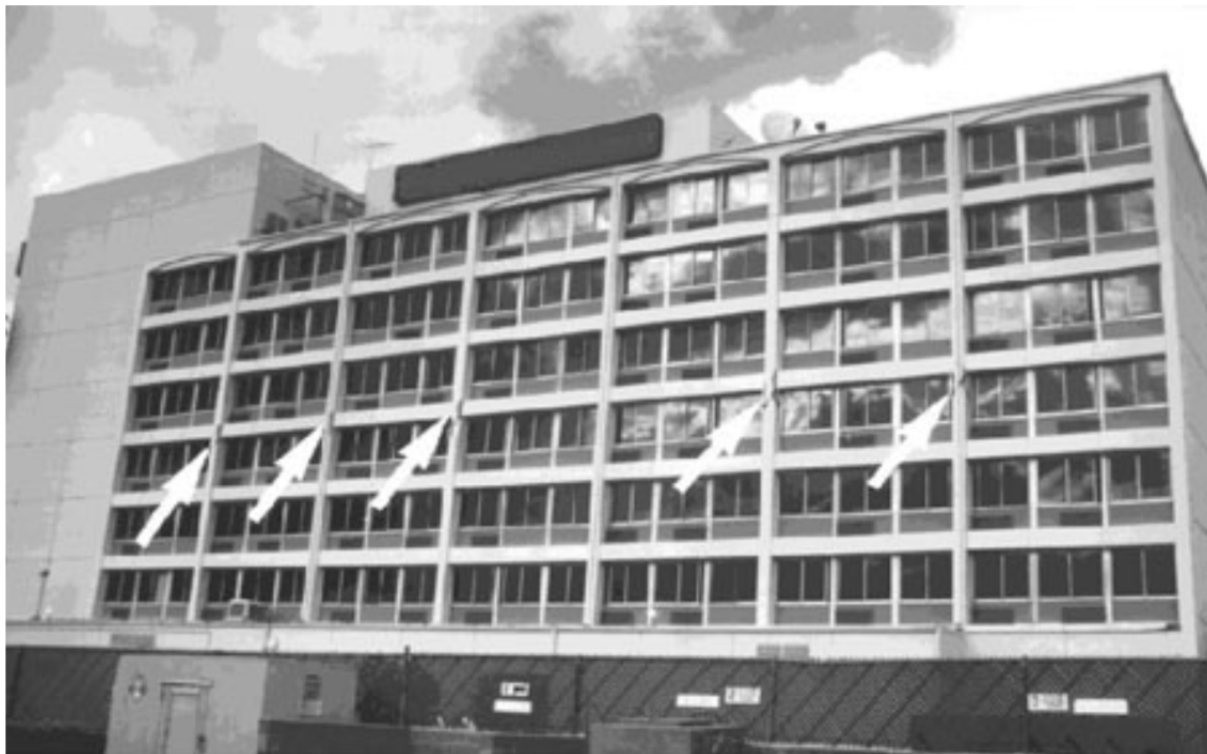
Figure E-28 Locations of failures at beam-to-column joints in nonductile frames, 1994 Northridge earthquake.

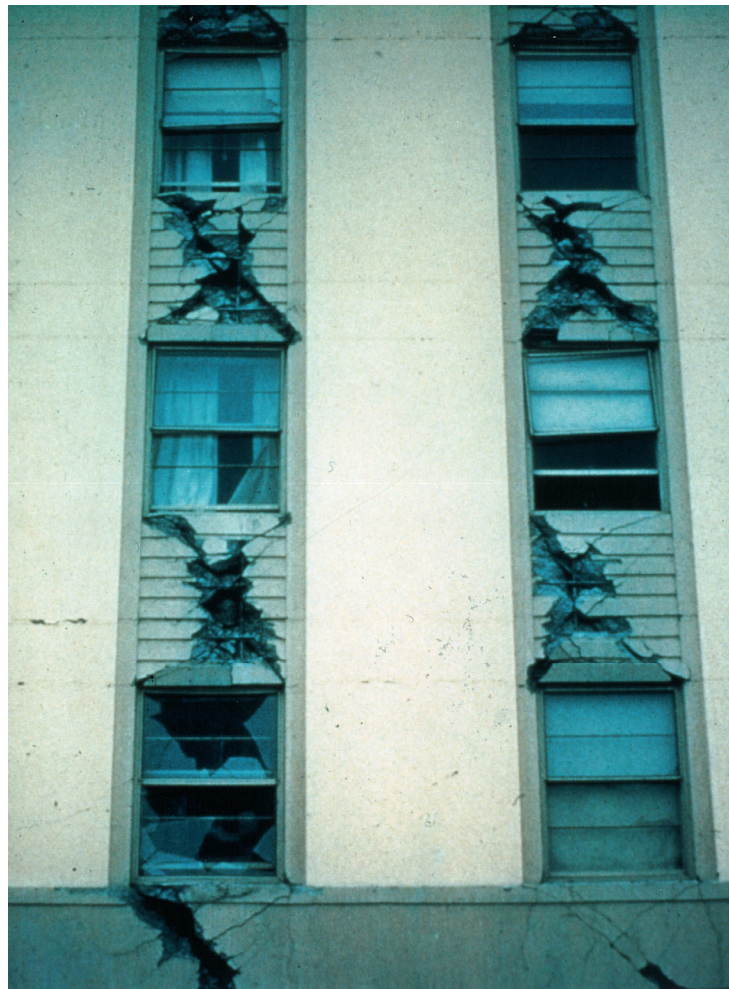
Figure E-30 Tall concrete shear wall building: walls connected by damaged spandrel beams.

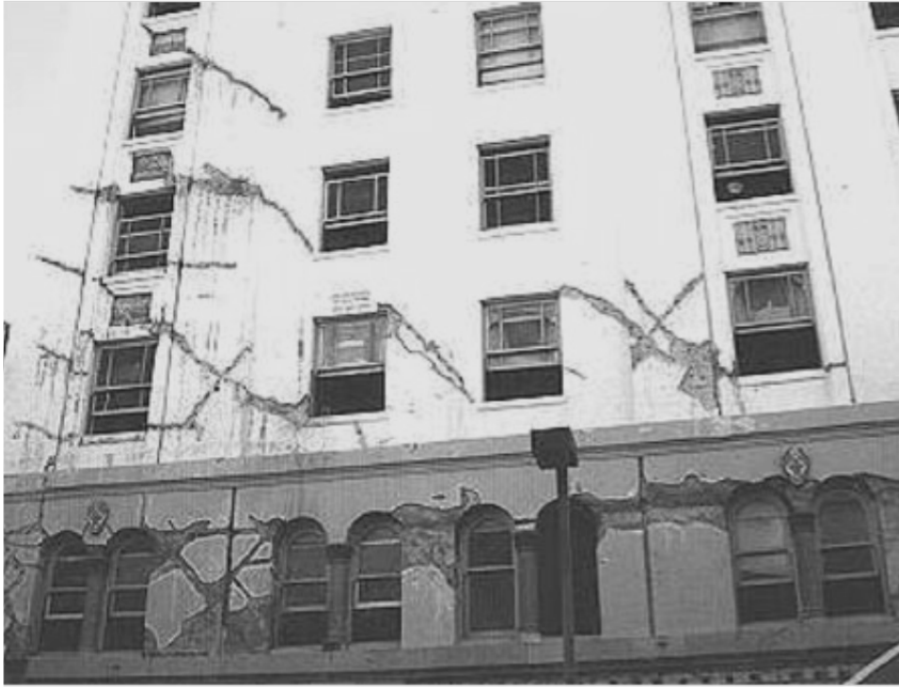
Figure E-31 Shear wall damage, 1989 Loma Prieta earthquake.

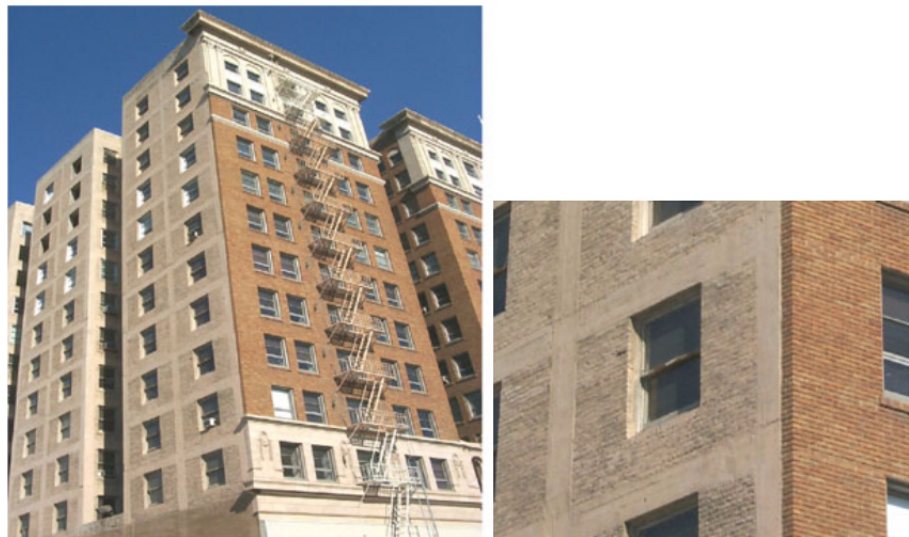
Figure E-33 C3 building and detail showing concrete frame with URM infill (left wall), and face brick (right wall).

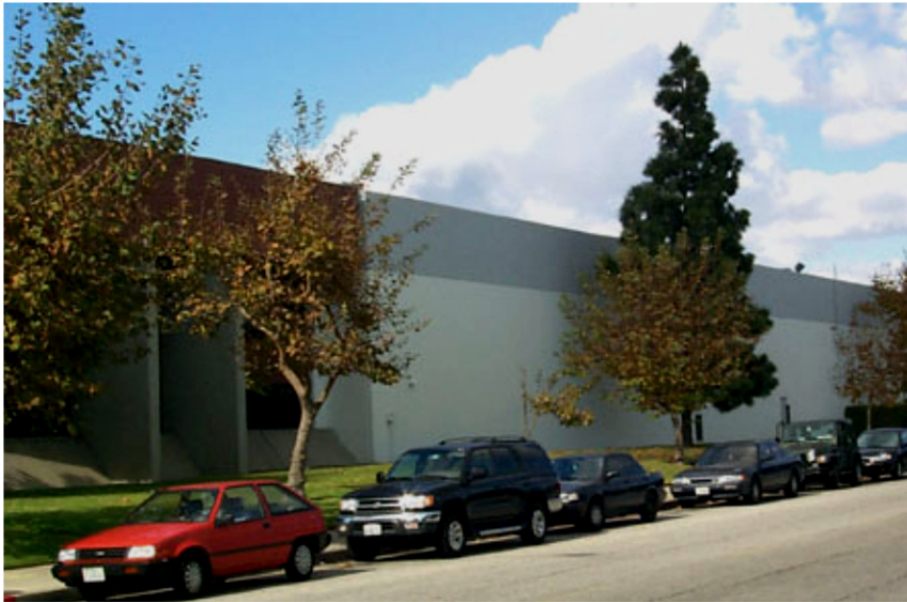
Figure E-35 Tilt-up industrial building, 1970s.

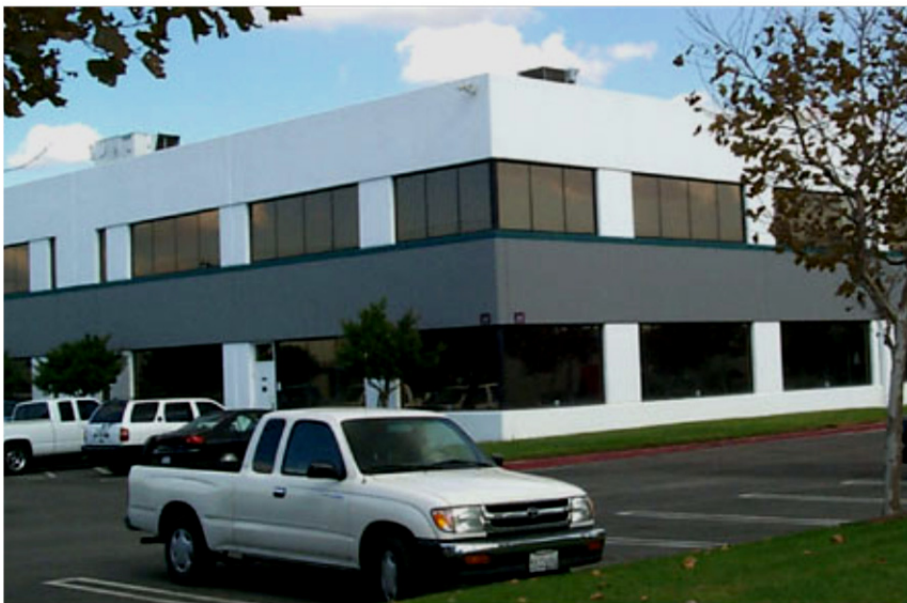
Figure E-36 Tilt-up industrial building, mid- to late-1980s.

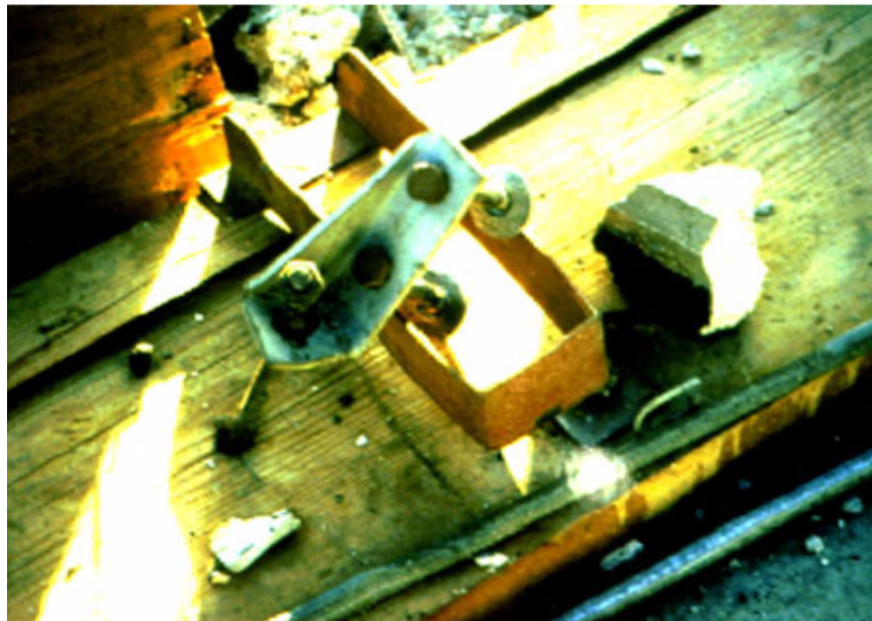
Figure E-37 Tilt-up construction anchorage failure.

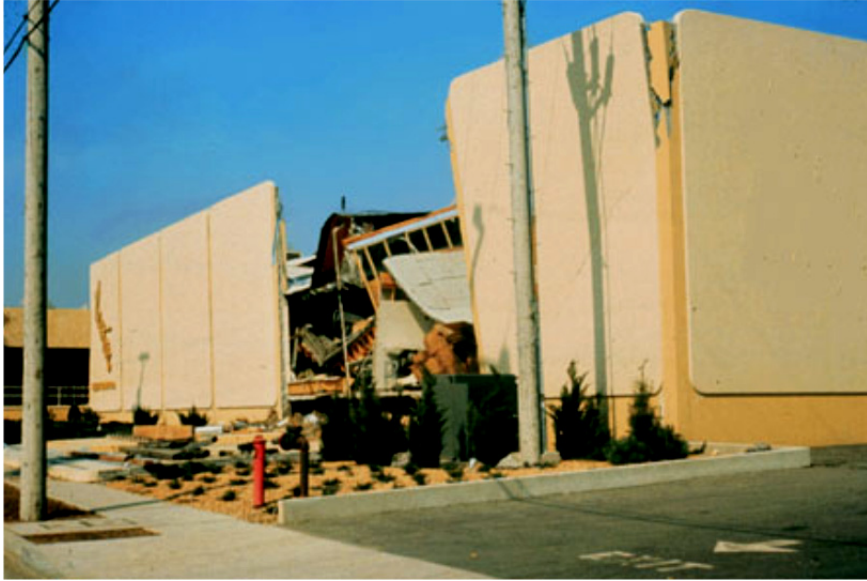
Figure E-38 Result of failure of the roof beam anchorage to the wall in tilt-up building.

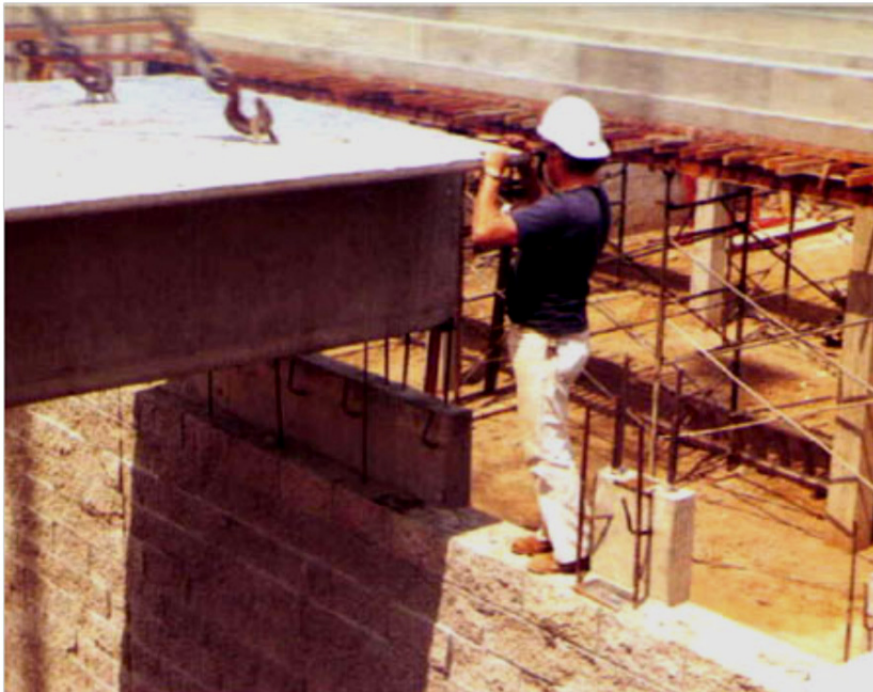
Figure E-43 Example of precast double “T” section during installation.

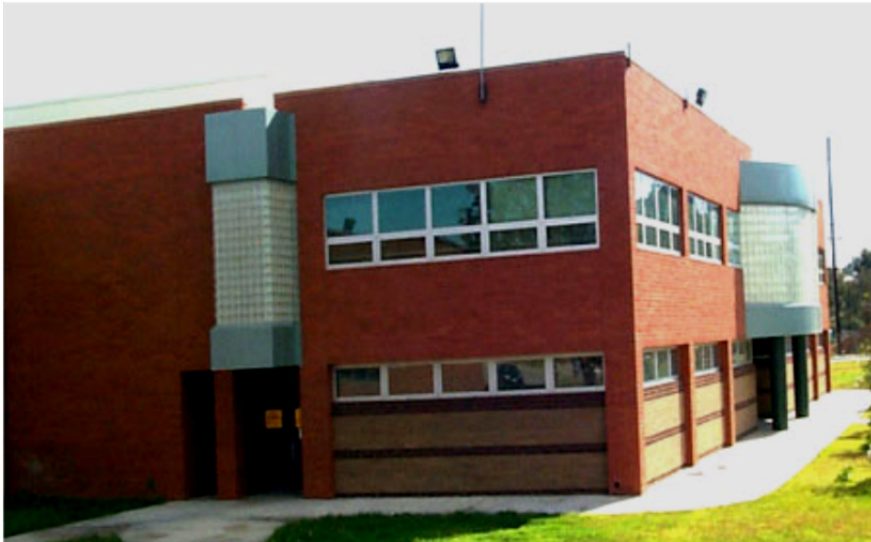
Figure E-45 Modern reinforced brick masonry.

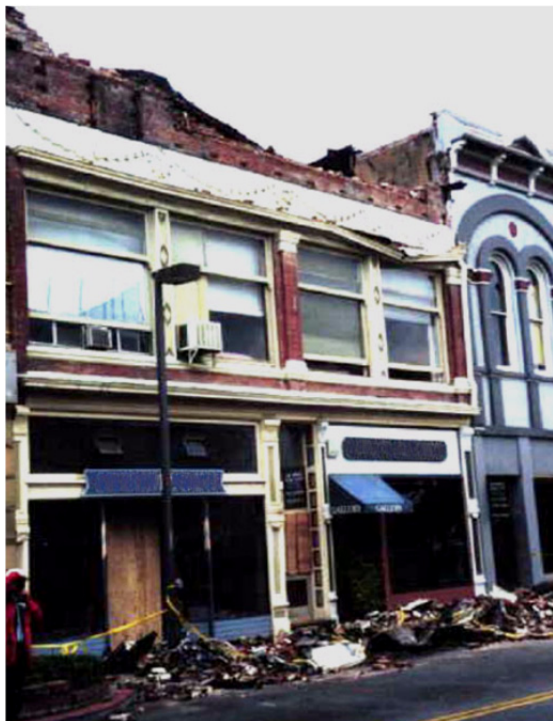
Figure E-52 Parapet failure leaving an uneven roof line, due to inadequate anchorage, 1989 Loma Prieta earthquake.

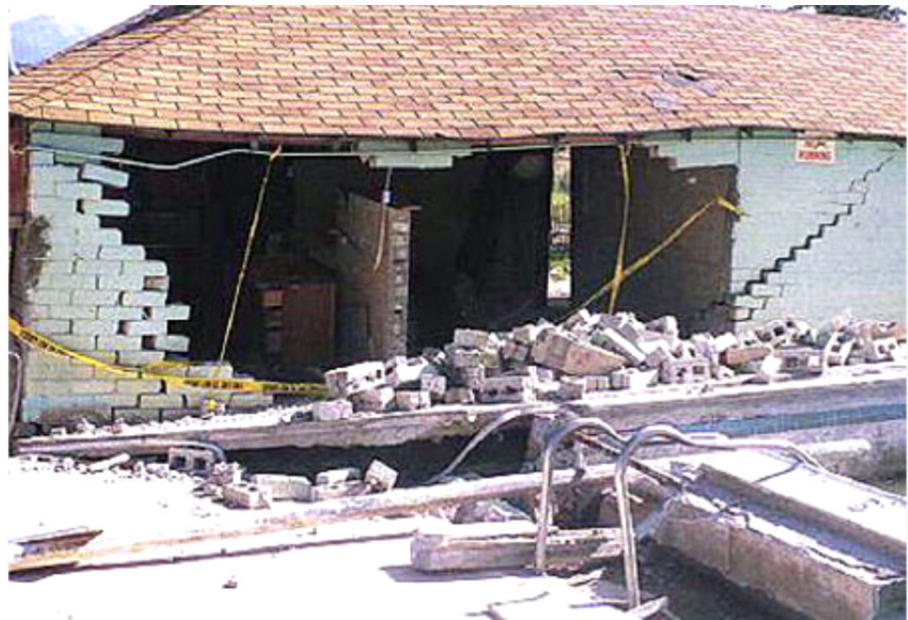
Figure E-53 Damaged URM building, 1992 Big Bear earthquake.

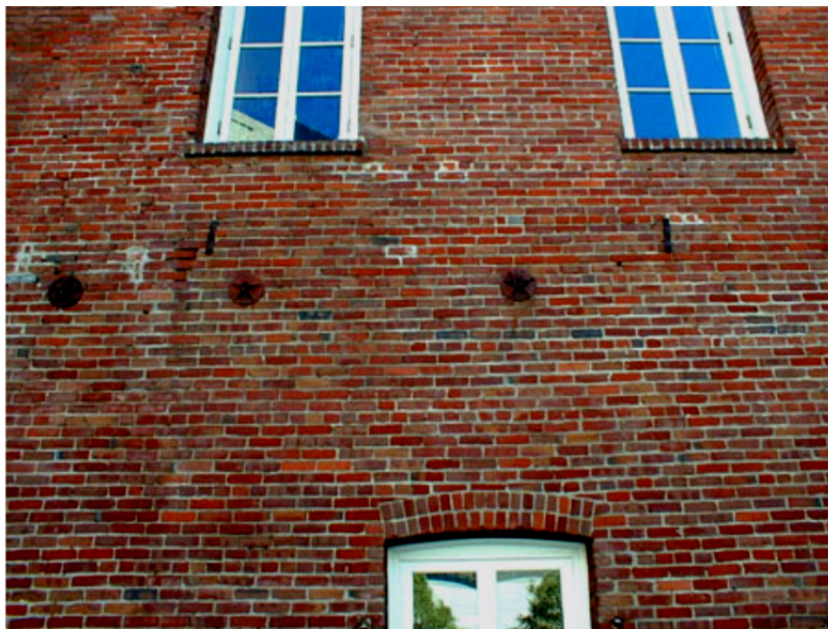
Figure E-54 Two existing anchors above three new wall anchors at floor line using decorative washer plates.

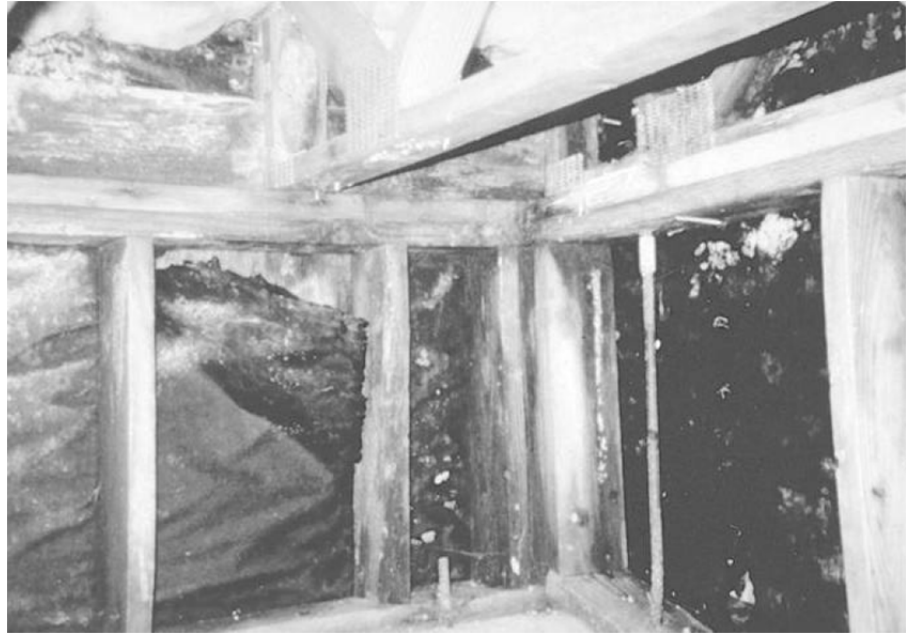
Figure F-1 Wood decay in cripple wall.

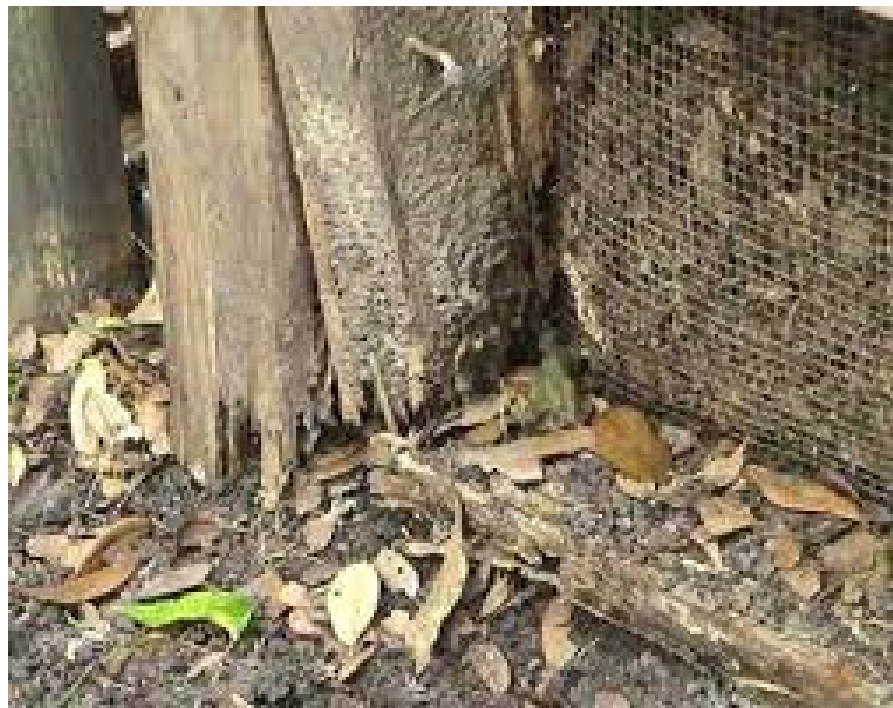
Figure F-2 Damaged wood post.

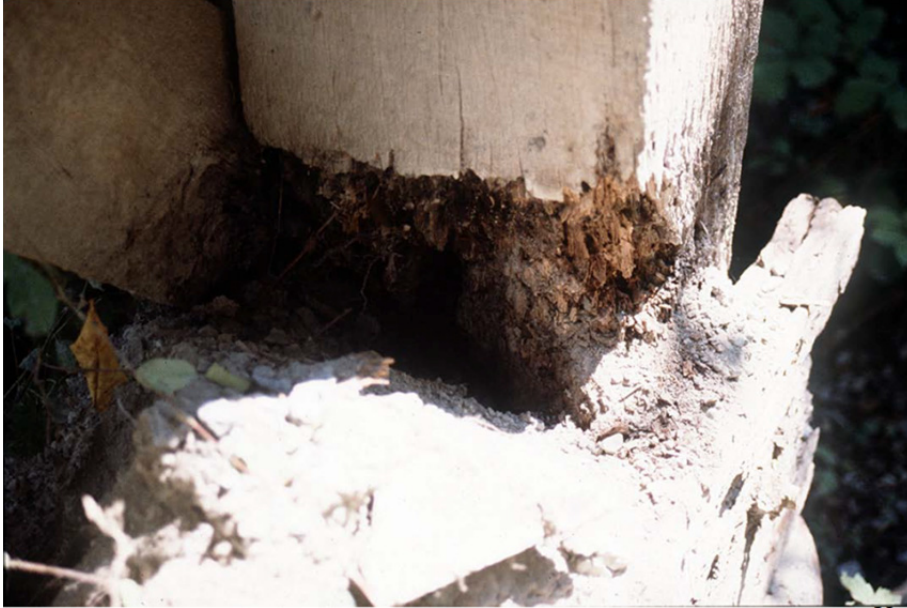
Figure F-3 Rotted timber column.

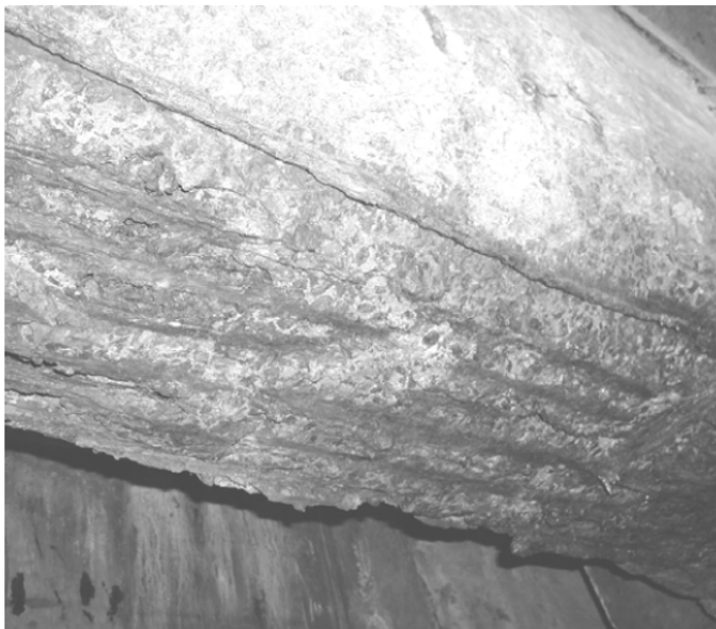
Figure F-6 Exposed reinforcing steel.

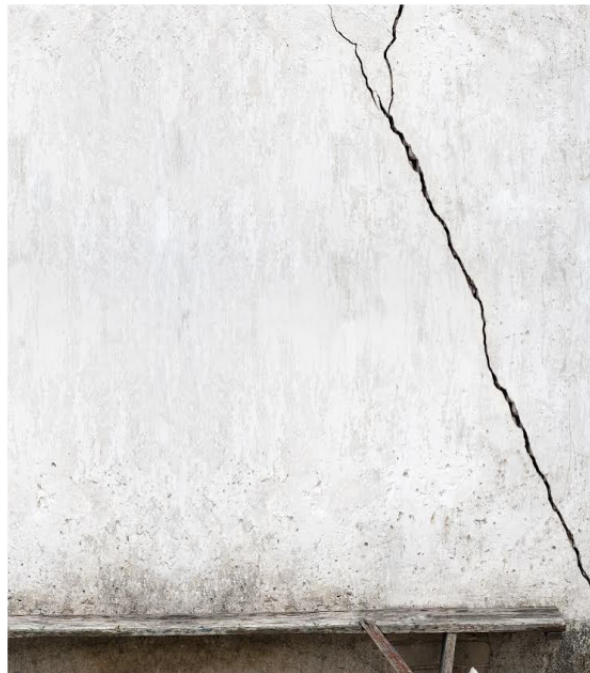
Figure F-7 Concrete cracks.

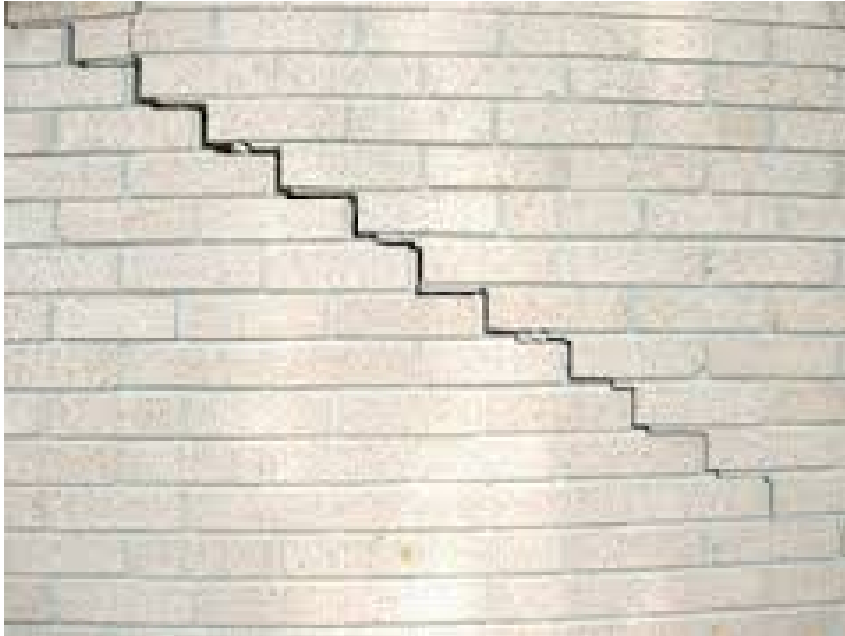
Figure F-8 "Stair-step" cracking.

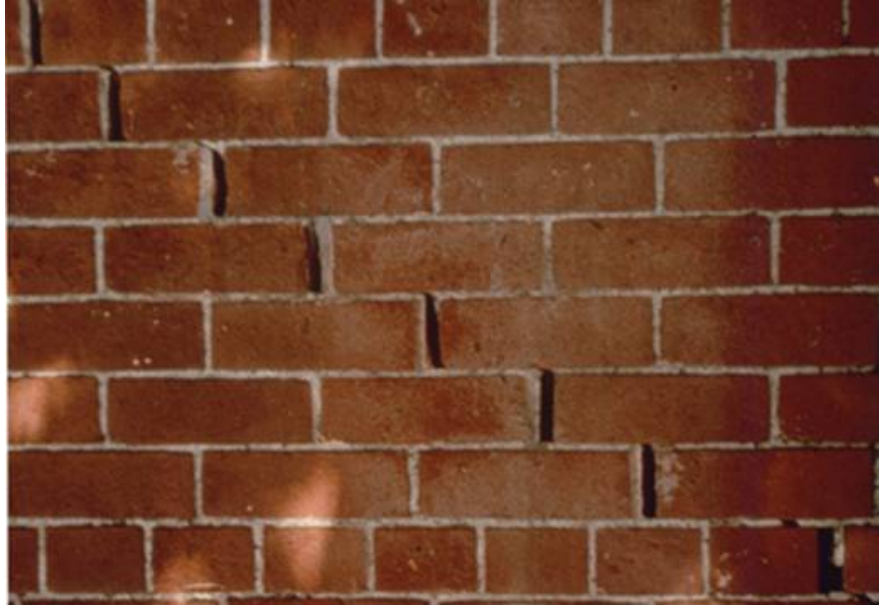
Figure F-9 Masonry joint separations.

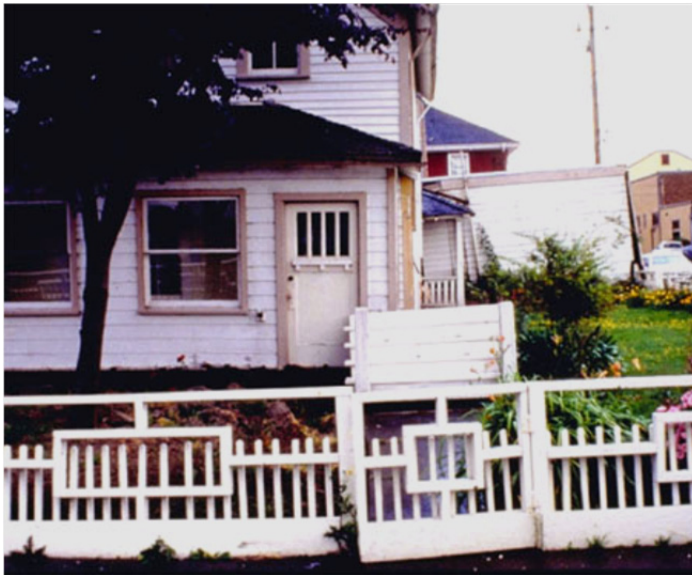
Figure G-7 Photo of house settled to the ground due to collapse of its post and pier foundation.
