Appendix 1. New St. Louis Catholic High School Campus Plans. This 377-page set of construction drawings is dated April 2022. They were prepared by RHH Architects, Associated Design Group, Inc., and Champeaux, Evans, Howard Architects. **Due to the inability to make all of the above documents 508 accessible and below our size constraints, they are not included in the published EA but are available by request. The first twenty pages of plans are included in Appendix A of the published EA. Should you have any questions, please contact Tiffany Spann-Winnfield at 504-218-6800 or tiffany.spann@fema.dhs.gov.**

Appendix 2. DOLC New SLCHS Property Geo Tech Report. This 96-page study was prepared by Terracon Consultants, Inc dated July 28, 2023. This report presents the findings of the subsurface exploration and provides geotechnical recommendations concerning earthwork and the design and construction of foundations, floor slabs, and pavements for the proposed project. The geotechnical exploration Scope of Services for this project included the advancement of 44 test borings to depths ranging from approximately 6 to 50 feet below existing site grades.

APPENDIX 1. New St. Louis Catholic Hig

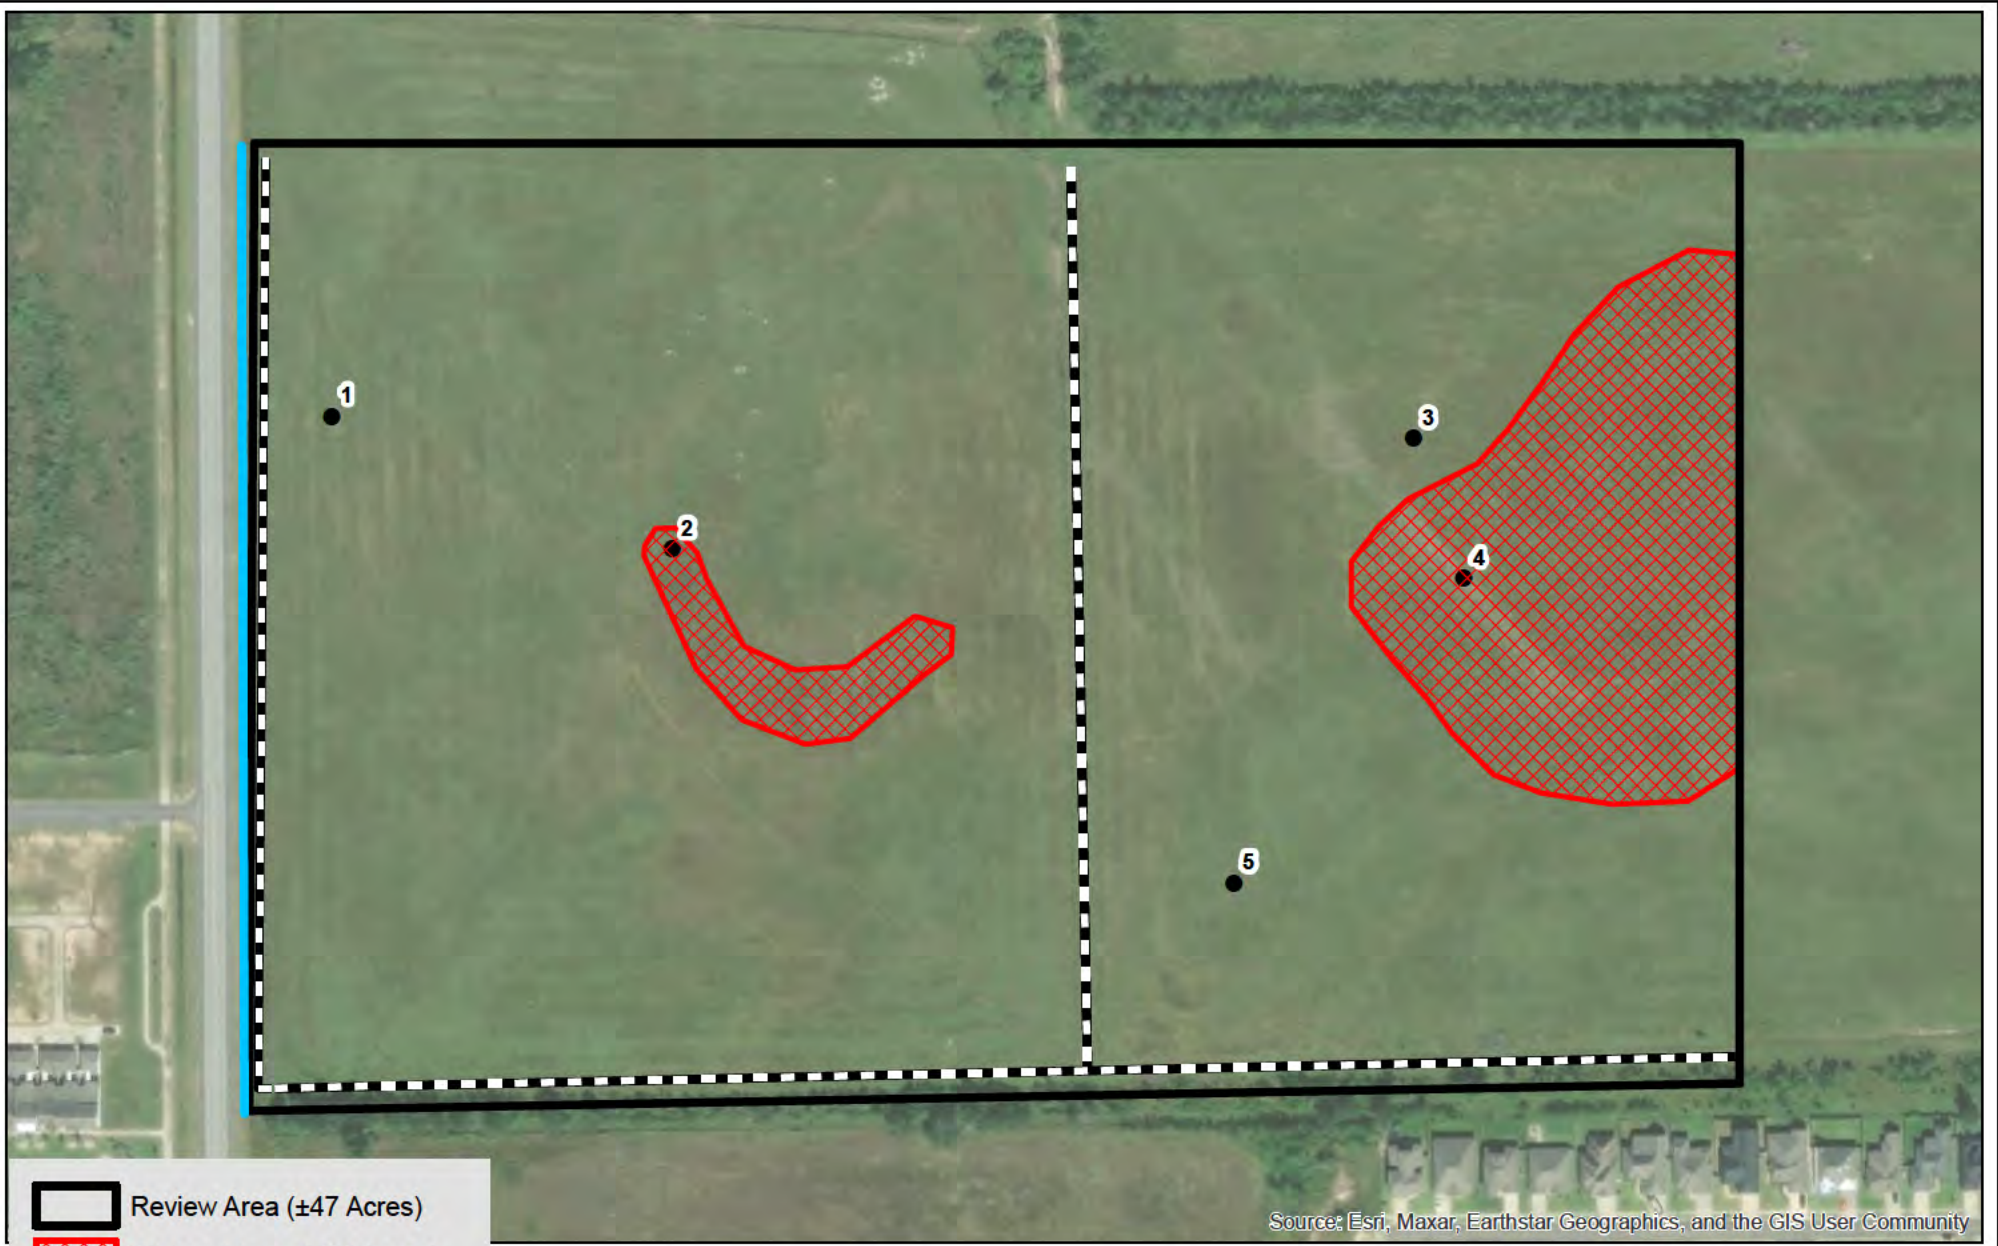
-   Review Area (±47 Acres)
-   Wetland Area (±6.1 Acres)
-   Sample Plot & ID
-   Roadside Ditch (1,175 Feet)
-   Field Road
