Summary Report on Building Performance

2004 Hurricane Season

FEMA 490 / March 2005

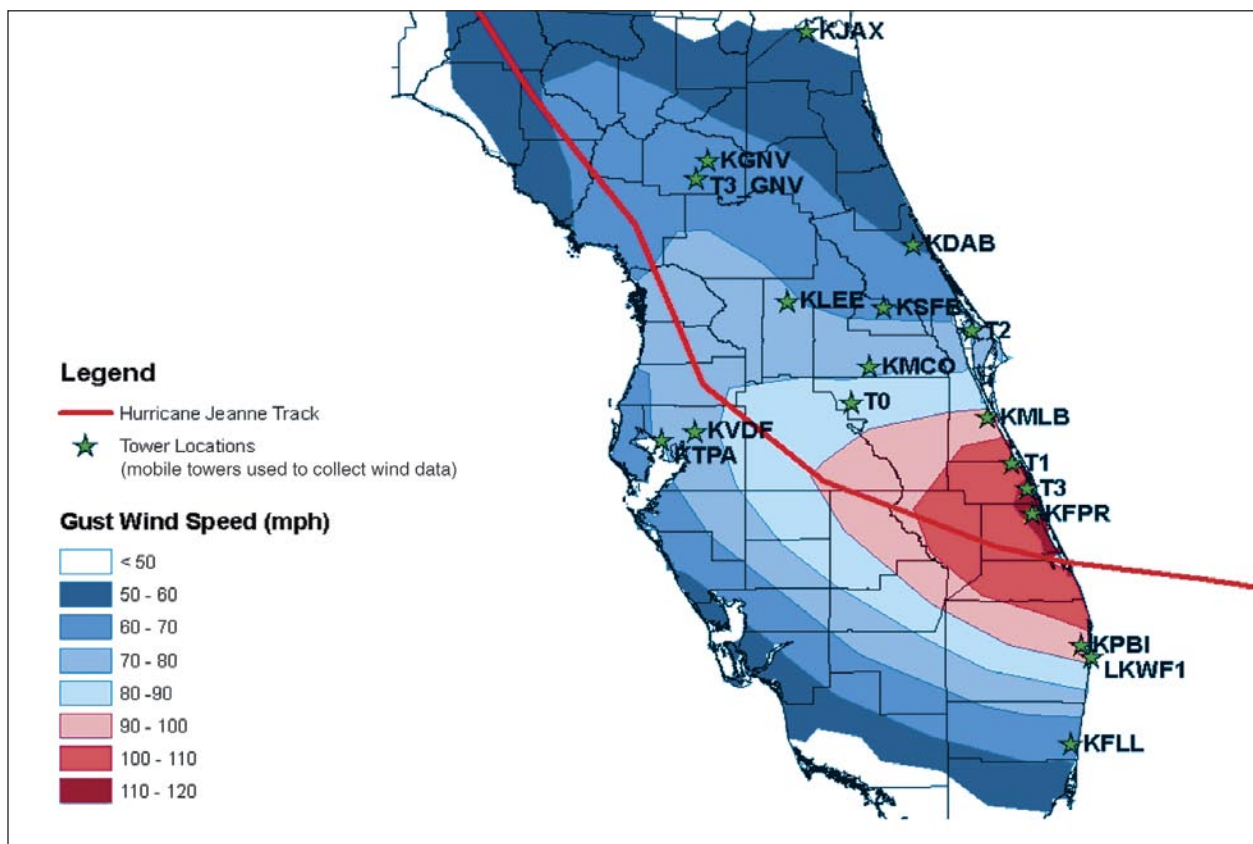
Figure 5. Hurricane Jeanne Wind Swath Map

Hurricane Jeanne made landfall as a Category 3 hurricane on September 25 at Hutchinson Island, just east of Stuart, Florida. The storm's landfall location was only about 2 miles north (3 km) from Sewall's Point, where Hurricane Frances struck Florida just 3 weeks earlier. According to the NHC, Jeanne's eye diameter at the time of landfall was approximately 60 miles, its maximum winds were 120 mph over a very small area north of the center of circulation, and movement was west-northwest at approximately 9 mph (Figure 5, Hurricane Jeanne Wind Swath Map). Storm surge of 3.8 feet above normal tide levels was measured near Port Canaveral, Florida, about an hour after Jeanne made

landfall. The maximum storm surge was estimated to be 6 feet above normal tide levels.

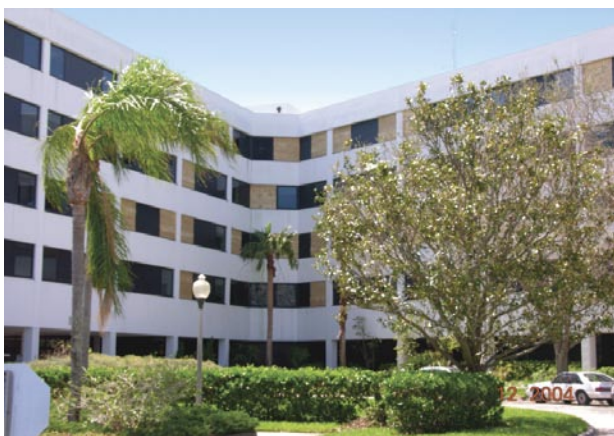
Aggregate from the Indian River Memorial Hospital's roof (Vero Beach) broke several of the patient room windows (which were covered with plywood after Hurricane Frances).

Staff removed loose aggregate from the built-up roofs just prior to Frances' landfall, likely minimizing window breakage and thereby preserving the availability of patient rooms. Additionally, the aggregate surface of a portion of the upper roof had been previously re-roofed in a manner that encapsulated the aggregate, preventing aggregate blow-off.

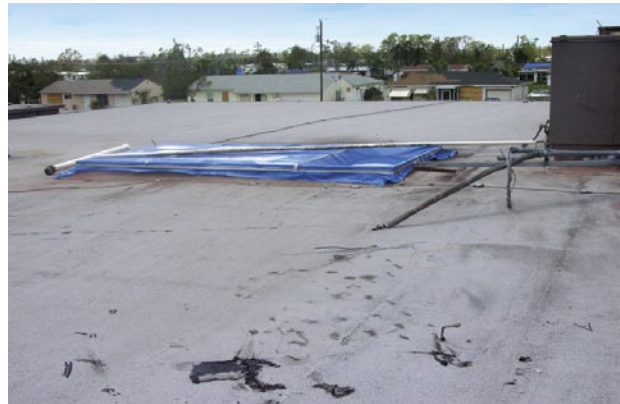
A large HVAC package unit was blown off this curb during Hurricane Charley. Note the loose LPS conductors this side of the curb. This school had significant damage from several pieces of rooftop equipment that blew off the building roof. (Port Charlotte Middle School)

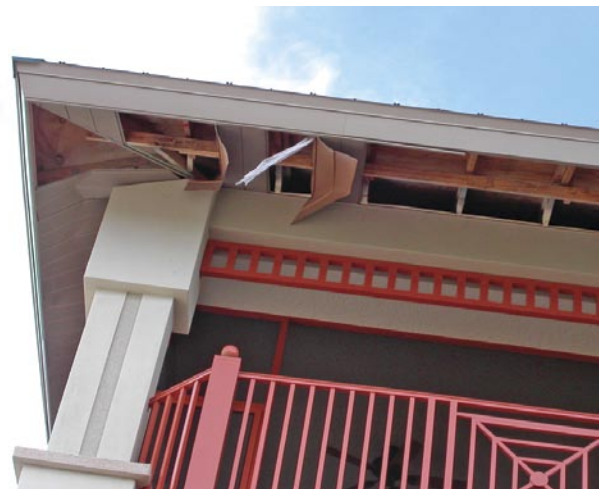
Soffit damage on the third story of a multi-family building. (Captiva Island)

Soffit failure led to many instances of significant damage to building interiors.

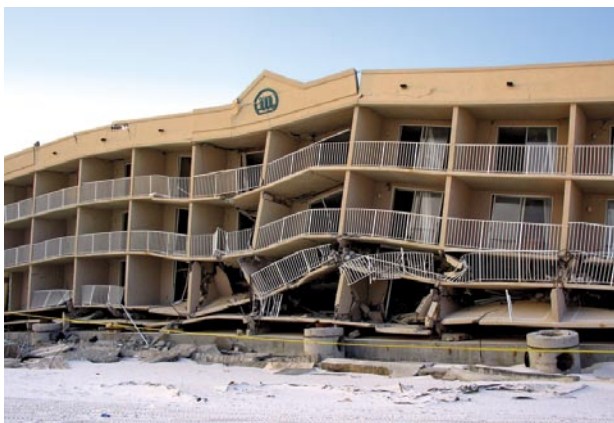
A multi-family condominium collapsed after Hurricane Ivan due to erosion of supporting soil under the shallow foundation.

Several multi-family buildings constructed on shallow foundations in areas along the Gulf coast were severely damaged due to erosion and scour. Many of these buildings were originally constructed in Zones B, C, or X, which did not require deep foundations, but now would require deep foundations if the flood zone was determined from the current methodologies and coastal conditions.
