# Design Guide

for Improving School Safety in Earthquakes,  
Floods, and High Winds

FEMA P-424 / December 2010

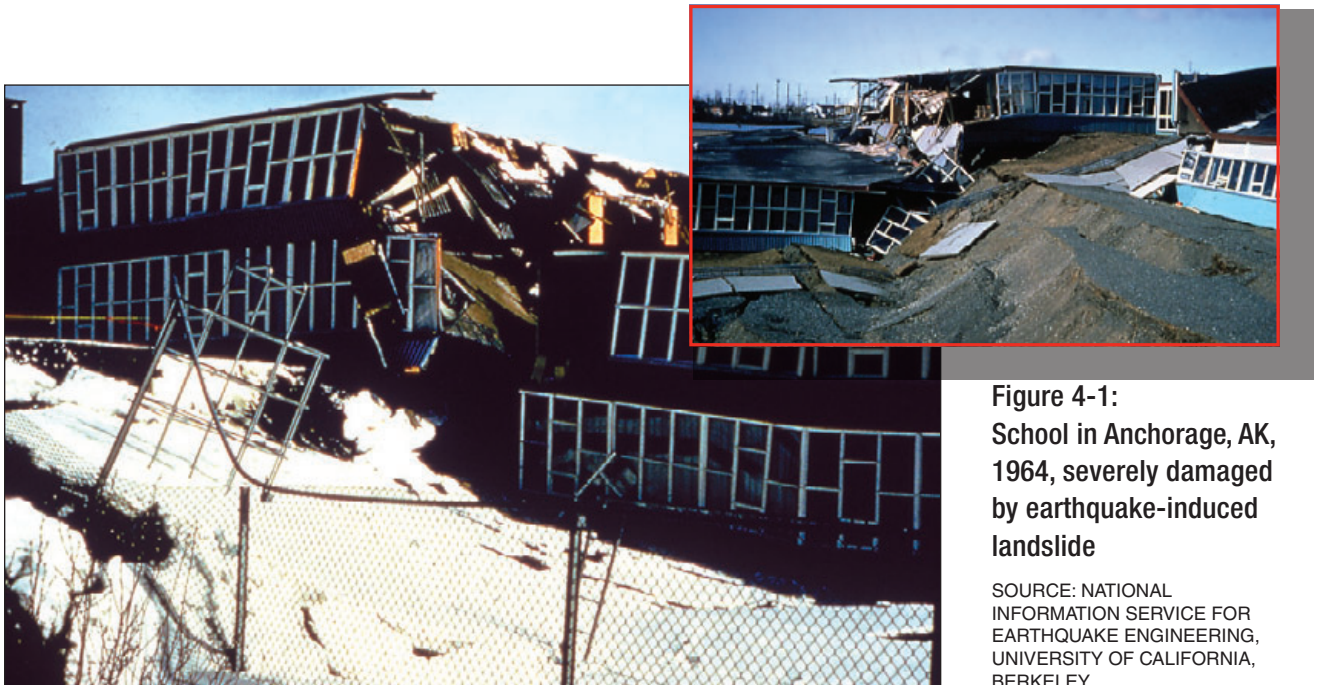
**Figure 4-1:**  
School in Anchorage, AK,  
1964, severely damaged  
by earthquake-induced  
landslide

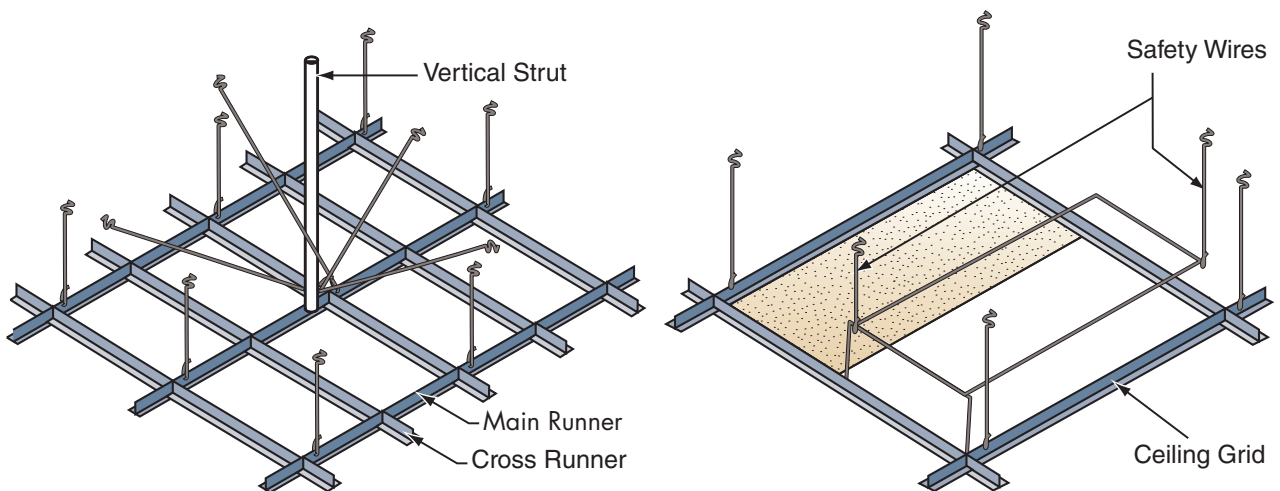
Figure 4-30: Suspended ceiling and light fixture bracing and support

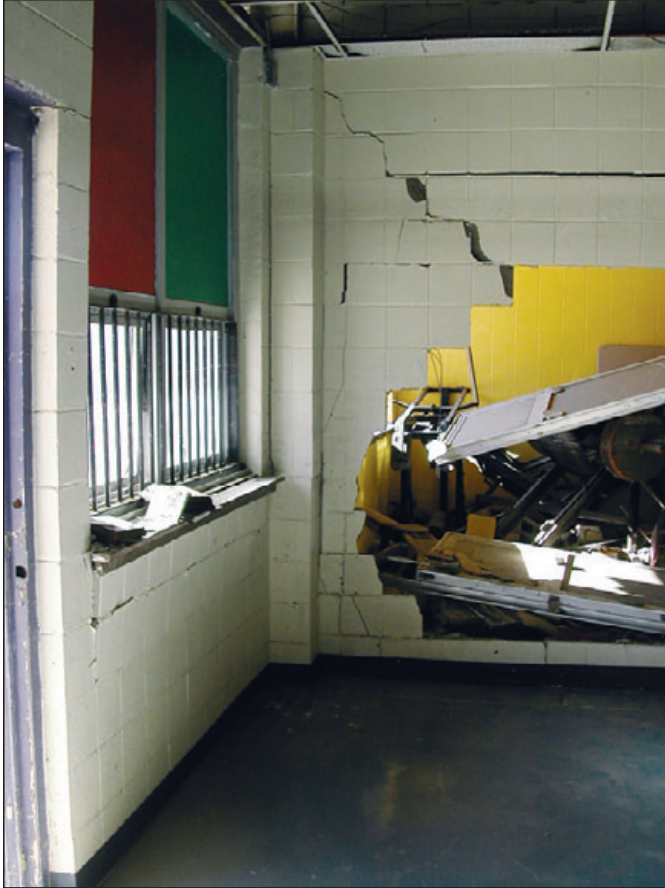
**Figure 5-14:** Interior unreinforced masonry walls of the Port Sulphur High School in Louisiana were damaged by hydrostatic loads associated with Hurricane Katrina's storm surge (2005)

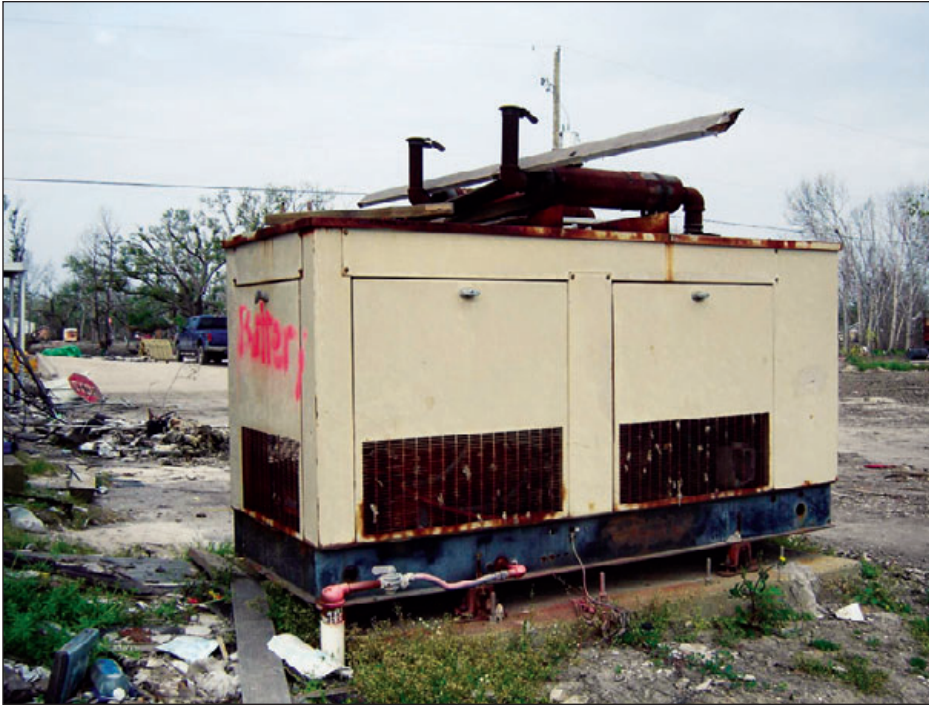
**Figure 5-19:** Although it was anchored and not displaced by floodwaters, this generator was out of service after being submerged (Hurricane Katrina, 2005)

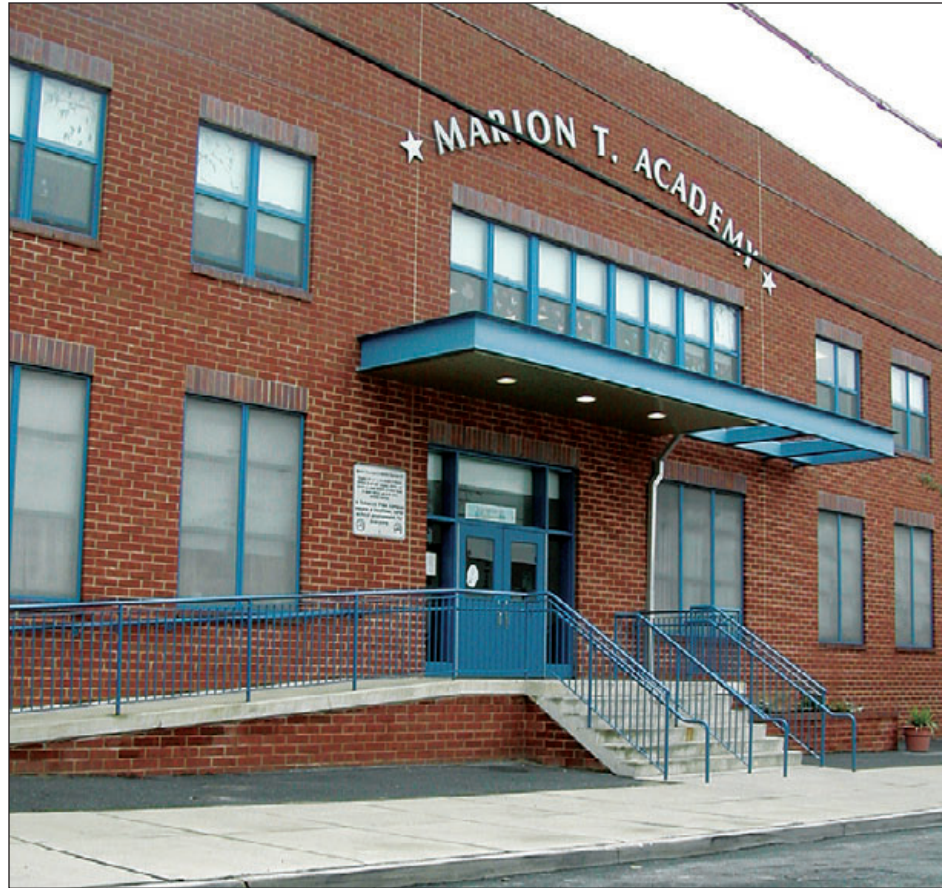
Figure 5-24:  
School elevated on  
columns

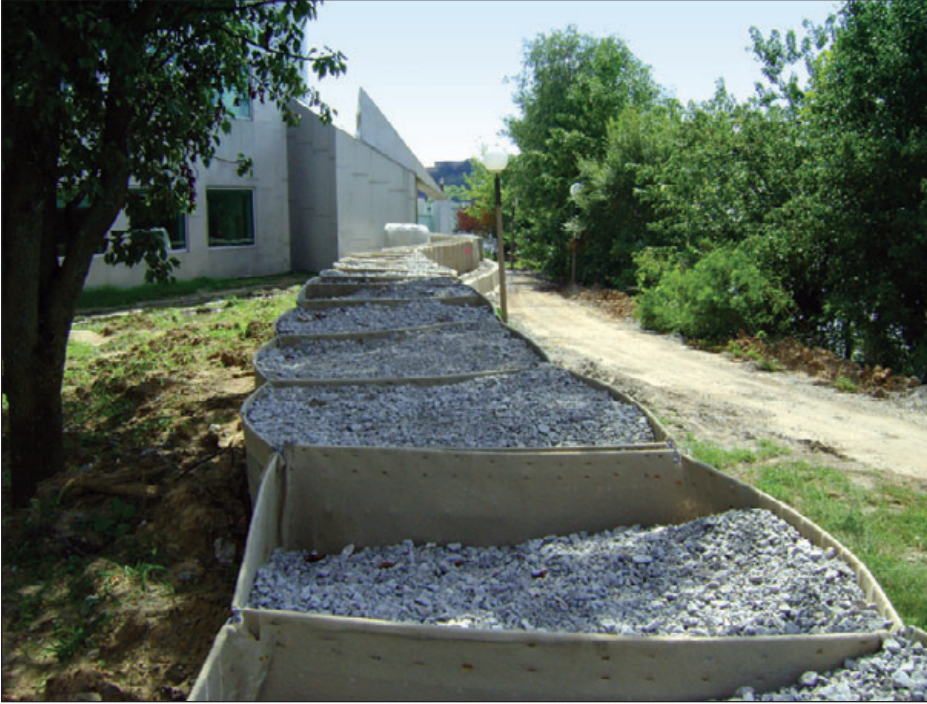
Figure 5-31:  
Gravel-filled containers  
form a barrier to protect  
the University of Iowa  
(2008)

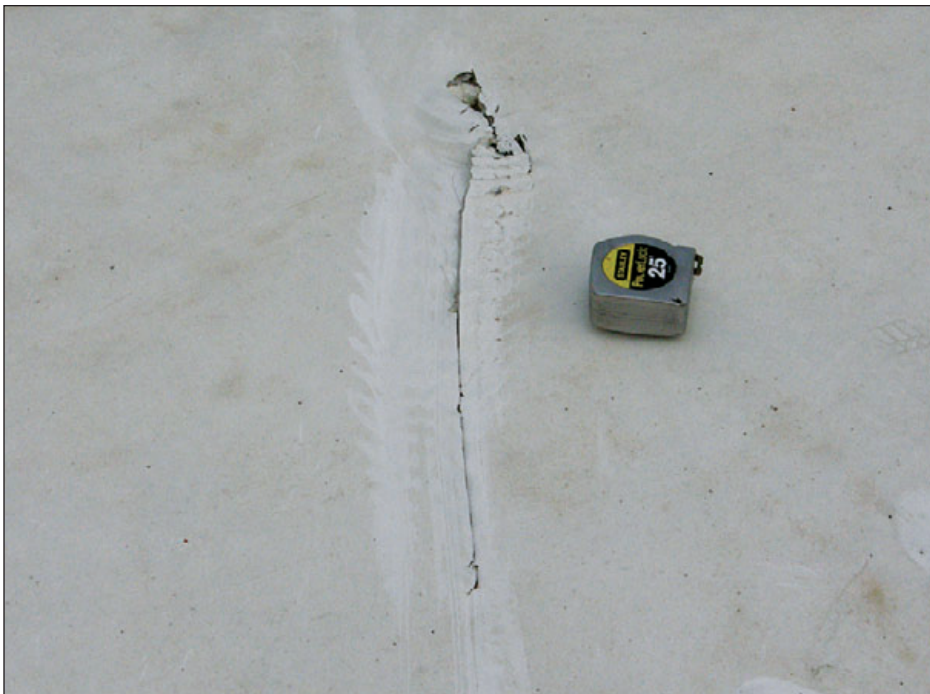
**Figure 6-11:** The single-ply roof membrane on this school was torn by a missile. The tear was still unprotected 6 days after it was damaged. A substantial amount of water can enter the building through such a tear, unless the deck is water tight (see Figure 6-13) or a secondary roof membrane is used as discussed in Section 6.3.3.7. Estimated wind speed: 105 to 115 mph. Hurricane Ivan (Florida, 2004)

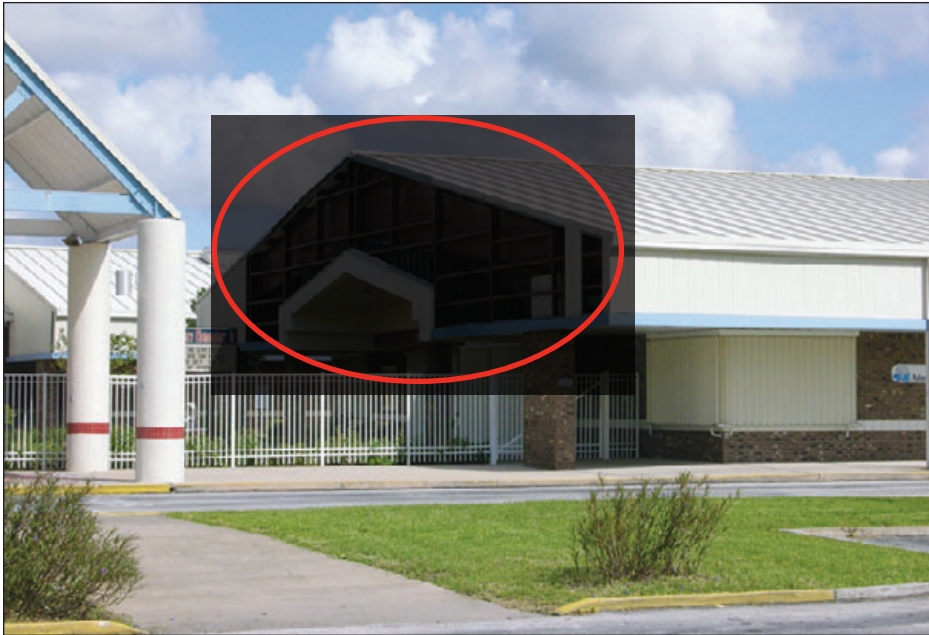
**Figure 6-15:** Blow-off of metal wall panels allowed wind-driven rain to enter this school. Hurricane Frances (Florida, 2004)

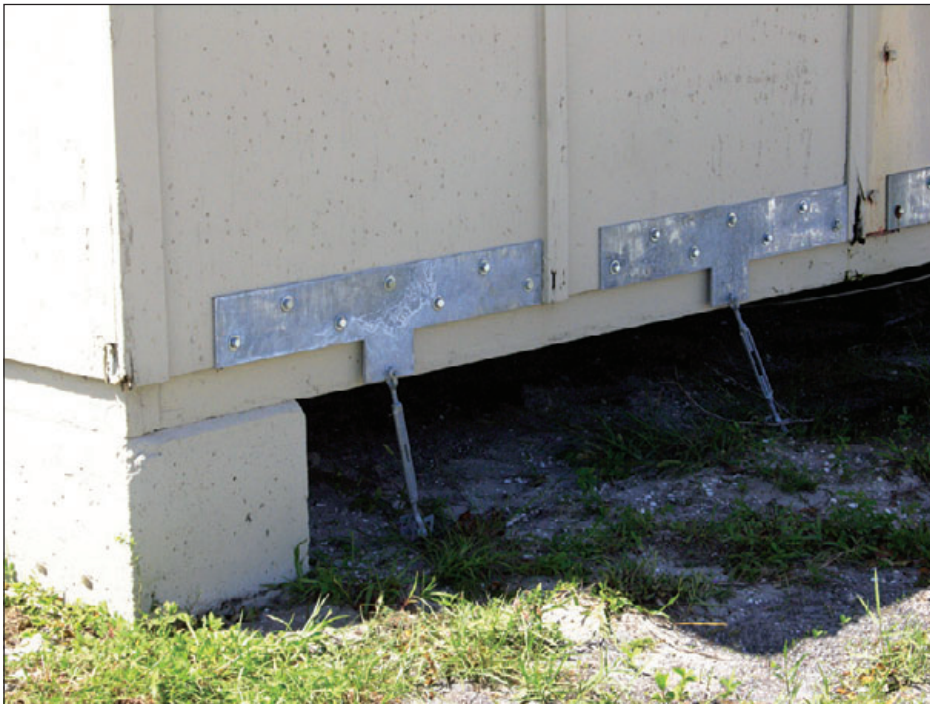
**Figure 6-27:** Unlike the portable classroom shown in Figure 6-22, with the thick T-shaped plates and taut turnbuckles, this portable classroom has a robust anchorage to the ground. Hurricane Francis (Florida, 2004)

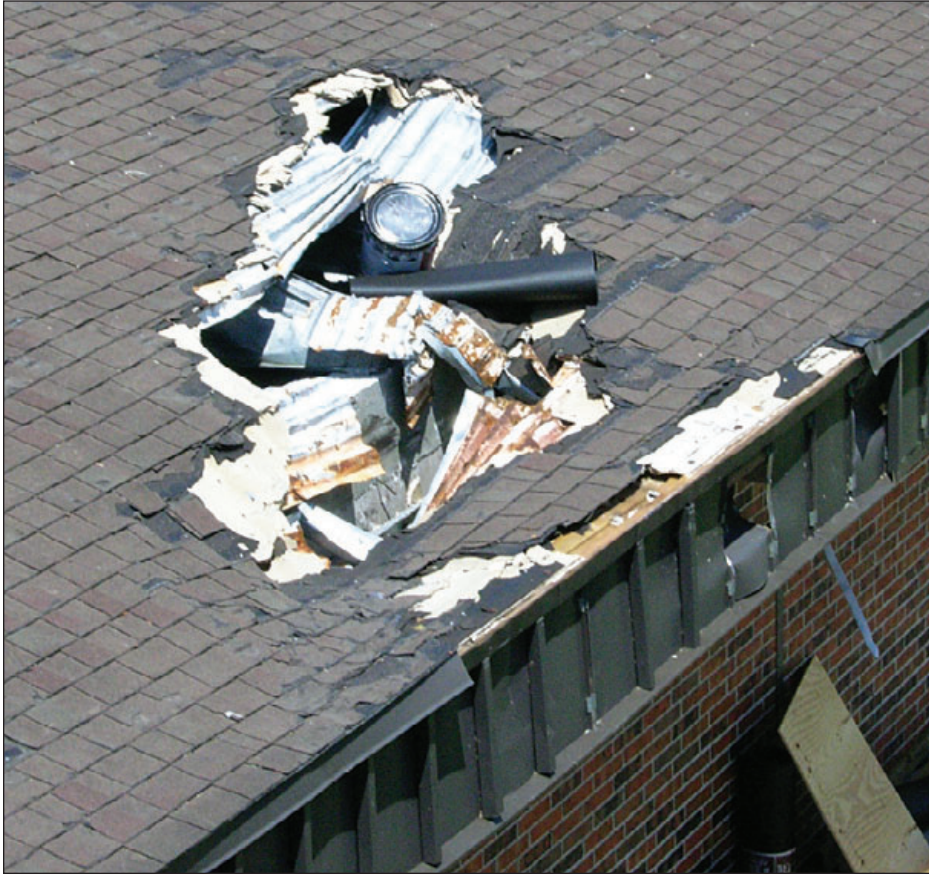
**Figure 6-42:**  
At the school shown in Figure 6-34, wind-borne debris ruptured the proprietary composite deck system composed of light gauge corrugated metal deck and gypsum board. Estimated wind speed: 140 to 160 mph. Hurricane Charley (Florida, 2004)

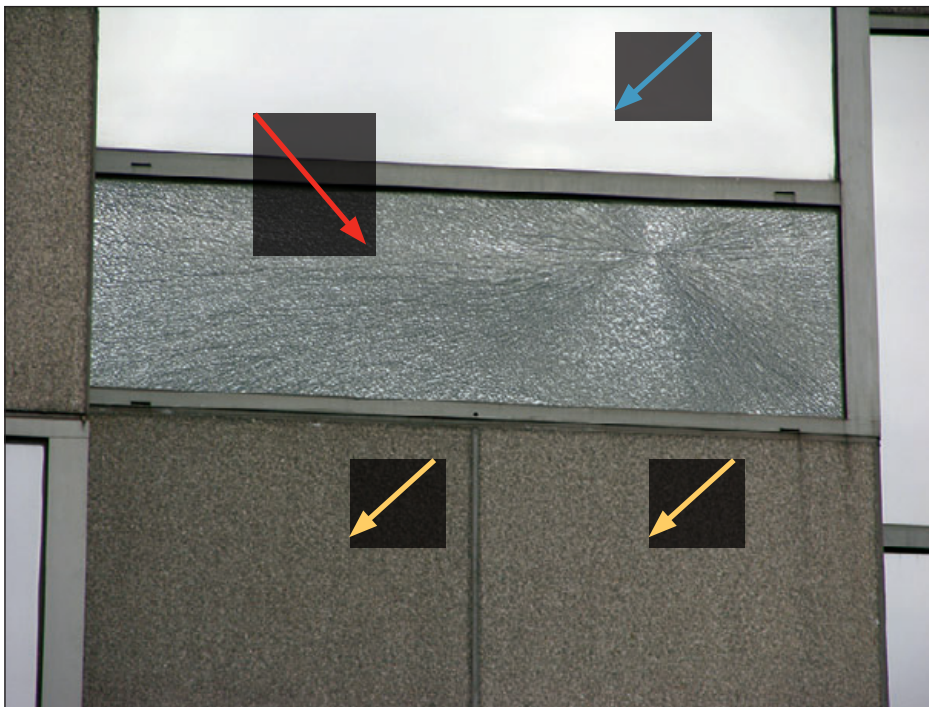
**Figure 6-54:** The red arrow shows a piece of laminated glass that was broken, but remained in the frame to protect the building's interior. The blue arrow shows unbroken laminated glass. The yellow arrows show granite wall panels. Estimated wind speed: 105 mph. Hurricane Katrina (Louisiana, 2005)

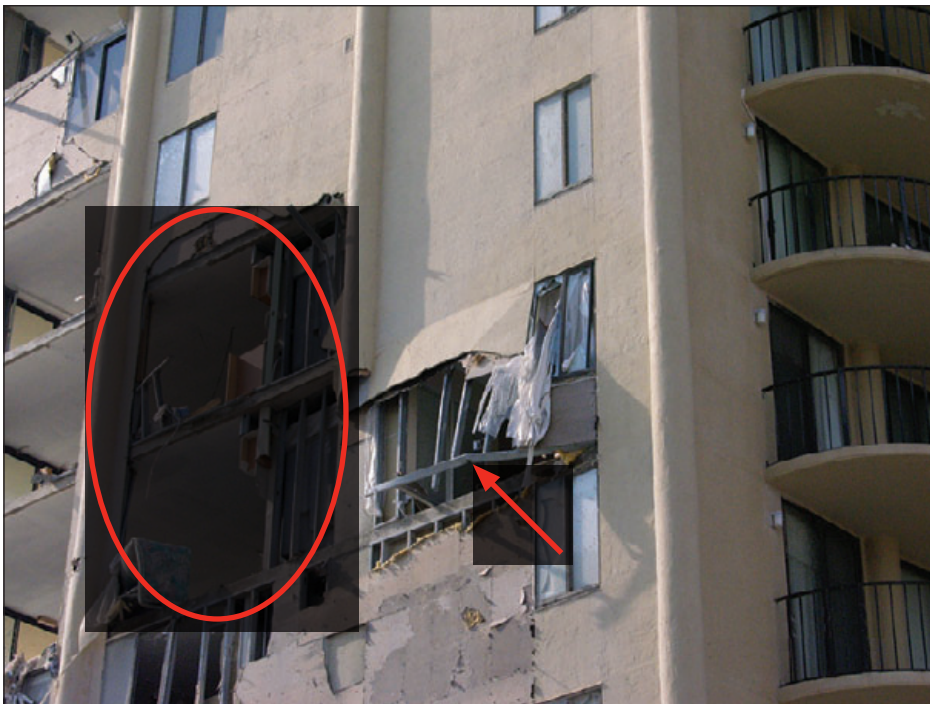
**Figure 6-63:** The stucco wall failure was caused by inadequate attachment between the stud tracks and the building's structure. All of the metal stud framing within the red oval blew away. The arrow shows a bottom stud track that detached and pulled away from the building. Estimated wind speed: 110–125 mph. Hurricane Ivan (Florida, 2004)

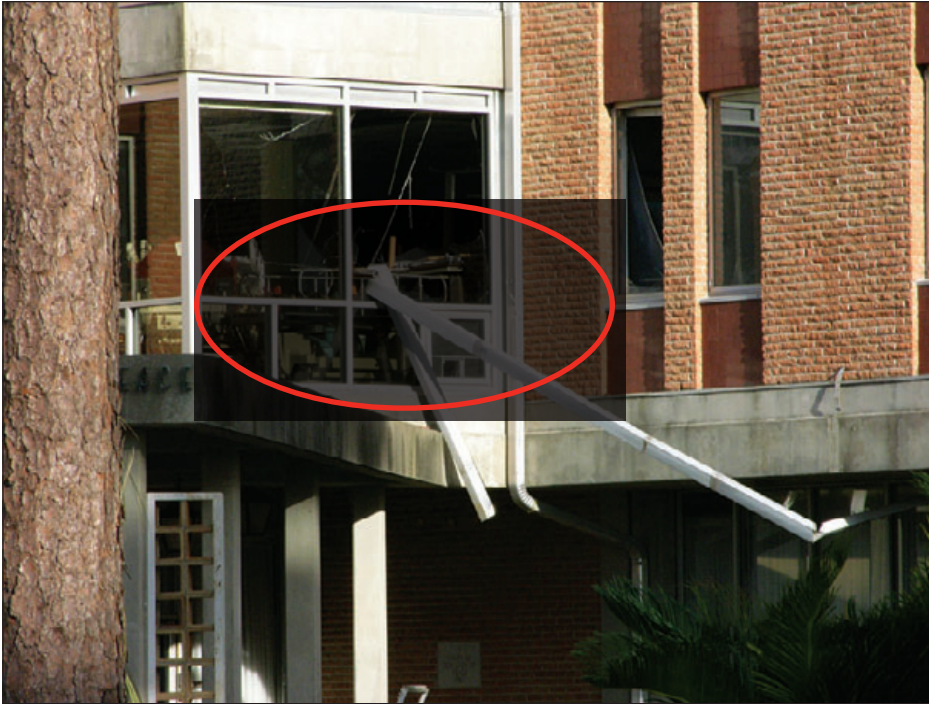
**Figure 6-78:** Blow-off of this downspout resulted in glazing breakage. Estimated wind speed: 105–115 mph. Hurricane Ivan (Florida, 2004)

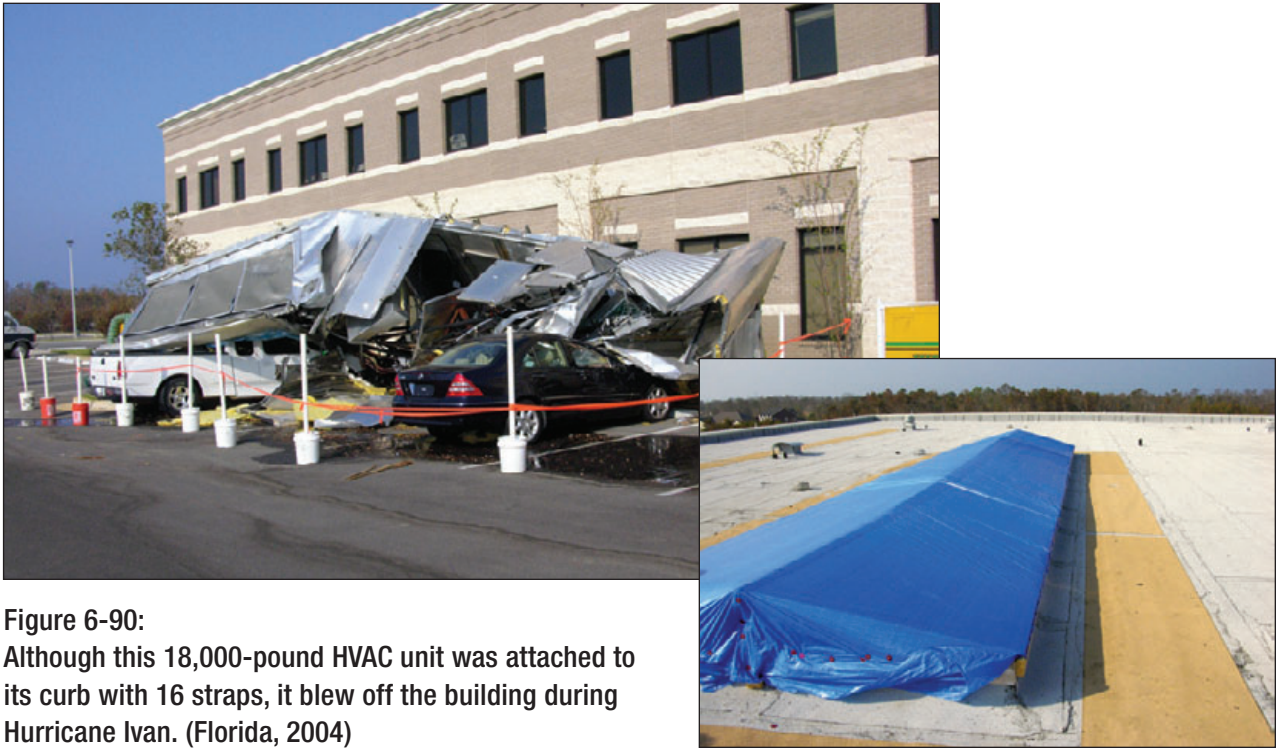
**Figure 6-90:**  
Although this 18,000-pound HVAC unit was attached to its curb with 16 straps, it blew off the building during Hurricane Ivan. (Florida, 2004)

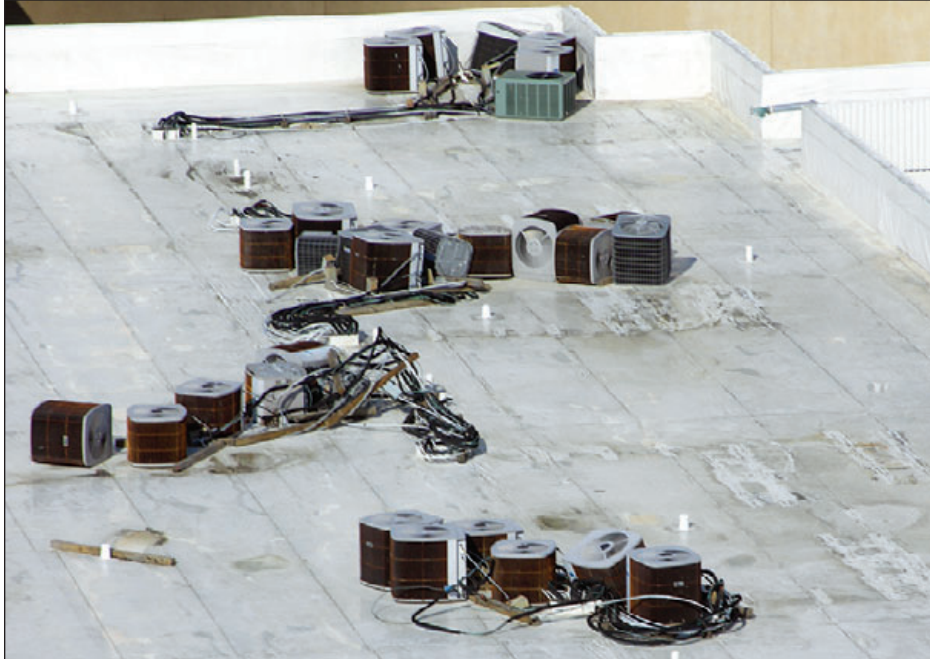
**Figure 6-94:** These condensers were blown off their sleepers. Displaced condensers can rupture roof membranes and refrigerant lines. Estimated wind speed: 120 mph. Hurricane Katrina (Mississippi)

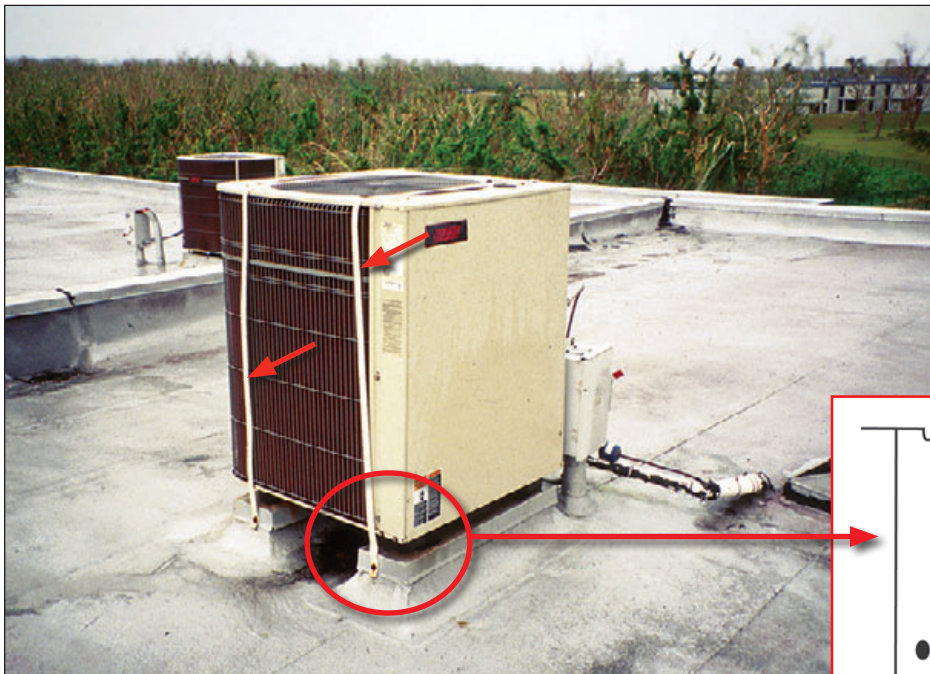
**Figure 6-95:** This condenser had supplemental attachment straps (see red arrows). Typhoon Paka (Guam, 1997)

Where condensers are mounted to curbs that are adequately anchored to the deck, straps can be installed as shown in Figure 6-95 if the condenser attachment is inadequate. If condensers are mounted on sleepers (see Figure 6-137), then the condensers should be re-mounted and anchored to curbs or stands that are anchored to the roof deck.

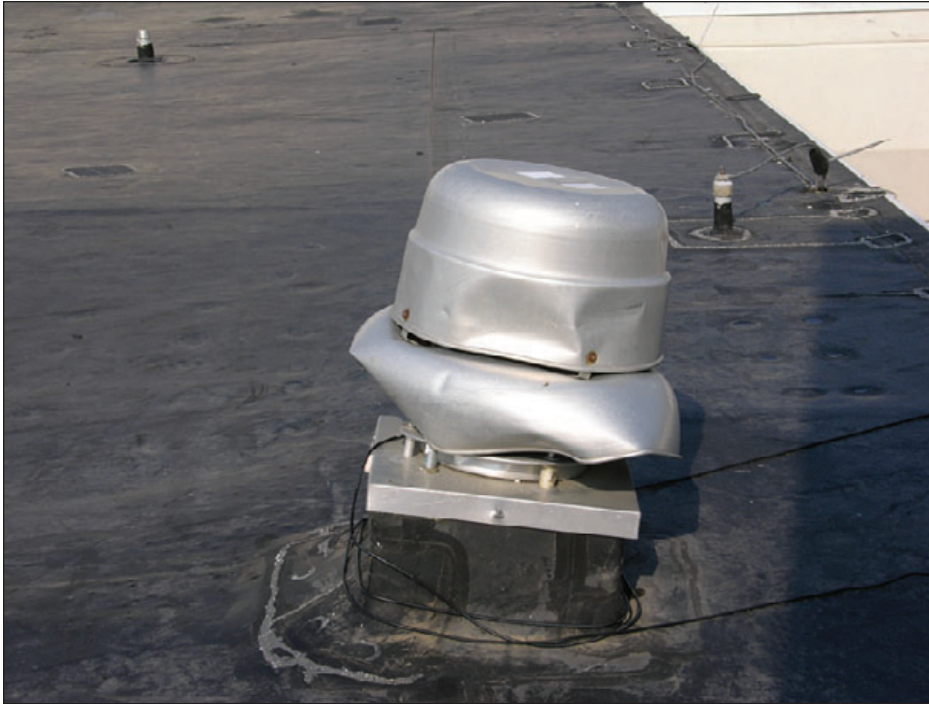
**Figure 6-103:** This exhaust fan was impacted by wind-borne debris. Although it is often impractical to place all equipment such as fans in penthouses, doing so to the extent possible avoids debris damage. Estimated wind speed: 130 mph. Hurricane Katrina (Mississippi, 2005)

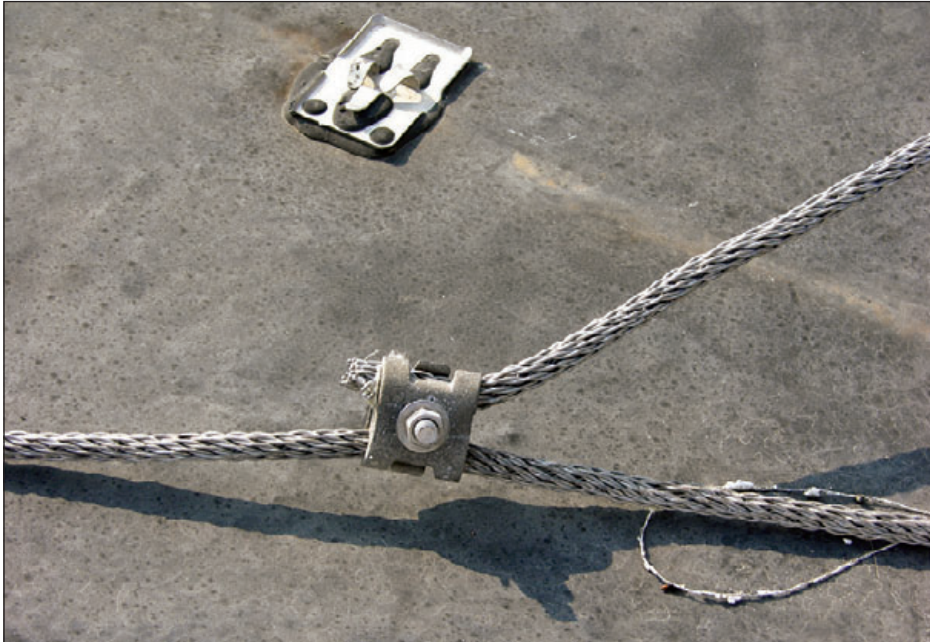
**Figure 6-117:** Bolted splice connectors are recommended to prevent free ends of connectors from being whipped around by wind. Estimated wind speed: 130 mph. Hurricane Katrina (Mississippi, 2005)

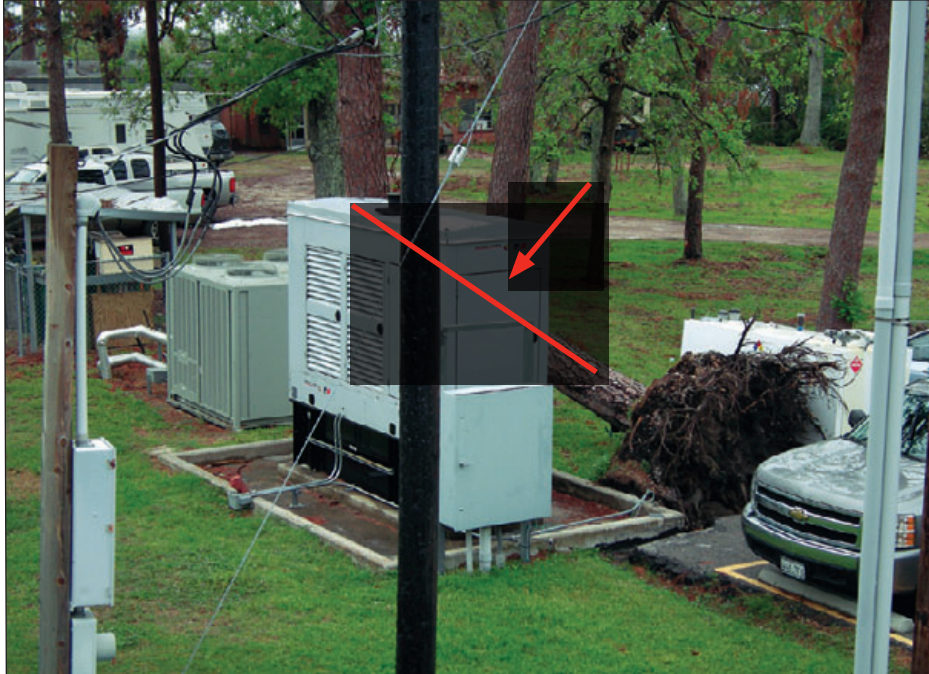
**Figure 6-119:**  
The tree shown by the red line nearly fell on the emergency generator (red arrow). Estimated wind speed: 110 mph. Hurricane Ike (Texas, 2008)

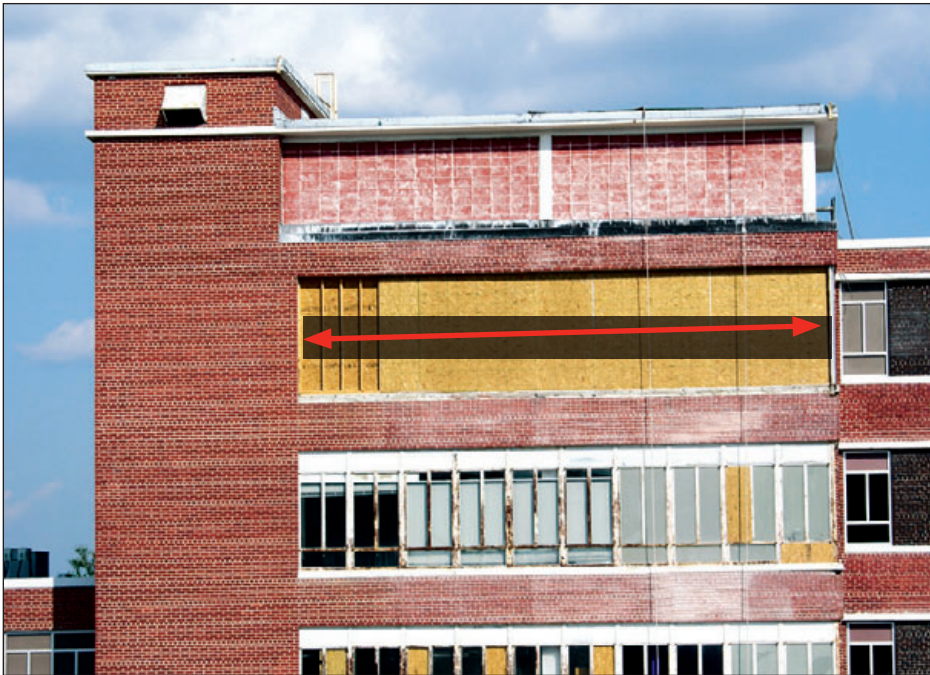
**Figure 6-123:**  
Wind pressure caused the window frames on the upper floors to fail (red arrow). Estimated wind speed: 130 mph. Hurricane Katrina (Mississippi, 2005)

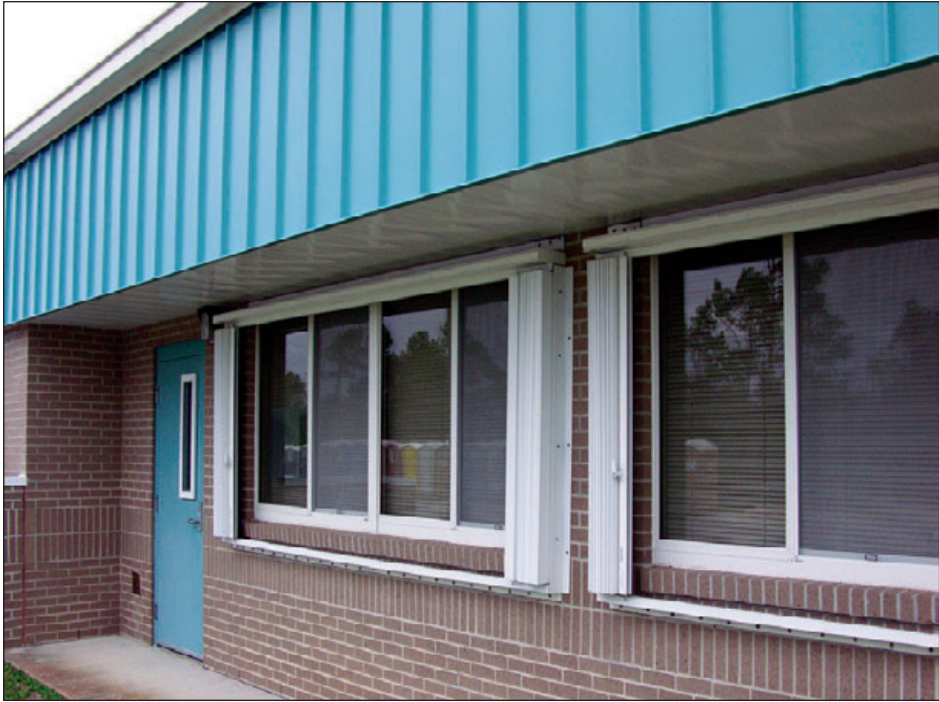
Figure 6-125:  
This school has  
accordion shutters.  
Estimated wind  
speed: 105–115 mph.  
Hurricane Ivan (Florida,  
2004)
