APPENDIX A
Maps & Figures

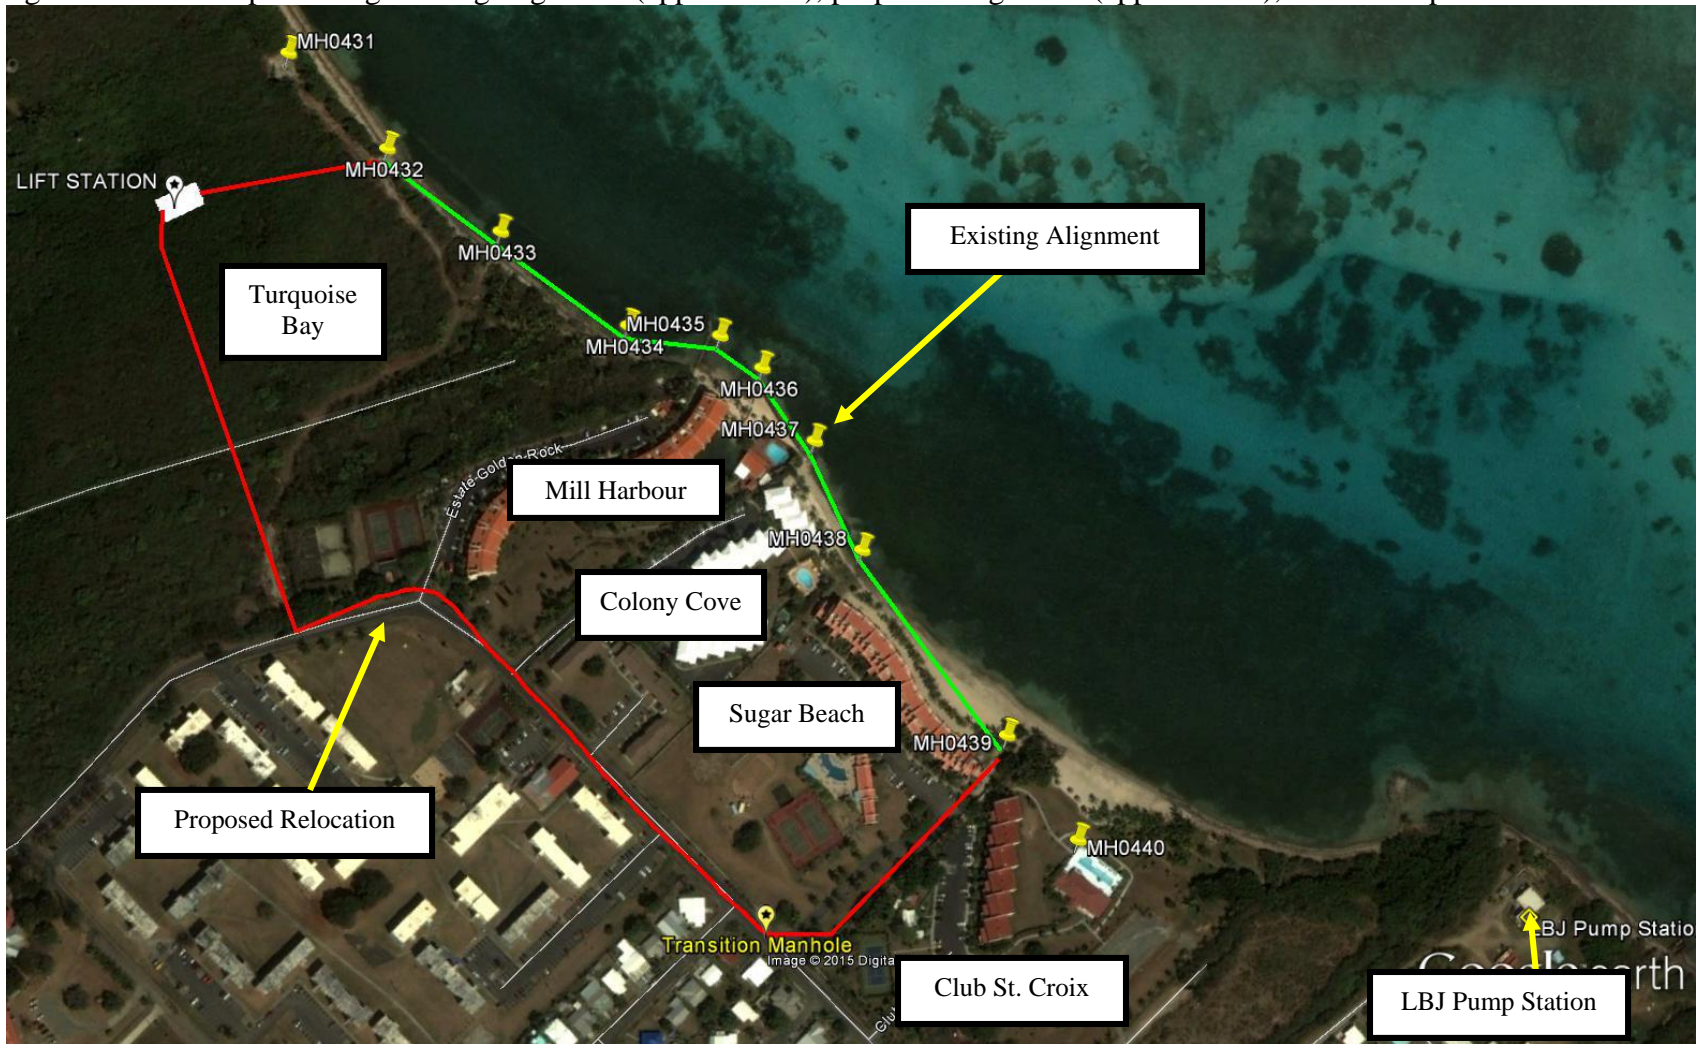
Figure 2. Aerial map showing existing alignment (approximate), proposed alignment (approximate), and development names.

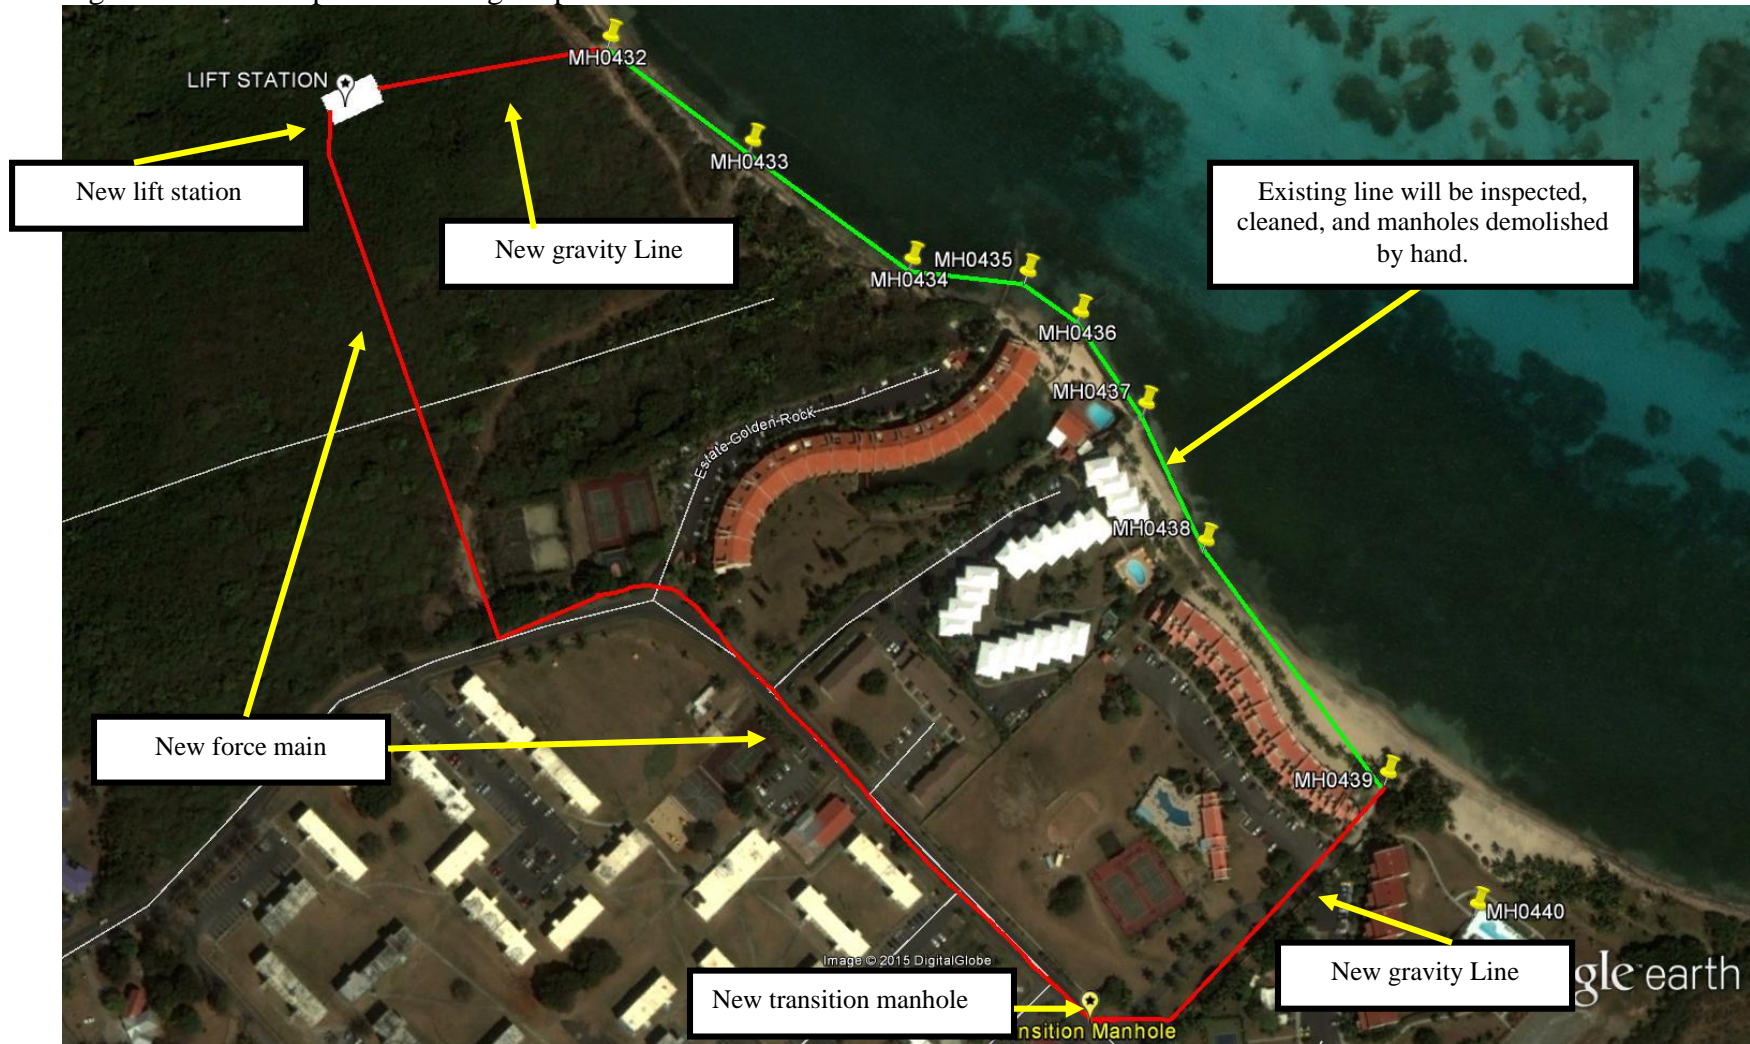
Figure 3. Aerial map summarizing scope of work for Alternative I.

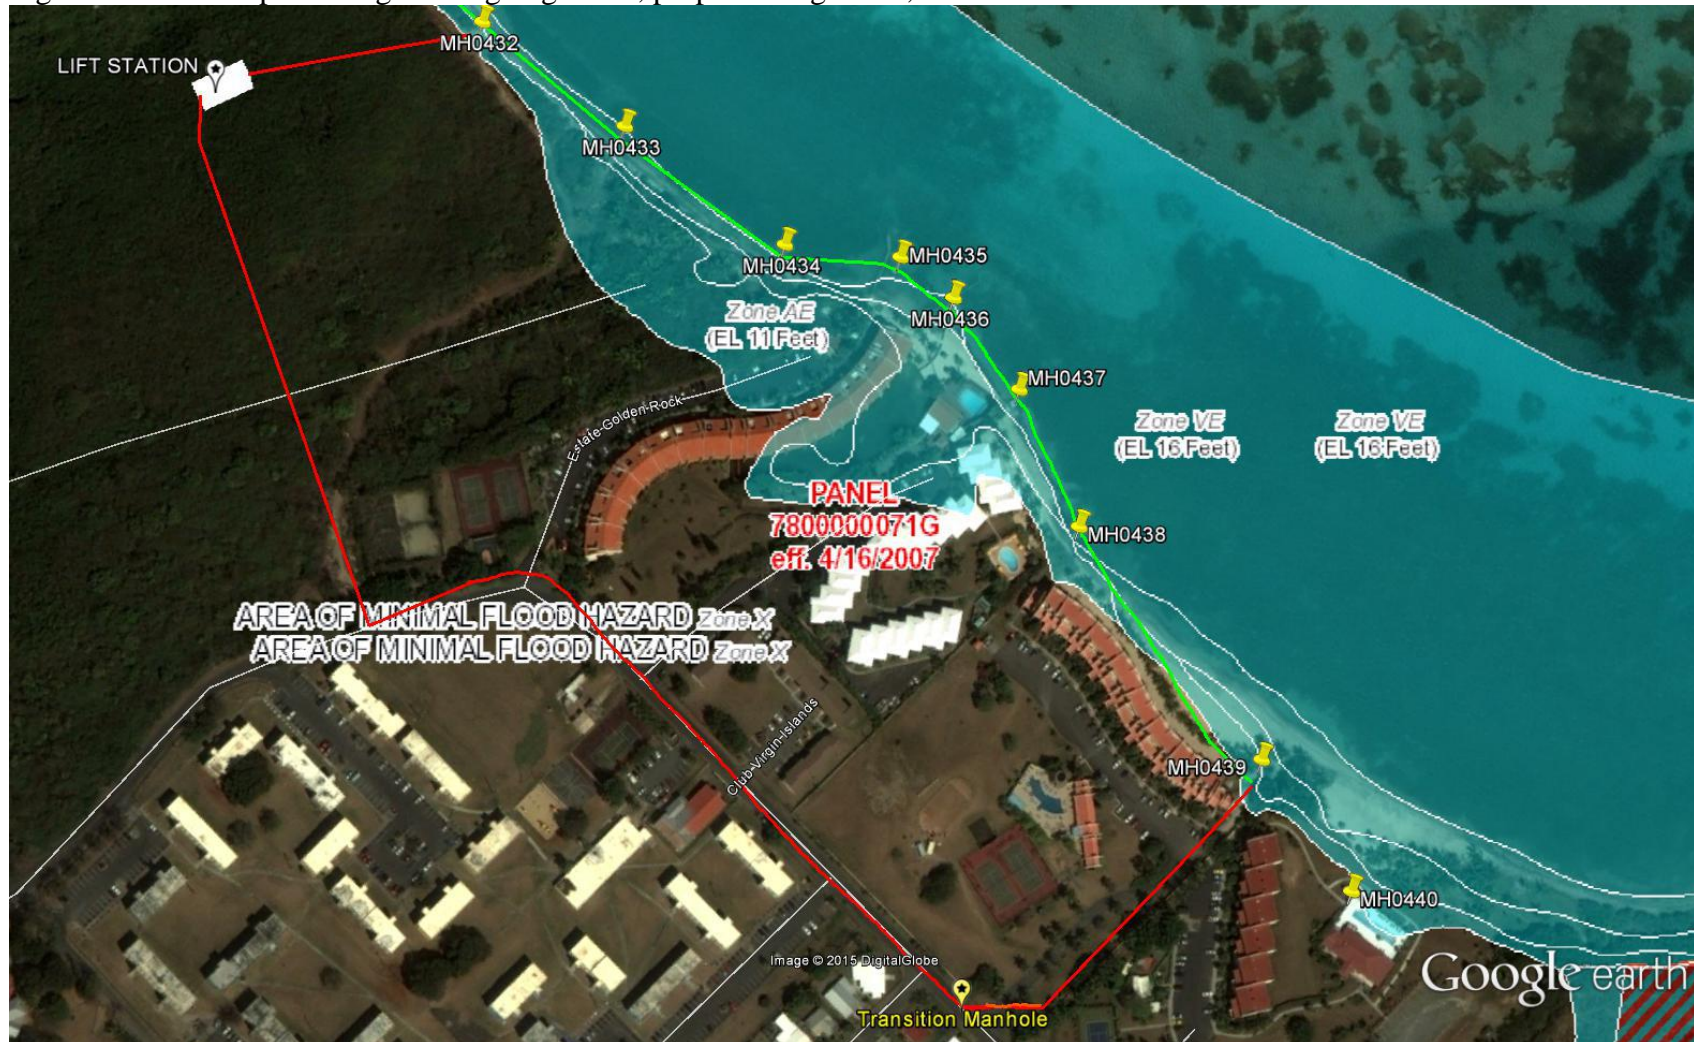
Figure 4. Aerial map showing existing alignment, proposed alignment, and base flood elevations.

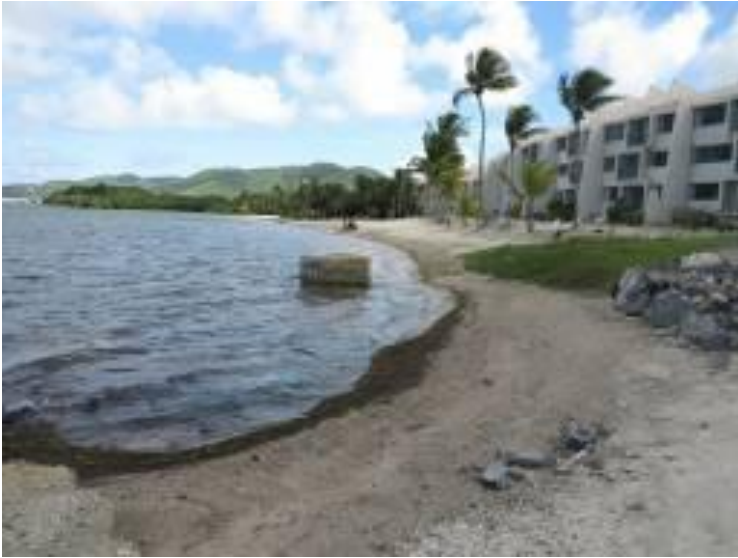
Photograph 1. Due to erosion over time, manhole (MH) 0438 between Sugar Beach and Colony Cove is now more than 10 feet off shore. (Photograph courtesy of Bioimpact, Inc.).

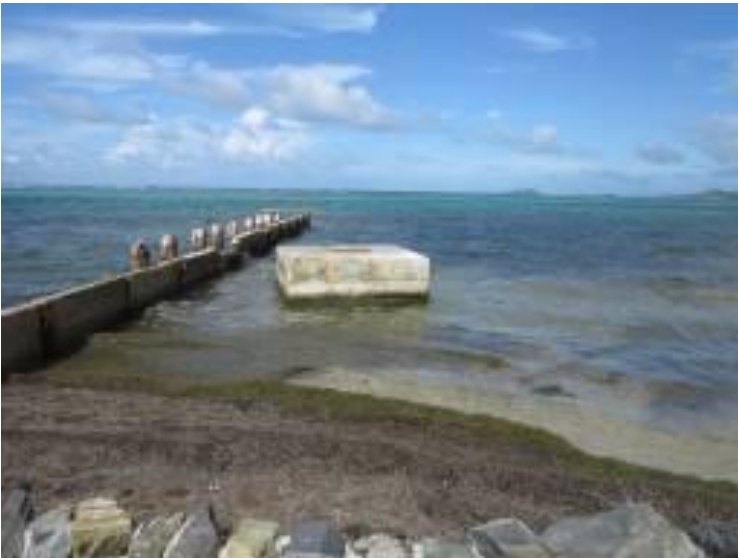
Photograph 2. Photograph of MH 0436, between Colony Cove and Mill Harbor. The photograph illustrates the erosion into the seagrass bed. (Photograph courtesy of Bioimpact, Inc.).

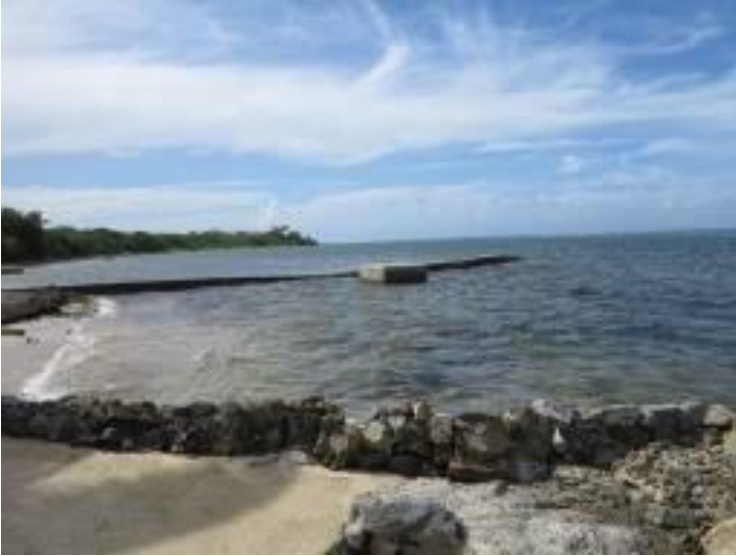
Photograph 3. This photograph shows MH 0435 off of Mill Harbour adjacent to a groin which was constructed to maintain the sand on Mill Harbour's Beach. (Photograph courtesy of Bioimpact, Inc.).

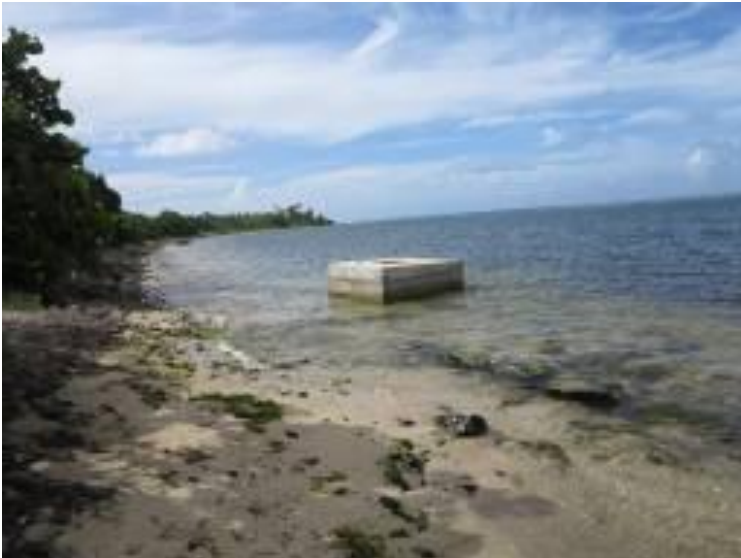
Photograph 4. This photograph shows MH 0434 off of the Turquoise Bay property. The dark green algae noted at the water's edge and on the beach is Chaetomorpha, a filamentous green algae which indicates eutrophic conditions. (Photograph courtesy of Bioimpact, Inc.).

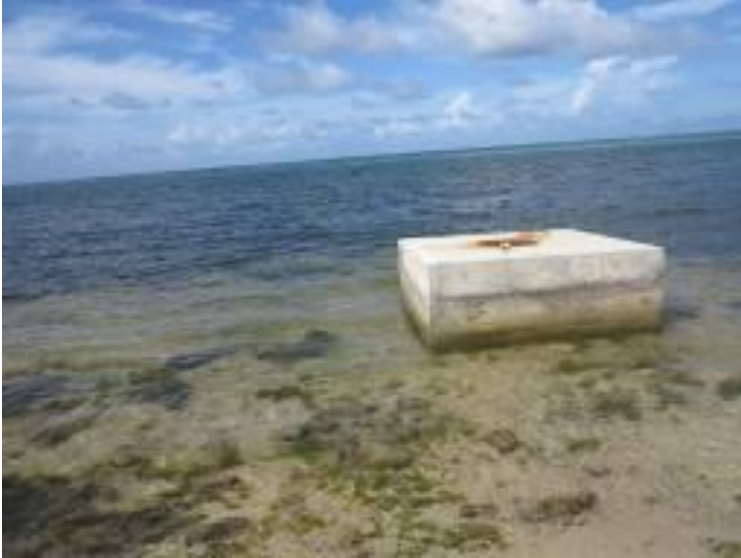
Photograph 5. This photograph shows a typical MH. Note the halo. (Photograph courtesy of Bioimpact, Inc.).

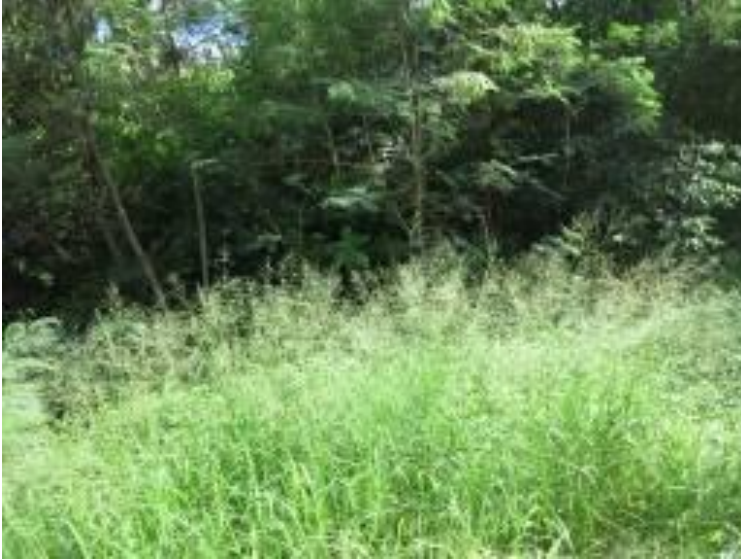
Photograph 6. This photograph shows the typical vegetation along the proposed relocation route. (Photograph courtesy of Bioimpact, Inc.).
