Appendix A

City of Cedar Rapids Northwest quadrant aerial

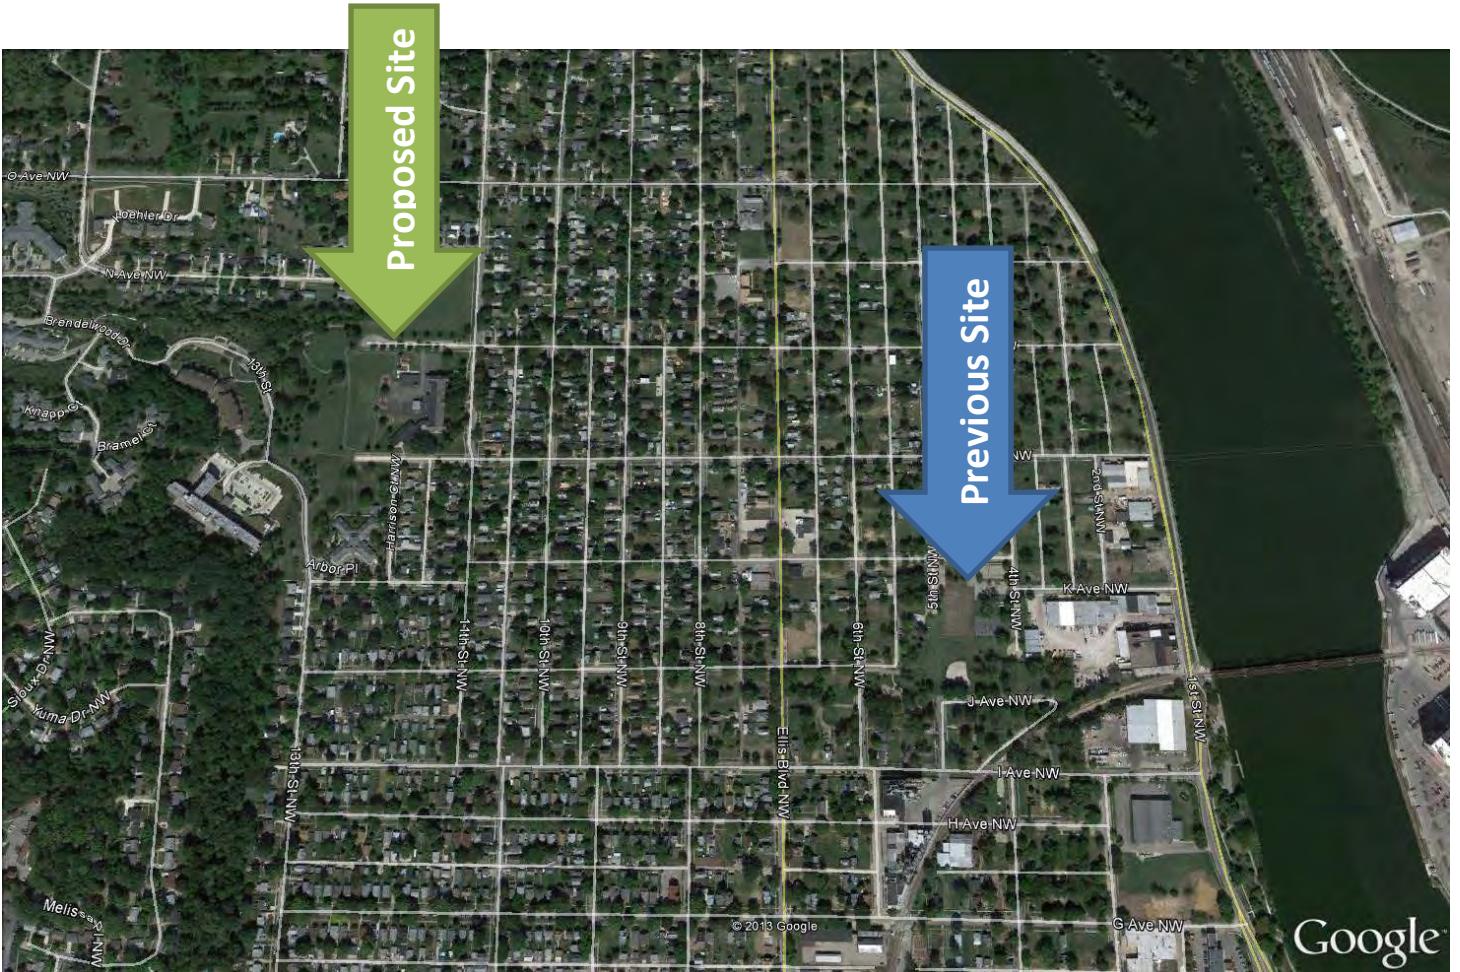
Figure 1: Aerial photograph of the Cedar Rapids area. The blue arrow indicates the location of the previous Time Check Recreation Center and the green arrow indicates the proposed location of the Time Check Recreation Center.

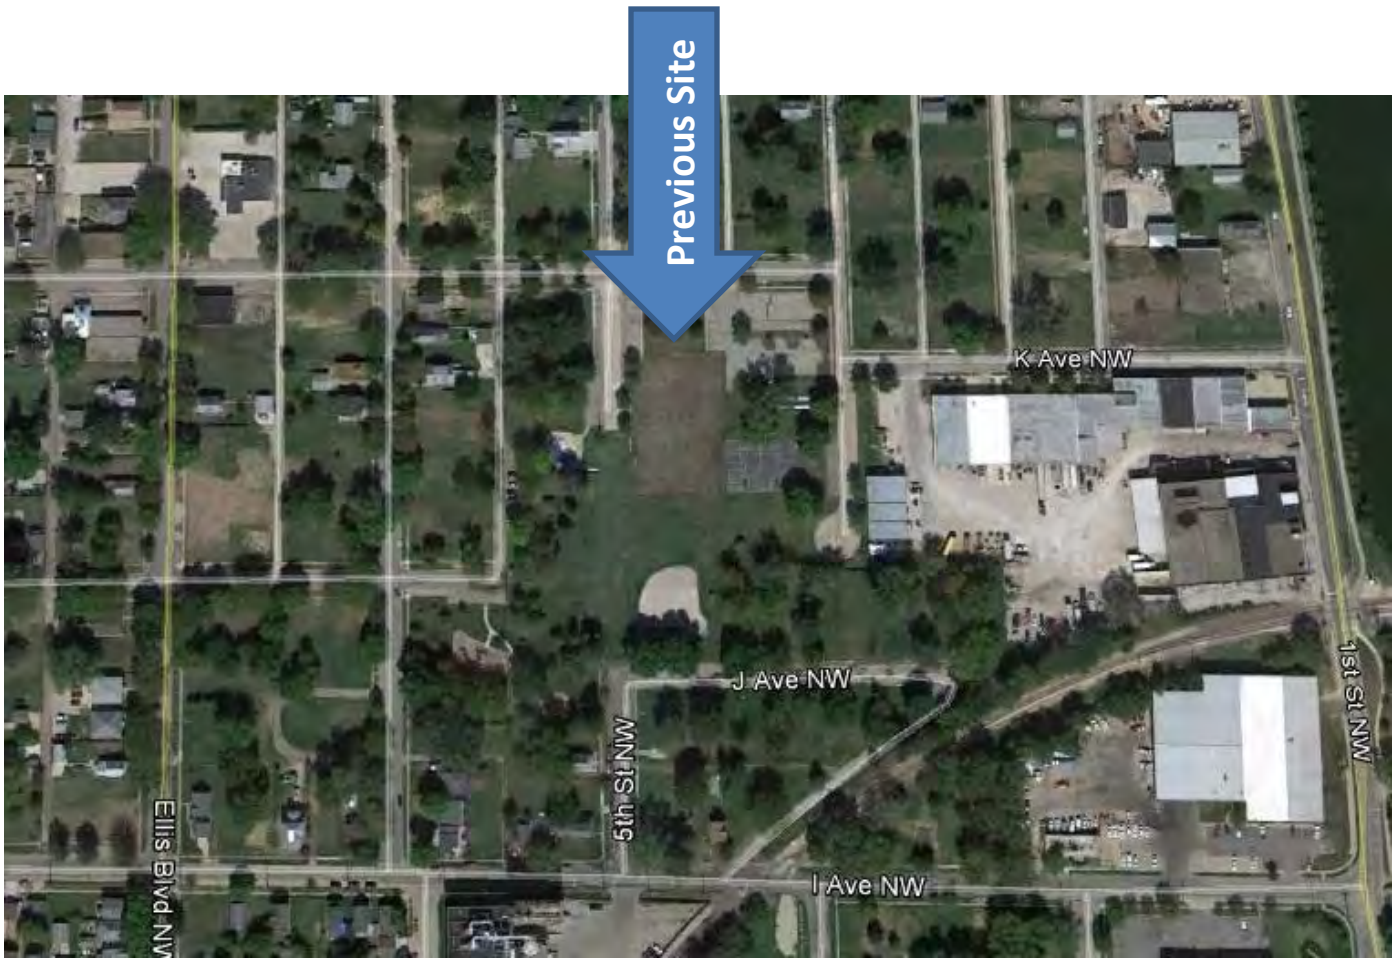
Location of the previous Time Check Recreation Center

Figure 2: Aerial photograph of the previous Time Check Recreation Center and vicinity.

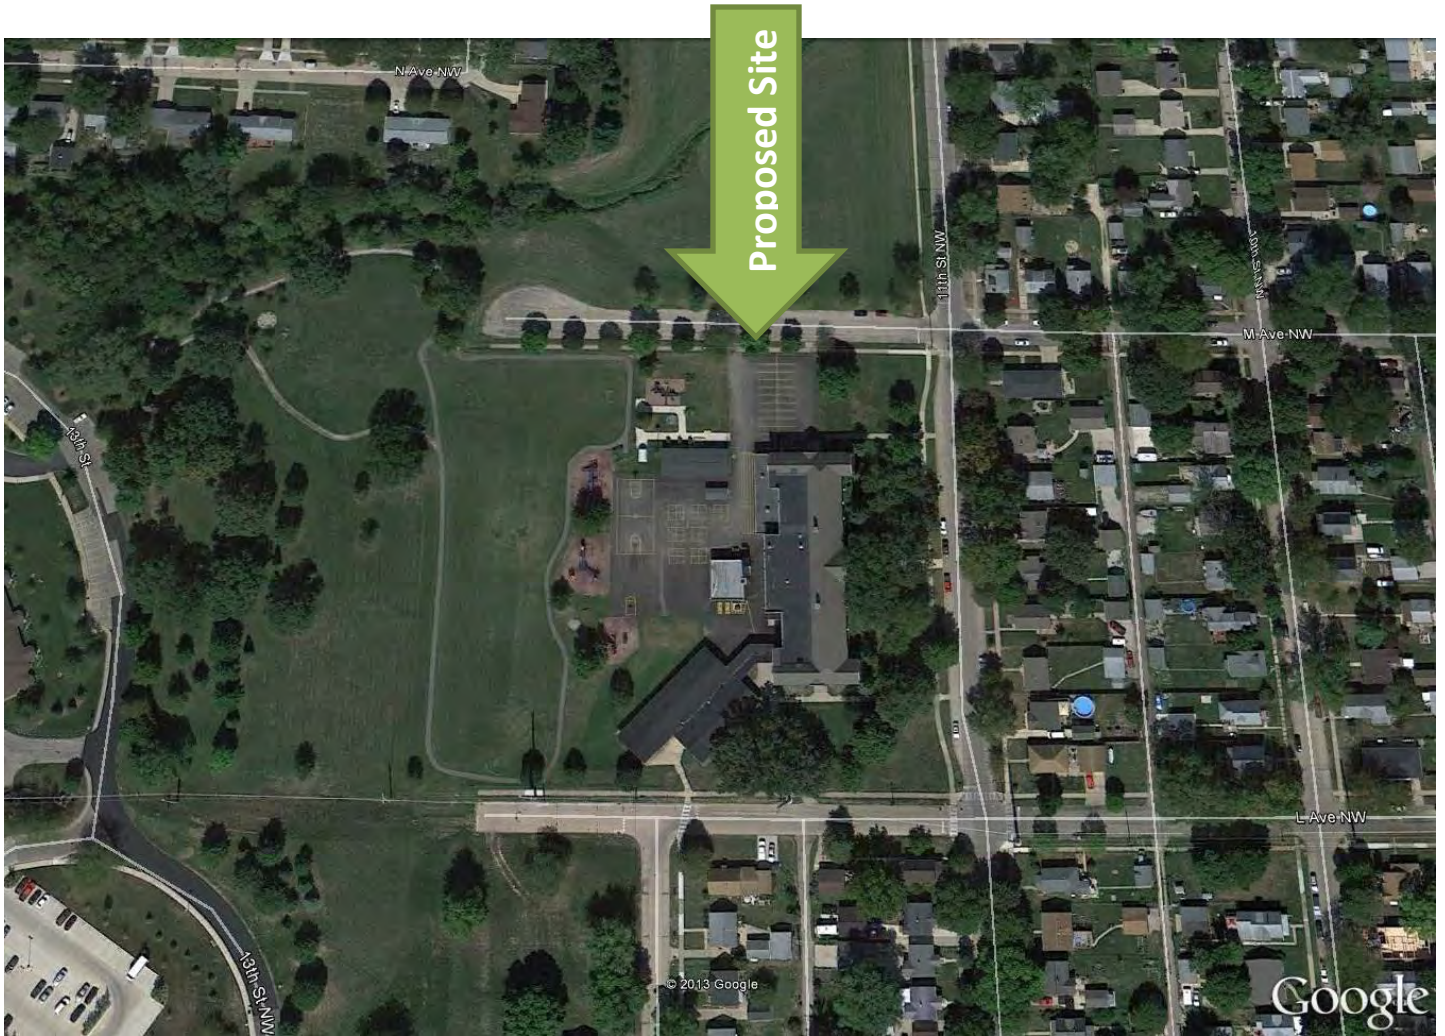
Proposed site: Time Check Recreation Center

Figure 3: Aerial photograph of the proposed Time Check Recreation Center and vicinity.

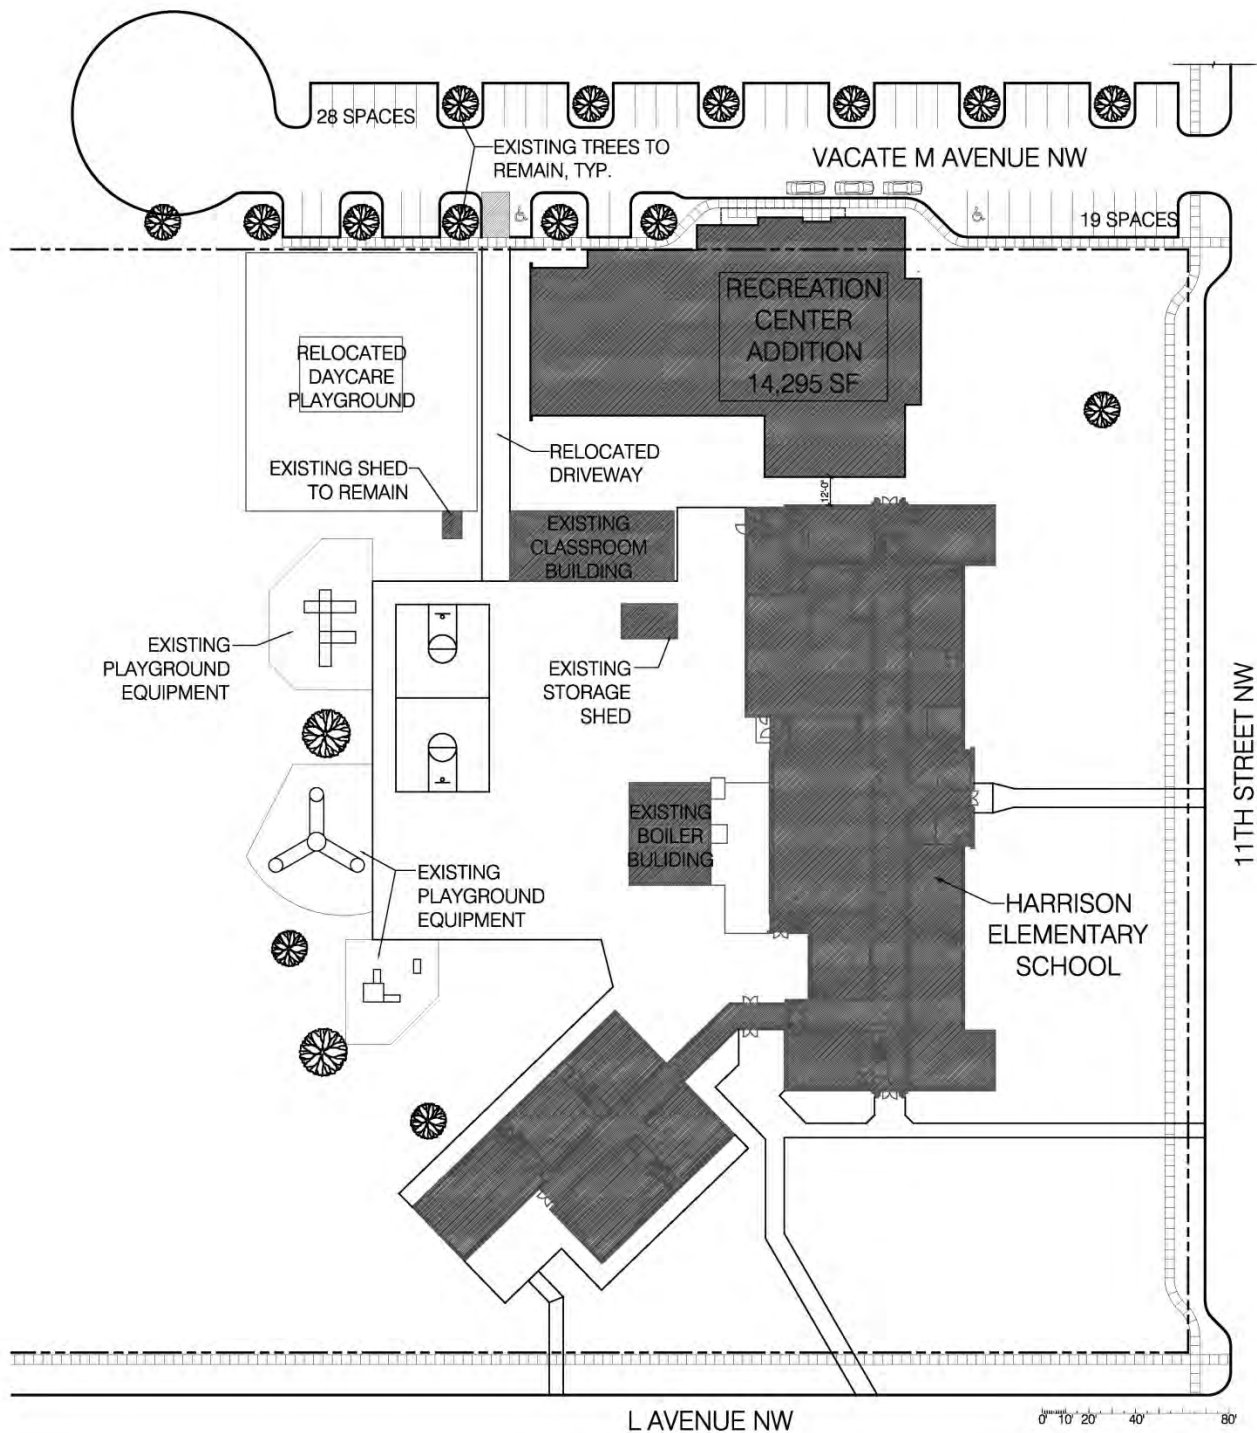
1 RECREATION CENTER SITE PLAN

Figure 4: Proposed site plan for the Time Check Recreation Center. Source: Provided by the Subgrantee.

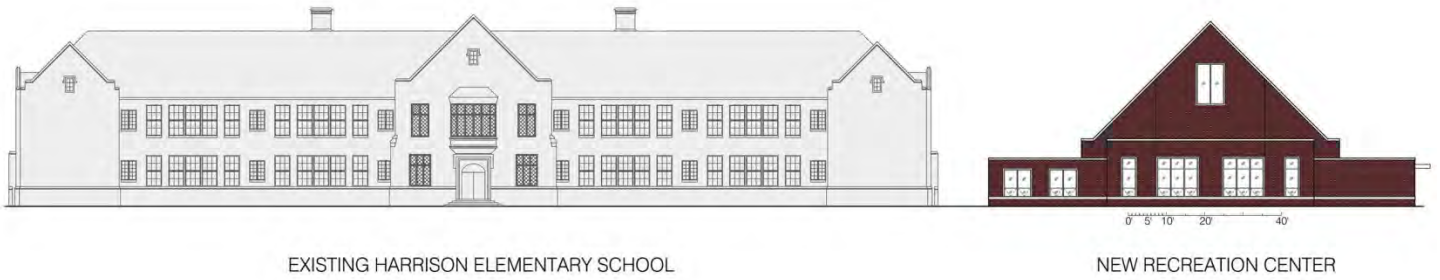
5 EAST ELEVATION WITH EXISTING SCHOOL
SCALE: NONE 6.25.13

Figure 5: East Elevation of the proposed Time Check Recreation Center.

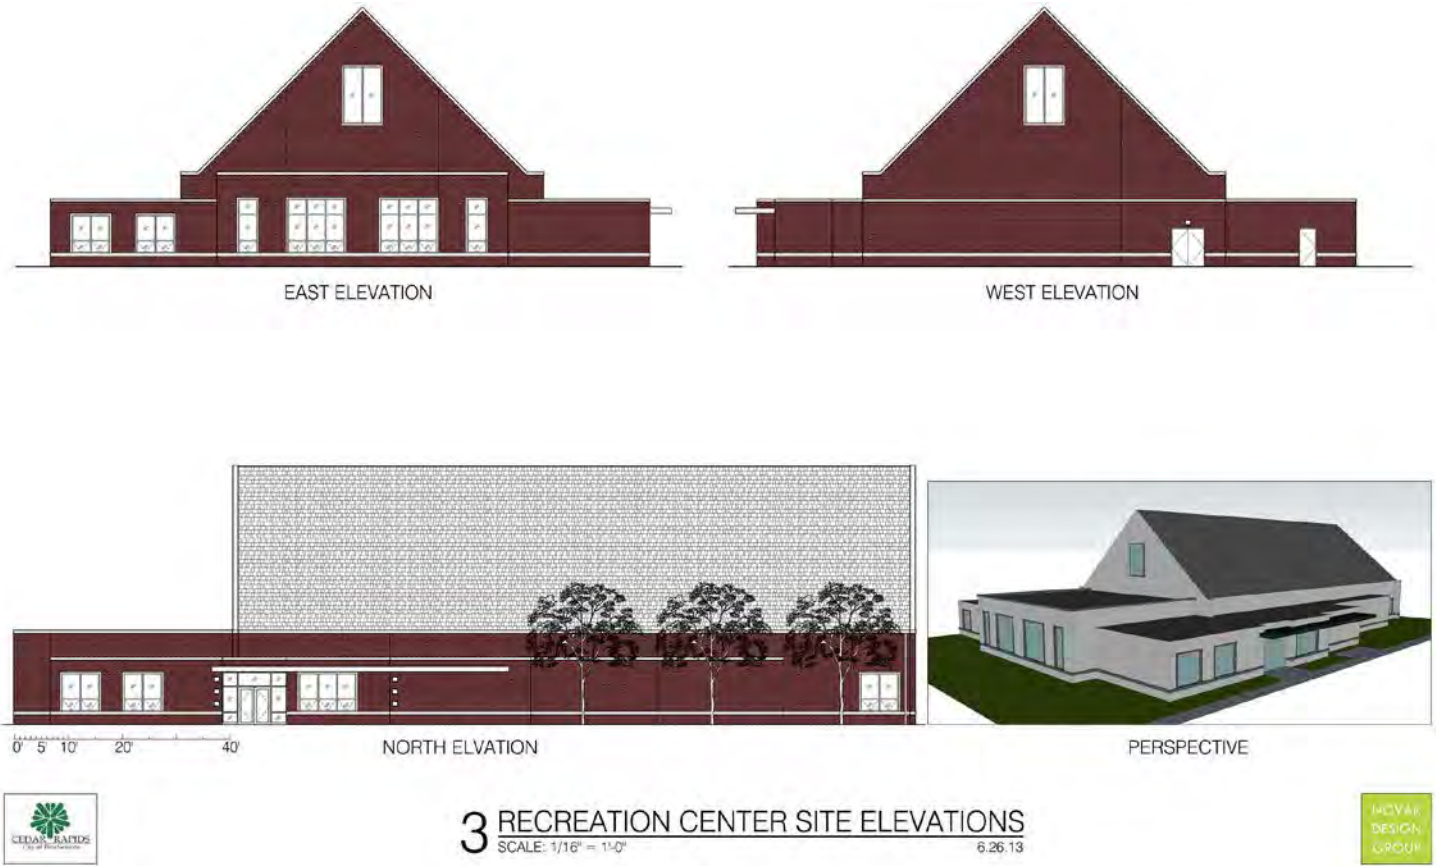
Figure 6: Site Elevations of the proposed Time Check Recreation Center.

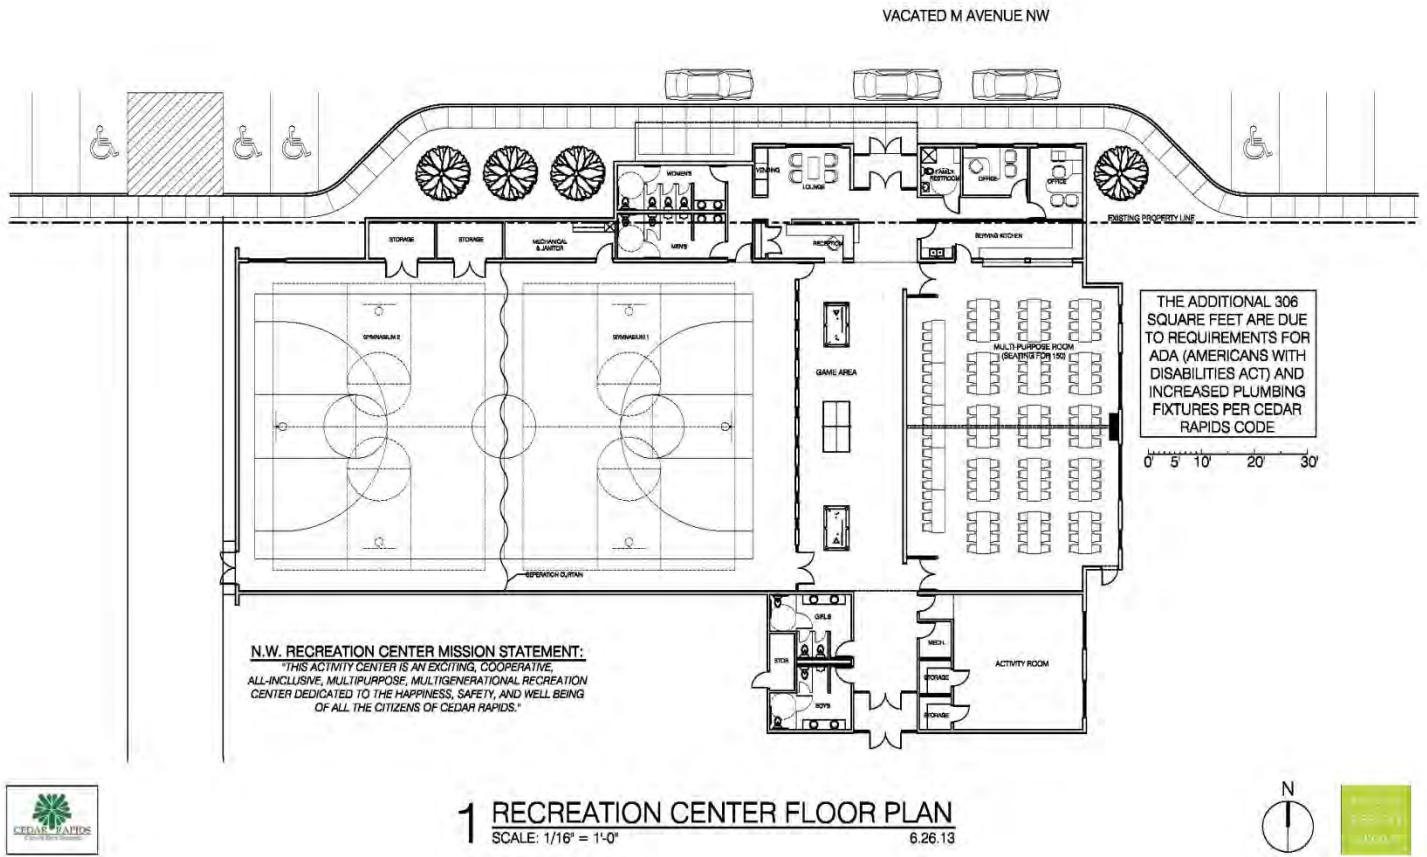
Figure 7: Floor Plan of the proposed Time Check Recreation Center.

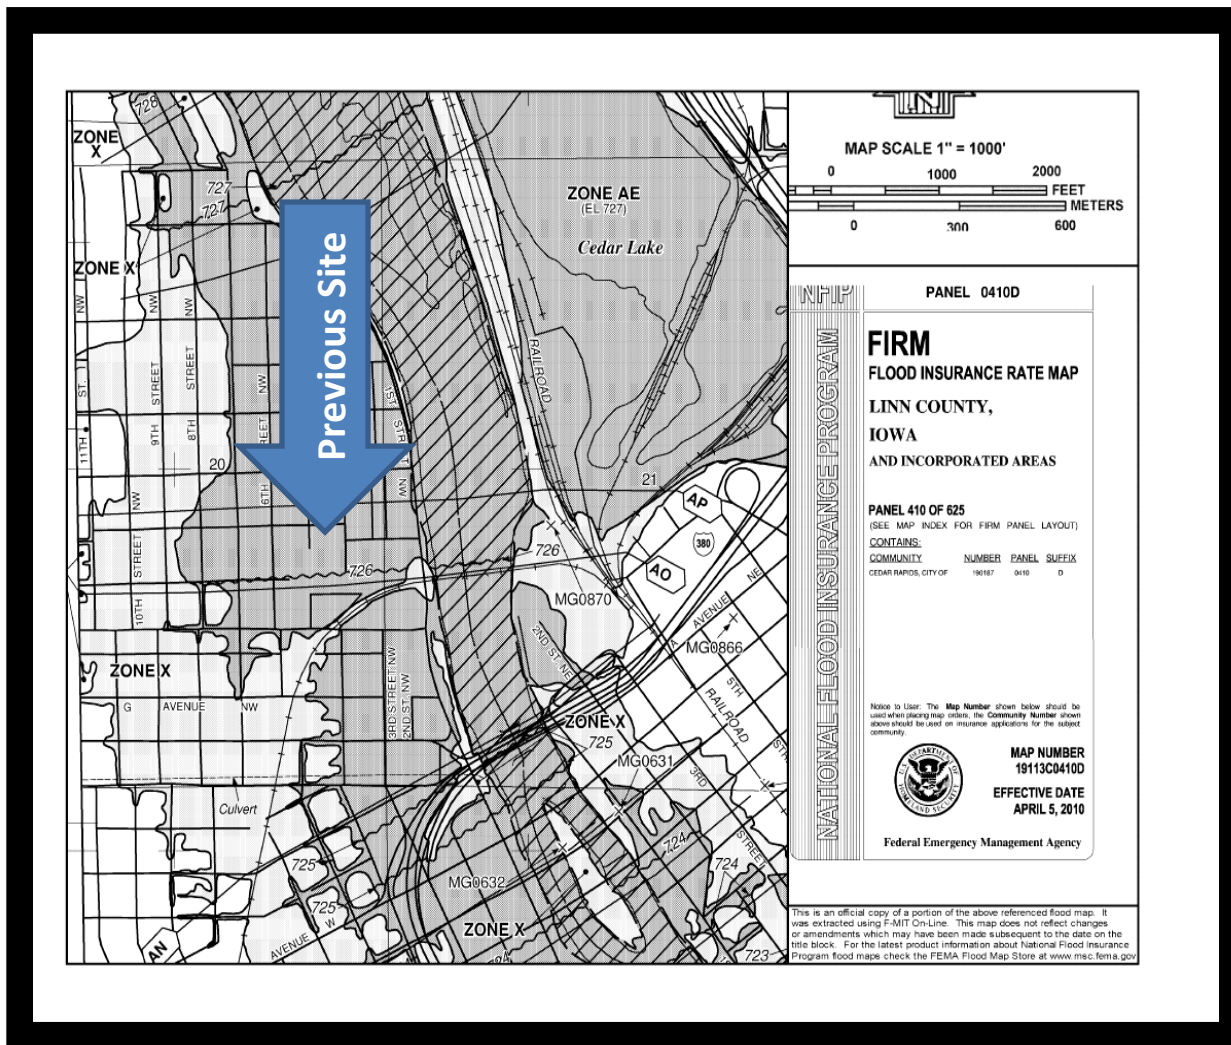
Figure 8: National Flood Insurance Program (NFIP) Flood Insurance Rate Map (FIRM) of Cedar Rapids area. FIRM panel number 19113C0410D, effective April 5, 2010, indicates that the location of the previous Time Check Recreation Center (blue arrow) is in Zone A and in the regulatory floodway of the 100-year floodplain which is within a special flood hazard area.

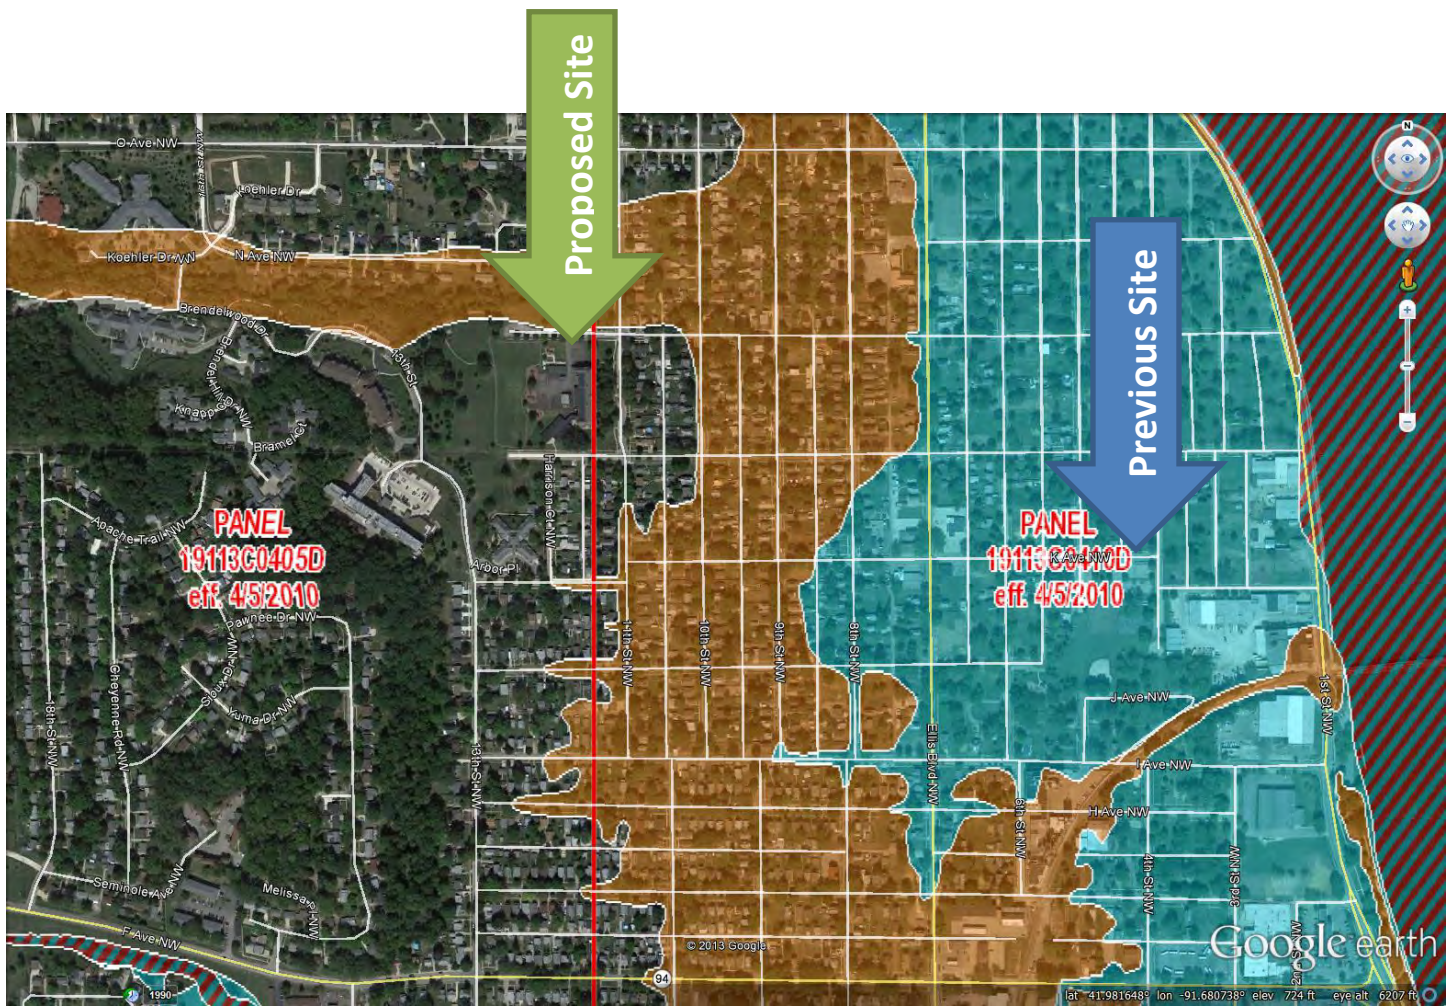
Figure 9: Google Earth aerial image with National Flood Insurance Program (NFIP) Flood Insurance Rate Map (FIRM) layer indicates that the location of the previous Time Check Recreation Center (blue arrow) is in Zone A and the regulatory floodway of the 100-year floodplain which is within the special flood hazard area. The FIRM indicates that proposed location of the Time Check Recreation Center (green arrow) is outside the orange Zone X within the 500-year floodplain and also out of the blue Zone A 100-year floodplain.

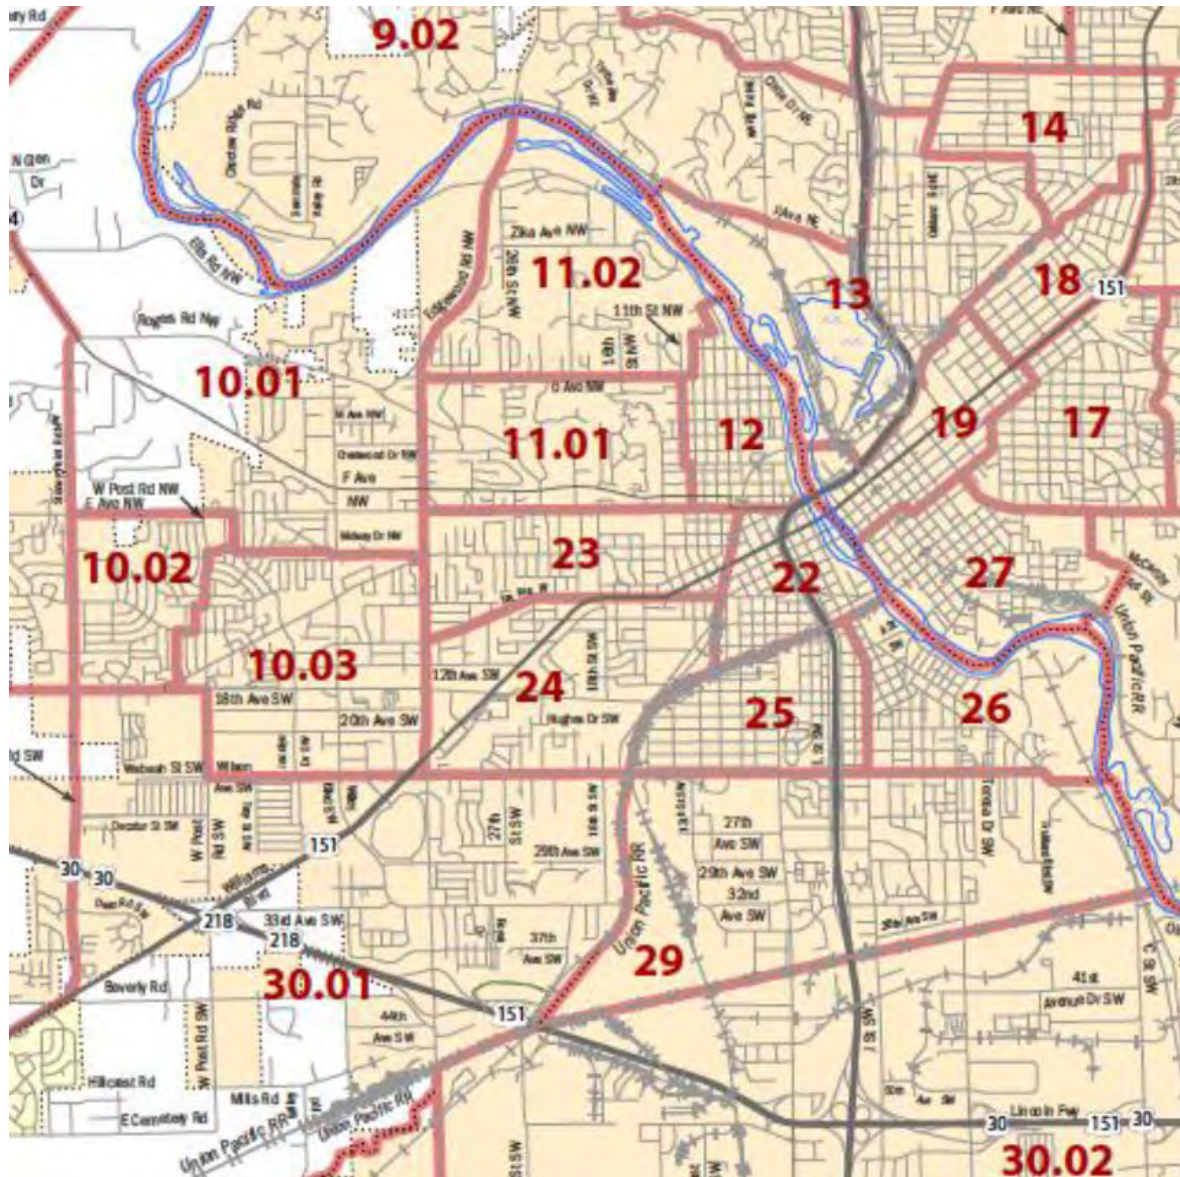
Figure 10: 2010 Census Tract Boundaries for Cedar Rapids. The green arrow indicates the proposed location of the Time Check Recreation Center. The proposed Parkade would be located in Census Tract 27. Census Tract 27 is mainly an urban commercial district with few residents; however this tract has a higher minority and low income proportions compared to Cedar Rapids as a whole. *FEMA 1763-DR-IA – Cedar Rapids Time Check Recreation Center Facility Draft Environmental Assessment – Appendix A*

Socio-Economic Demographics	Census Tract 27	Cedar Rapids
2010: Housing Units	841	57,217
2010: Population	1,549	126,326
