# Performance of Residential Buildings

Mitigation Assessment Team Summary Report and  
Recommendations

State of Hawai'i  
Maui Wildfires

Revised April 2025

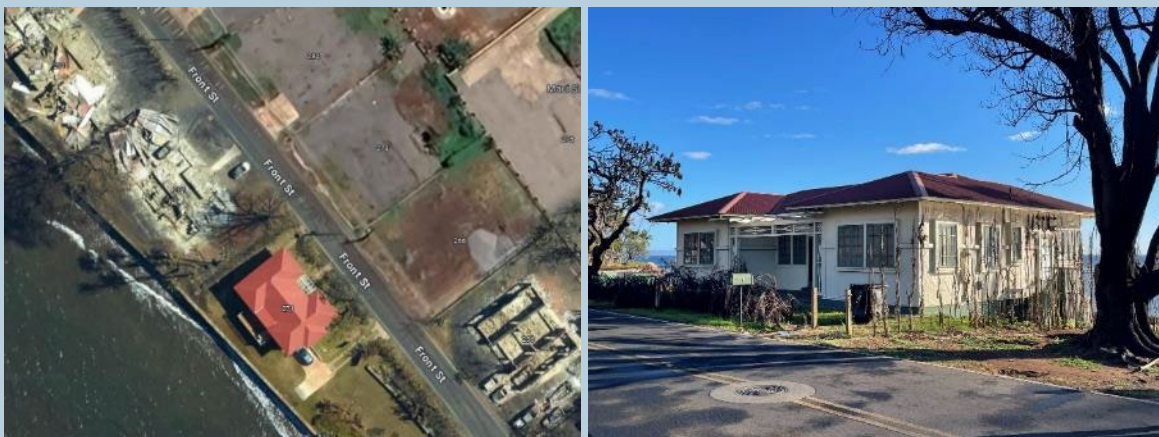
Shortly after the Maui wildfires, local and national news media outlets dubbed one house along the Lahaina coast as the “miracle house.” The historic building survived the devastating Lahaina Fire, while its surrounding neighbors did not. While it cannot be determined precisely why this house survived when many others didn’t, a combination of features likely contributed to its wildfire resilience (Figure 5). According to news articles from Honolulu Civil Beat and National Public Radio, the “miracle house” roof had undergone a detailed renovation that included replacement of the existing wood roof with a commercial grade metal roof.<sup>14,15</sup> Metal roofs are more resistant to ember and firebrand penetration than a wood roof. Additionally, a 3-foot perimeter of wood mulch and other vegetation immediately surrounding the building was removed and replaced with river stones. Although the stone was intended to reduce the risk of termite damage and improve water drainage, it also helped provide defensible space (hardscaping) to resist fire spread toward the home. The news articles and the MAT concluded that the combination of structural hardening and defensible space, combined with a considerable amount of luck, allowed the “miracle house” to earn its name.

**Figure 5. Aerial image of the “miracle house” (left) and a street view of the house with a metal roof that provided structural hardening and minimal landscaping that provided defensible space (right).**

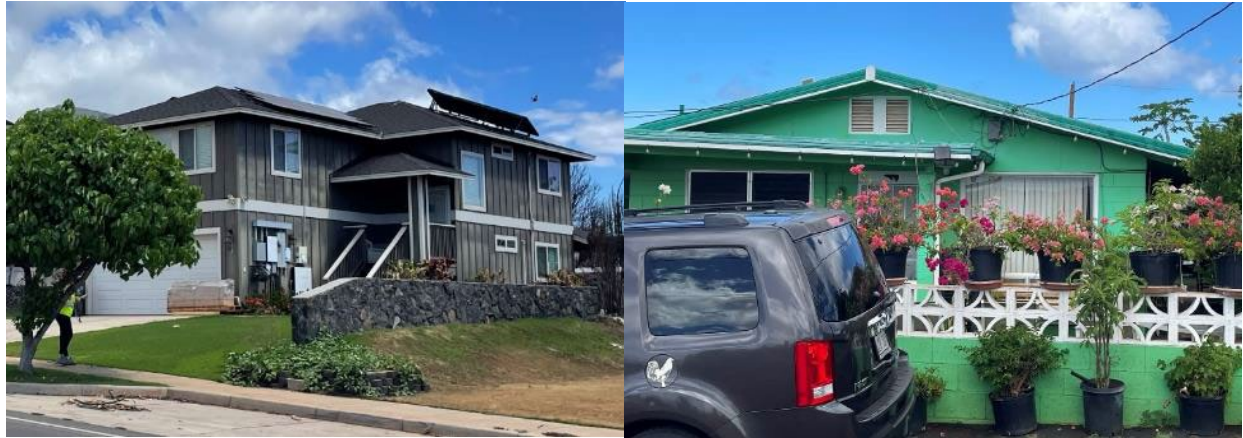
Most buildings observed by the MAT were one-, two- and three-story single-family homes or multi-family residential structures constructed of wood structural framing with exterior walls sheathed in wood or fiber-cement siding or masonry framed buildings with exterior walls finished with paint or stucco (Figure 14).

Buildings constructed with noncombustible structural framing materials (e.g. masonry framing, concrete framing, stone exterior walls) performed better than wood-framed structures. The MAT observed a few multi-family residential buildings with metal studs destroyed by fire.

**Figure 14. Wood-framed single-family residence with fiber cement siding in Lahaina (left) and painted masonry-framed single-family residence in Lahaina (right).**

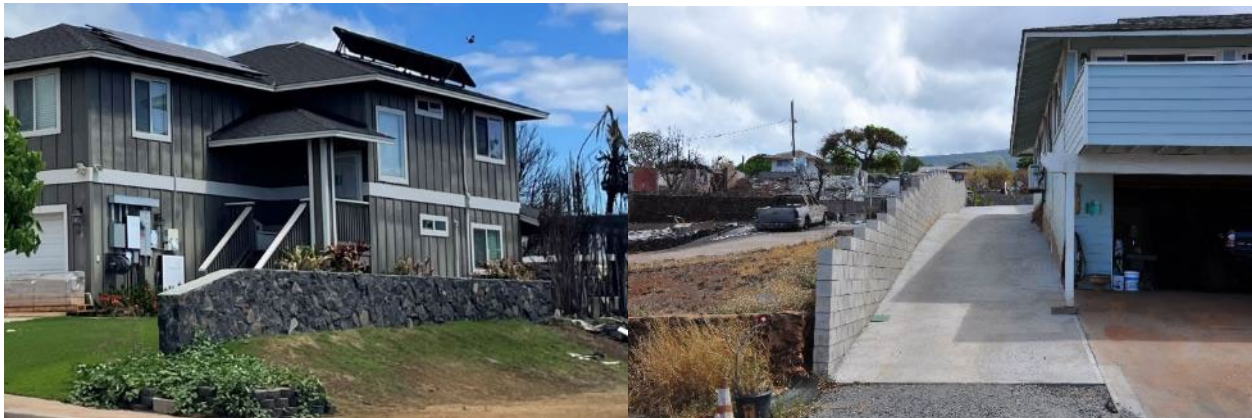
Many buildings on Maui were separated by property fences constructed of one or more materials including wood, vinyl, metal, masonry, or stone. Some fences extended back to the main structure, while others were separated from the structure. Fences constructed of wood were highly vulnerable to fire damage and vinyl fences were prone to melting or warping during the wind-driven wildfires (Figure 21). In some cases where the fence was very close to or attached to the structure (within five feet), the burning fence may have led to ignition of the structure. Although not directly observed, findings regarding wood fence vulnerabilities and observed vinyl fence damage were consistent with the findings of NIST Technical Note 2228, *Wind-Driven Fire Spread to a Structure from Fences and Mulch*, published in August 2022.<sup>27</sup> By contrast, fences constructed of metal (chain link), masonry or mortared stone were often undamaged; in some cases masonry or stone fences may have limited structure-to-structure fire spread (Figure 22).

**Figure 22. Homes with stone or masonry property fences that appeared to resist wildfire damage.**

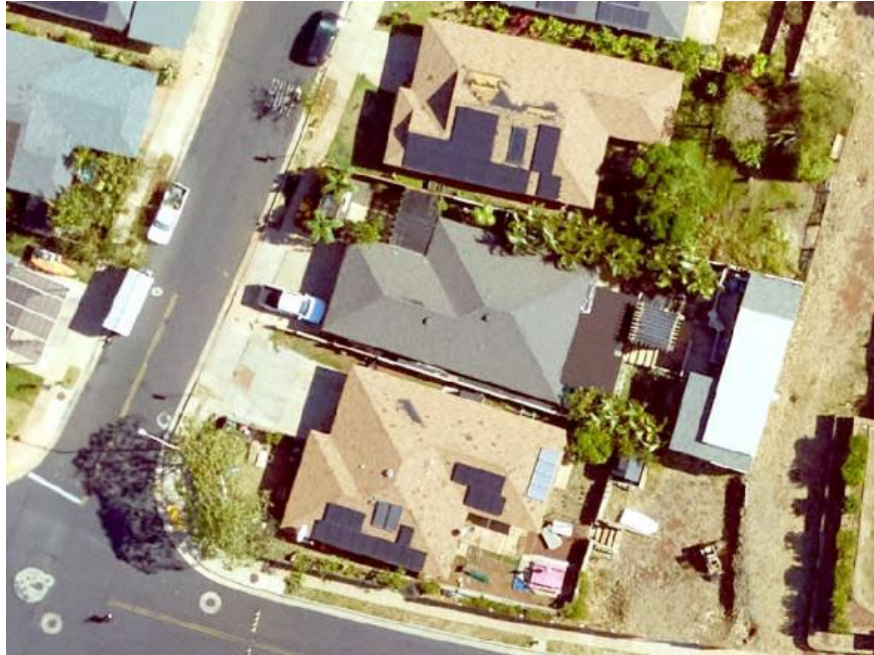
Small parcel sizes observed throughout the impacted and unimpacted neighborhoods of Lahaina and Kula limited homeowners from incorporating defensible space best practices on their own property. This resulted in residences proximate (e.g., within five to 30 feet) to their property line or

their neighbor's home with insufficient defensible space, compounded by a lack of fuel treatments or other forms of defensible space on the adjacent neighbor's property (Figure 26). Many of the neighborhoods impacted by the Lahaina fire featured densely spaced buildings with limited fire separation distances (i.e., less than 10 feet of separation) (Figure 27). At the time of the fire, local planning, building and fire codes did not incorporate wildfire hazard and risk assessments as part of the planning or development process. *Maui Wildfires MAT Recovery Advisory #2 (RA-2) Reducing Wildfire Risk to Your Home* provides guidance and best practices for defensible space considerations on Maui.<sup>32</sup>

**Figure 26. Aerial imagery showing limited distances between residential buildings in Lahaina.**
