# Recommendations for Cordoning Earthquake-Damaged Buildings

FEMA P-2055-2 / September 2023

Prepared by  
APPLIED TECHNOLOGY COUNCIL  
201 Redwood Shores Parkway, Suite 240  
Redwood City, California 94065  
[www.ATCouncil.org](http://www.ATCouncil.org)

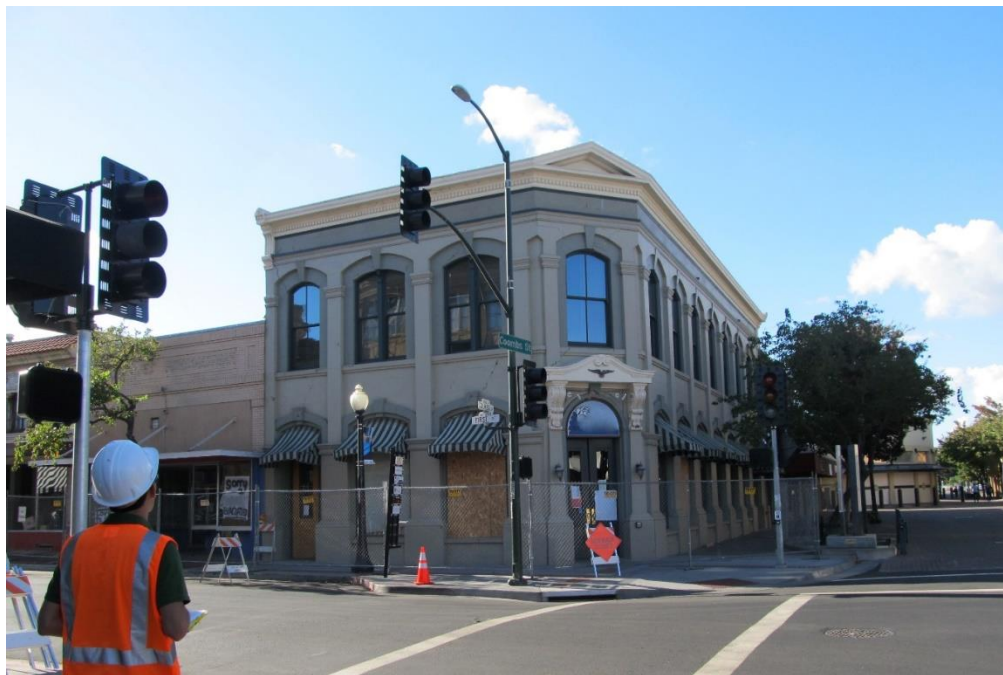
**Figure 2-3** A URM building with in UNSAFE placard with a very narrow cordon around it. (FEMA P-1024 Figure 12-1).

FEMA P-1024, *Performance of Buildings and Nonstructural Components in the 2014 South Napa Earthquake* (FEMA, 2015) documents the use of cordons and barricades immediately after the event and their transition to longer-term barricades. Chapter 12 of the report includes observations of initial barricades that were inadequately spaced from damaged buildings. For example, the building shown in Figure 2-3 is an unreinforced masonry (URM) building with an UNSAFE placard and significantly damaged masonry façades; however, the fence is located only several feet from the building, while the street remained fully operational.

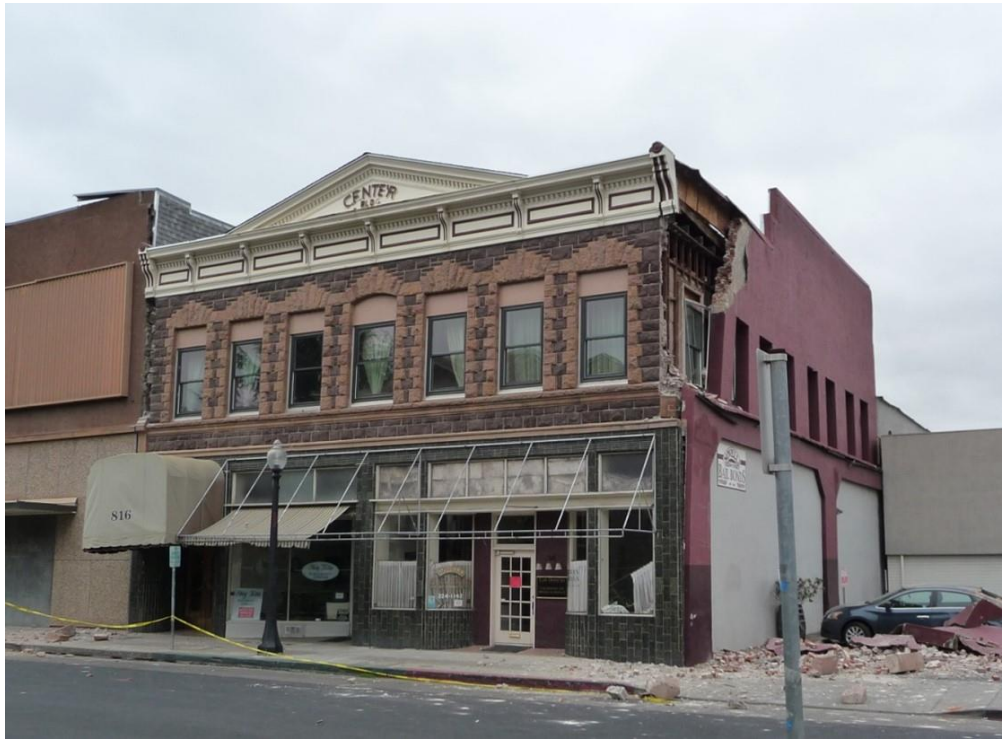
**Figure 2-4** Failure of URM south wall of URM building posted UNSAFE (FEMA P-1024 Figure 4-49, photo by Marko Schotanus).

FEMA P-1024 also documents the impact of debris from a damaged unretrofitted URM building on adjacent structures. The building shown in Figure 2-4 was posted UNSAFE; the masonry wall on the south side of the building (right side of the figure) separated from the structure and portions of it fell into the neighboring parking lot, striking an unoccupied, parked car. In addition, stones fell off the back of the building into the alleyway that separates the building from several retrofitted URM buildings. As a result, four of the neighboring buildings were also posted UNSAFE due to the risk of collapsing masonry walls striking the buildings. The surrounding buildings were subsequently posted INSPECTED following the erection of wood barriers (Figure 2-5), allowing the occupants, in this case businesses, to resume operations.

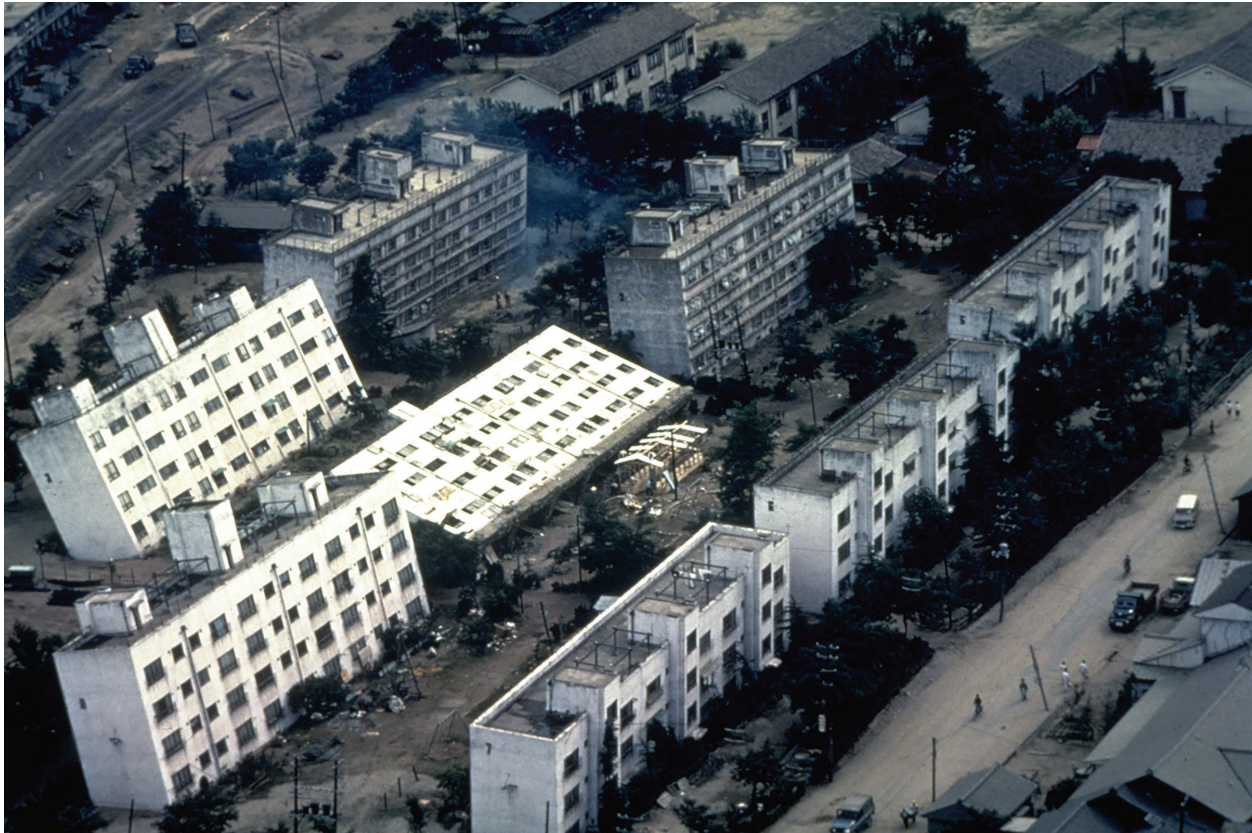
**Figure 3-5 Tilting of apartment buildings due to liquefaction in 1964 Niigata Japan earthquake (Photo Credit: NISEE).**

- Tilting of apartment buildings due to liquefaction in 1964 Niigata Japan earthquake (Figure 3-5)
- One of the five towers of the Piño Suarez building collapsed in the 1985 Mexico City Earthquake as a result of column buckling in the fourth story, crushing an adjacent tower (Figure 3-6)

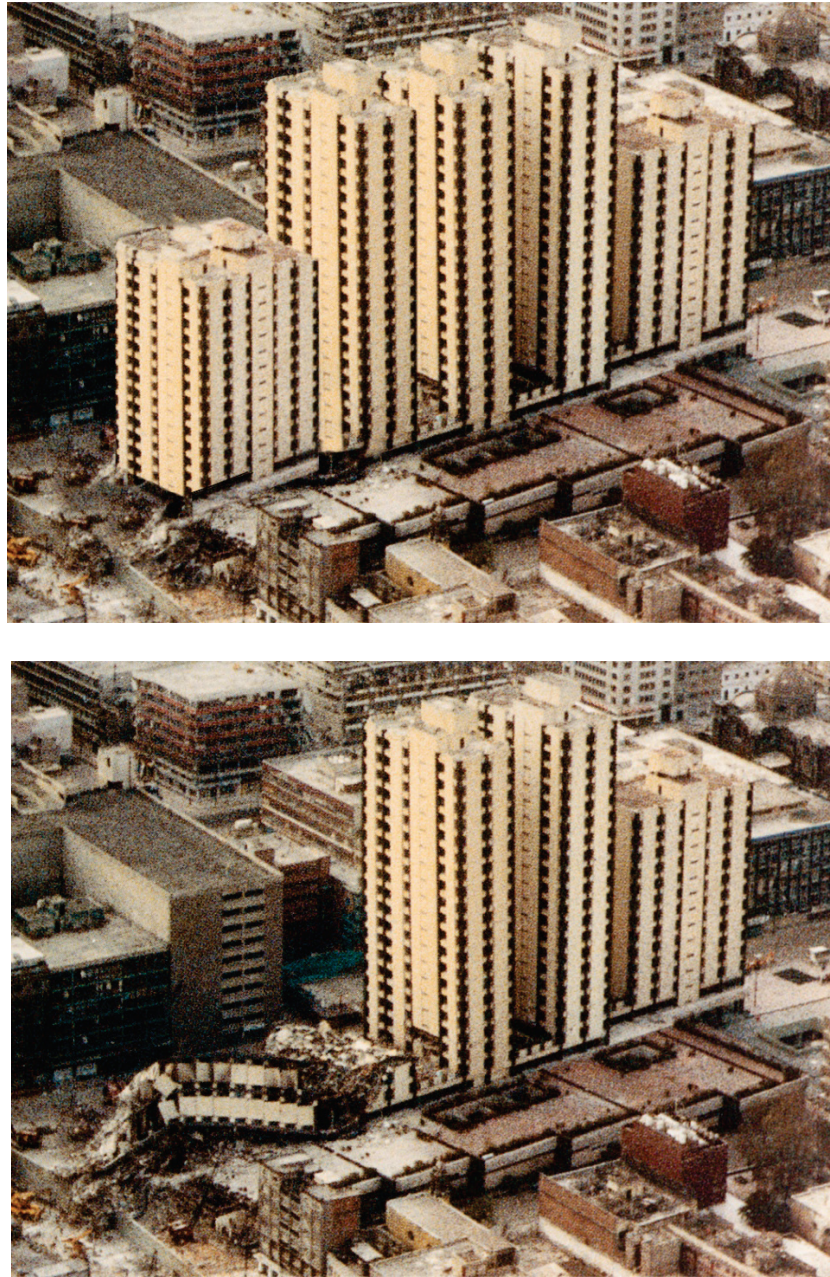
**Figure 3-6** Piño Suarez towers before and after the 1985 Mexico City Earthquake (from *Reports on the Damage Investigation of the 1985 Mexico Earthquake*, Architectural Institute of Japan, 1987; upper image photoshopped by Exponent to include all five original towers).

All of the monolithic overturning collapses identified in the literature review occurred during the main shock; literature review conducted did not identify buildings that collapsed monolithically in an aftershock. This is not surprising – if a structure survives the dynamic forces of the main shock and forces associated with partial collapse, without toppling, the damaged structure has established a stable equilibrium during the main shock. Further damage and movement will likely require forces comparable to those of the main shock. Therefore, buildings that survive the main shock without residual lean are highly unlikely to sustain a monolithic overturning failure in an aftershock. The Piño Suarez building (Figure 3-6), consisting of three identical 22-story towers, provides an excellent case study (albeit for a single earthquake). During the main shock, one of the three 22-story towers

collapsed, while the remaining two towers sustained similar column buckling and resulting visible residual lean; however, the two remaining towers did not collapse in the aftershocks.

An example of a cascading collapse occurred at the Piño Suarez complex (Mexico City, Mexico 1985) (Figure 3-6) where a 22-story tower collapsed onto an adjacent 15-story building, causing its collapse. If the first tower to collapse had been located at the other end of the line of towers, all three towers may have collapsed.

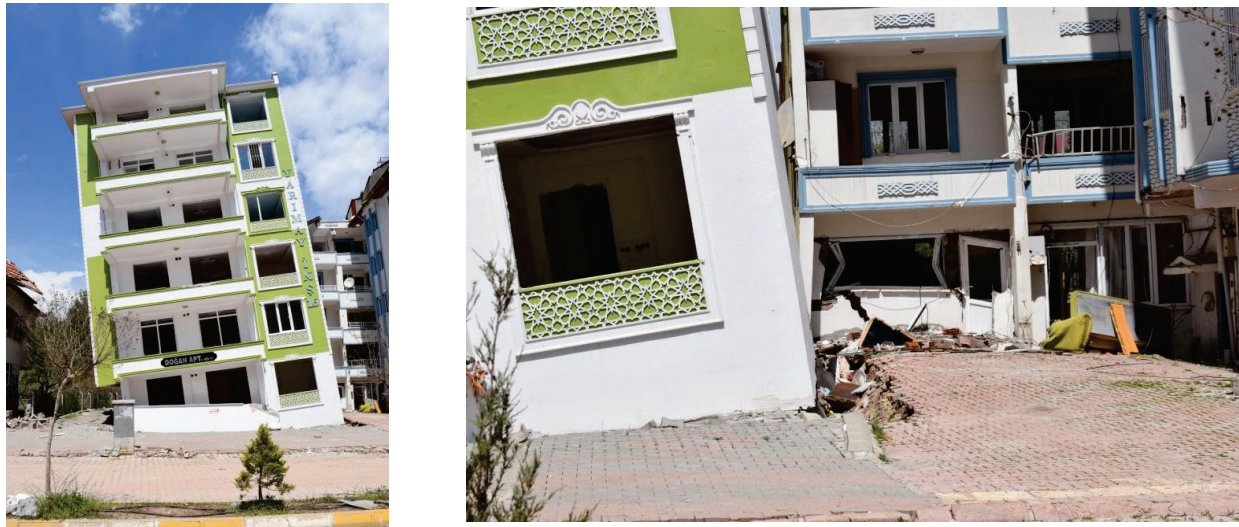
**Figure 3-9 Residential buildings in Gölbaşı in the 2023 Kahramanmaraş Earthquake (Türkiye) (Photo Credit: Thornton Tomasetti/Galvis).**

- One wing of the Royal Palm Resort partially collapsed in the 1993 Guam Earthquake due to shear failure of second story columns along the front face resulting in significant residual lean (Figure 3-7)
- The Weiguan Jinlong Building overturned during the 2016 Southern Taiwan Earthquake (Figure 3-8)
- Multiple residential buildings in Gölbaşı (Türkiye) were affected by liquefaction after the 2023 Kahramanmaraş earthquake sequence (Figure 3-9)

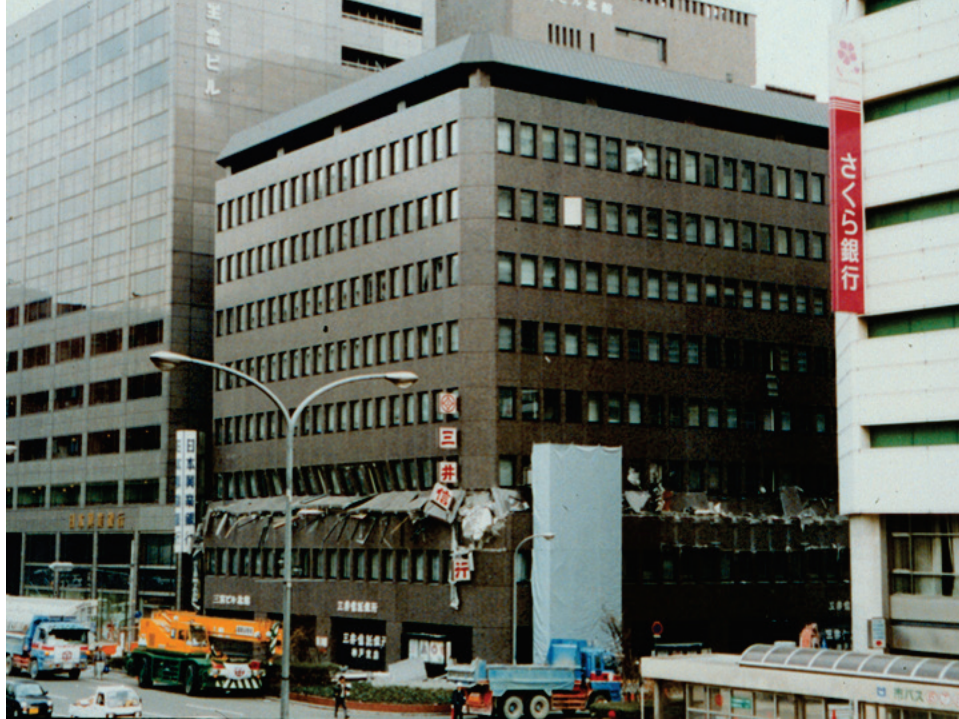
**Figure 3-14 Third story collapse of 10-story office building in 1995 Kobe Earthquake in Japan (Source: Exponent/Osteraas).**

- Weak or soft story collapses occurred in the mid-stories of several buildings in the 1995 Kobe Earthquake (Japan), as shown in Figures 3-14 and 3-15.

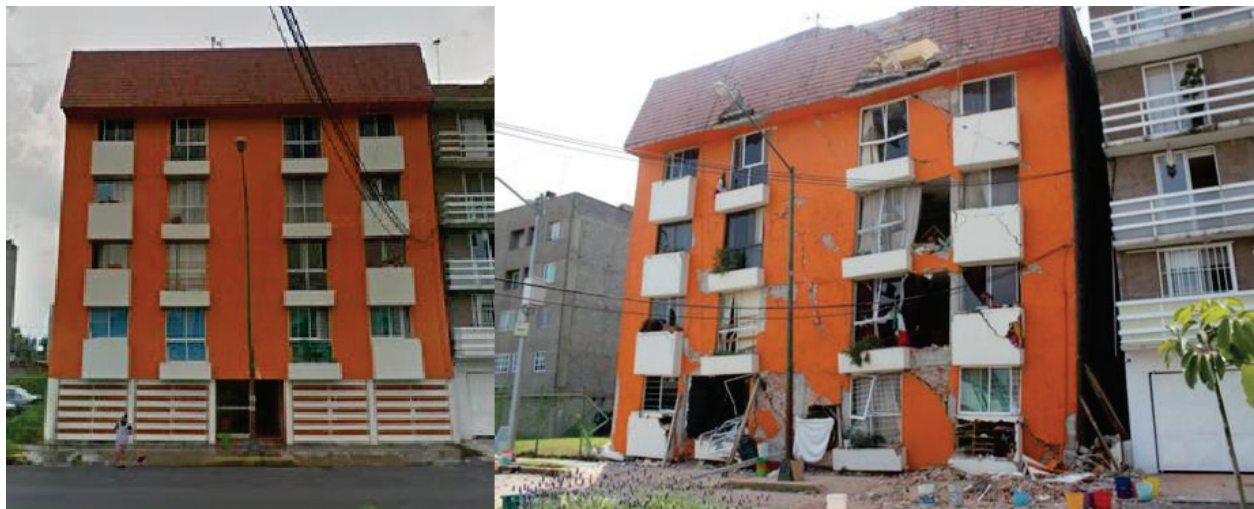
**Figure 3-16** Residential building before and after 2017 Puebla-Morelos Earthquake (Galvis et al. 2021).

- The first story of several buildings in Mexico City, Mexico collapsed after the 2017 Puebla-Morelos Earthquake, leaving the remaining portions of the buildings stable (albeit extensively damaged) against further collapse, as shown in the example of Figure 3-16. For the buildings identified in the literature review, the collapse shadow was well defined as a rectangle with a length equal to the height of the weak or soft story and width equal to the building width along the “front” side of the building. For buildings with potential cascading story failures, the length of the collapse shadow could extend to a length equal to the height of the building above the weak or soft story.

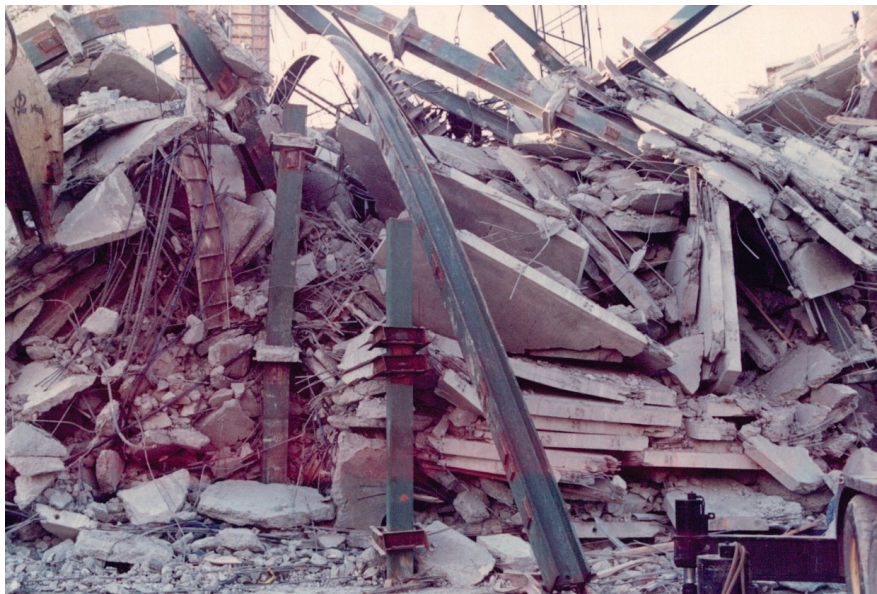
**Figure 3-27** L'Ambiance Plaza collapse during construction, Bridgeport, Connecticut, 1987 (Exponent/Peraza).

- Macy's department store floor collapse in the 1994 Northridge Earthquake (Figure 3-26)
- Collapse of L'ambiance Plaza in Bridgeport, Connecticut in 1987 (Figure 3-27). Note, this collapse occurred during the construction of the building.

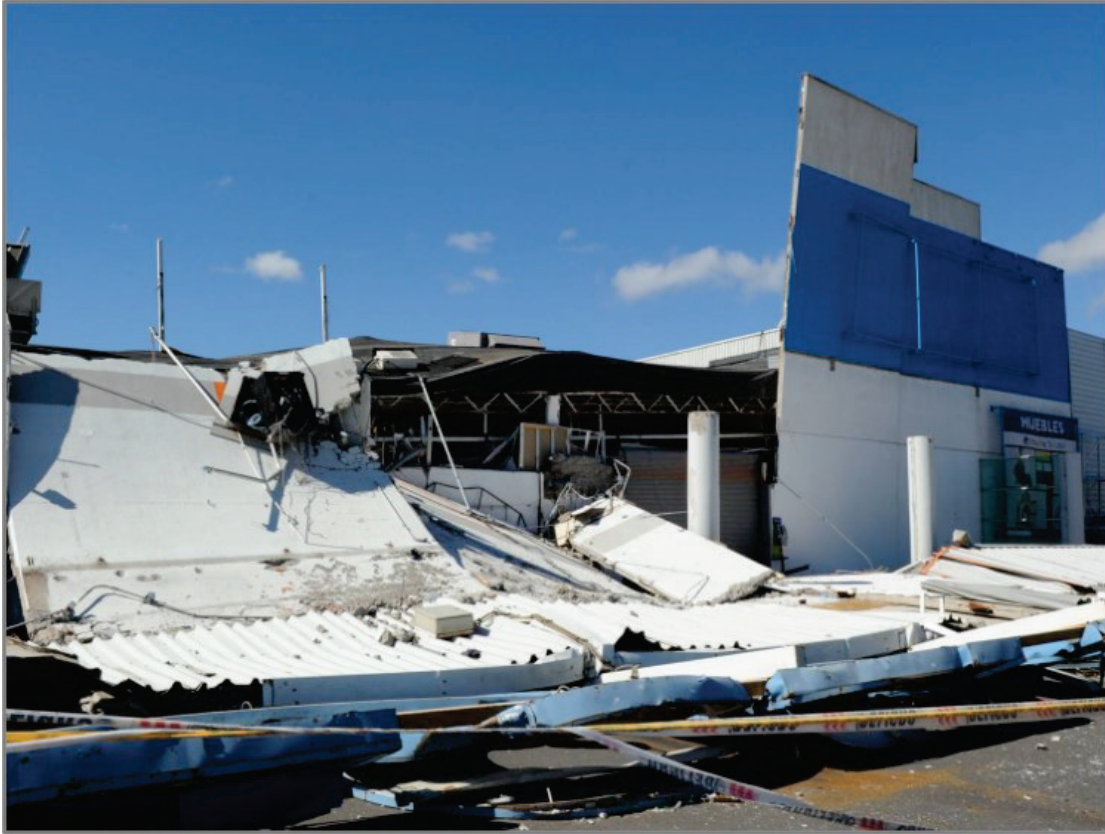
**Figure 3-31 Collapse of tilt-up walls in the 2010 Maule, Chile Earthquake (ATC-20 training slides).**

The tilt-down collapse mode derives its name from the tilt-up construction process, where reinforced concrete panels are cast horizontally on the building floor slab then tilted up into position around the building perimeter. The walls have a mutually beneficial relationship with the upper floors and roof diaphragm: the walls carry the gravity loads and in-plane seismic loads from the floors and roof, while the floors and roof hold the wall panels in a vertical position out of plane. When the connection between the walls and roof/floors is lost, the wall panels fall away from the building and the roof/floors collapse (Figures 3-30 and 3-31).

Tilt-up construction is only used for low-rise buildings (1-4 stories). The collapse shadow of buildings with tilt-up wall panels is always a rectangle perpendicular to the building wall, with length equal to the panel height, starting at the face of the building, and width equal to the width of the collapsed wall.

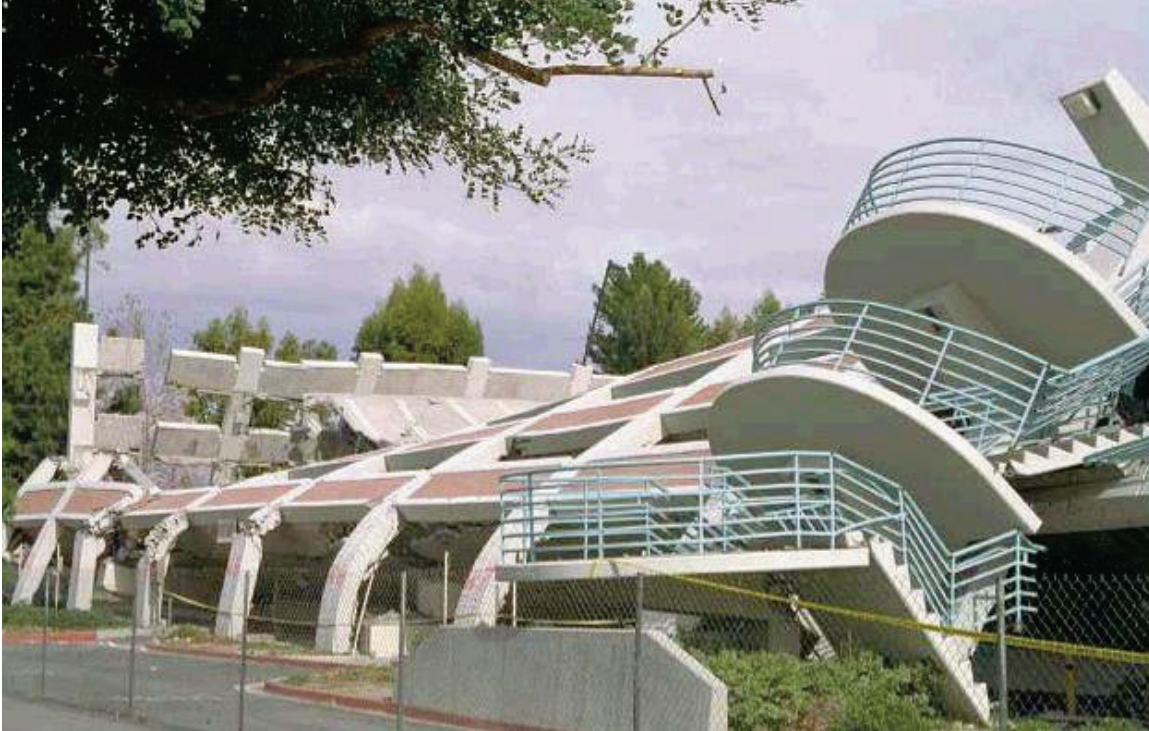
**Figure 3-36** Parking garage damage at Northridge CSU in the 1994 Northridge Earthquake (Exponent/Shusto).

- Northridge Campus parking garage collapsed in the 1994 Northridge Earthquake (Figure 3-36)

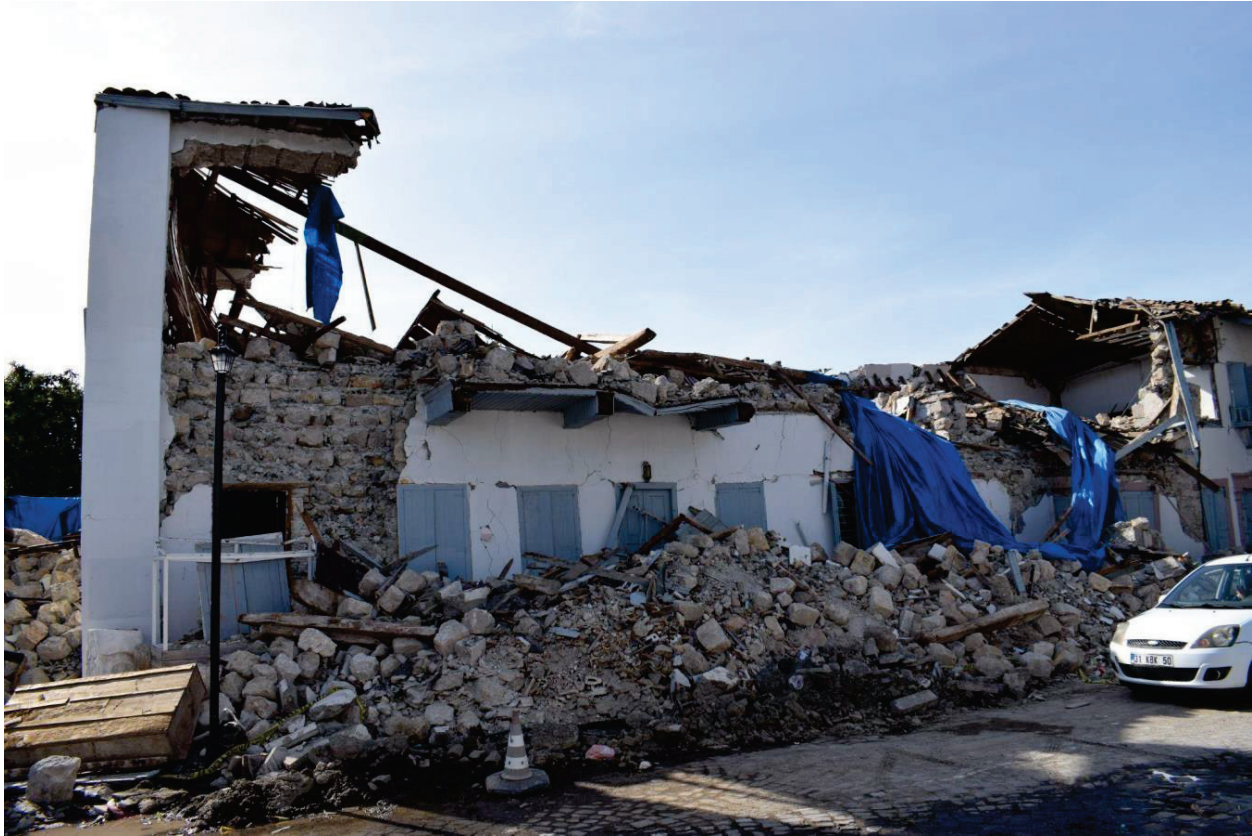
**Figure 3-39 Adobe dwelling in Arsuz after the 2023 Kahramanmaraş Earthquake (Türkiye)**  
(Photo Credit: Thornton Tomasetti/Galvis).

Buildings that are weak and poorly intra-connected, such as adobe, unreinforced masonry, and precast concrete, have little capacity to resist lateral loads caused by ground shaking or P-delta effects associated with tilting of a damaged building. Once cracks develop in the masonry or adobe or when precast members slip off their supports, there is no secondary load path to hold the components together. Thus, weak and poorly intra-connected buildings generally collapse into a rubble pile (Figure 3-39) that does not extend significantly beyond the building's footprint.
